Report on the investigation of the
near miss between
Pride of Cherbourg and Briarthorn
in the Eastern Solent
on
7 February 2001

Marine Accident Investigation Branch
First Floor
Carlton House
Carlton Place
Southampton
United Kingdom
SO15 2DZ

**Report No 4/2002
February 2002**

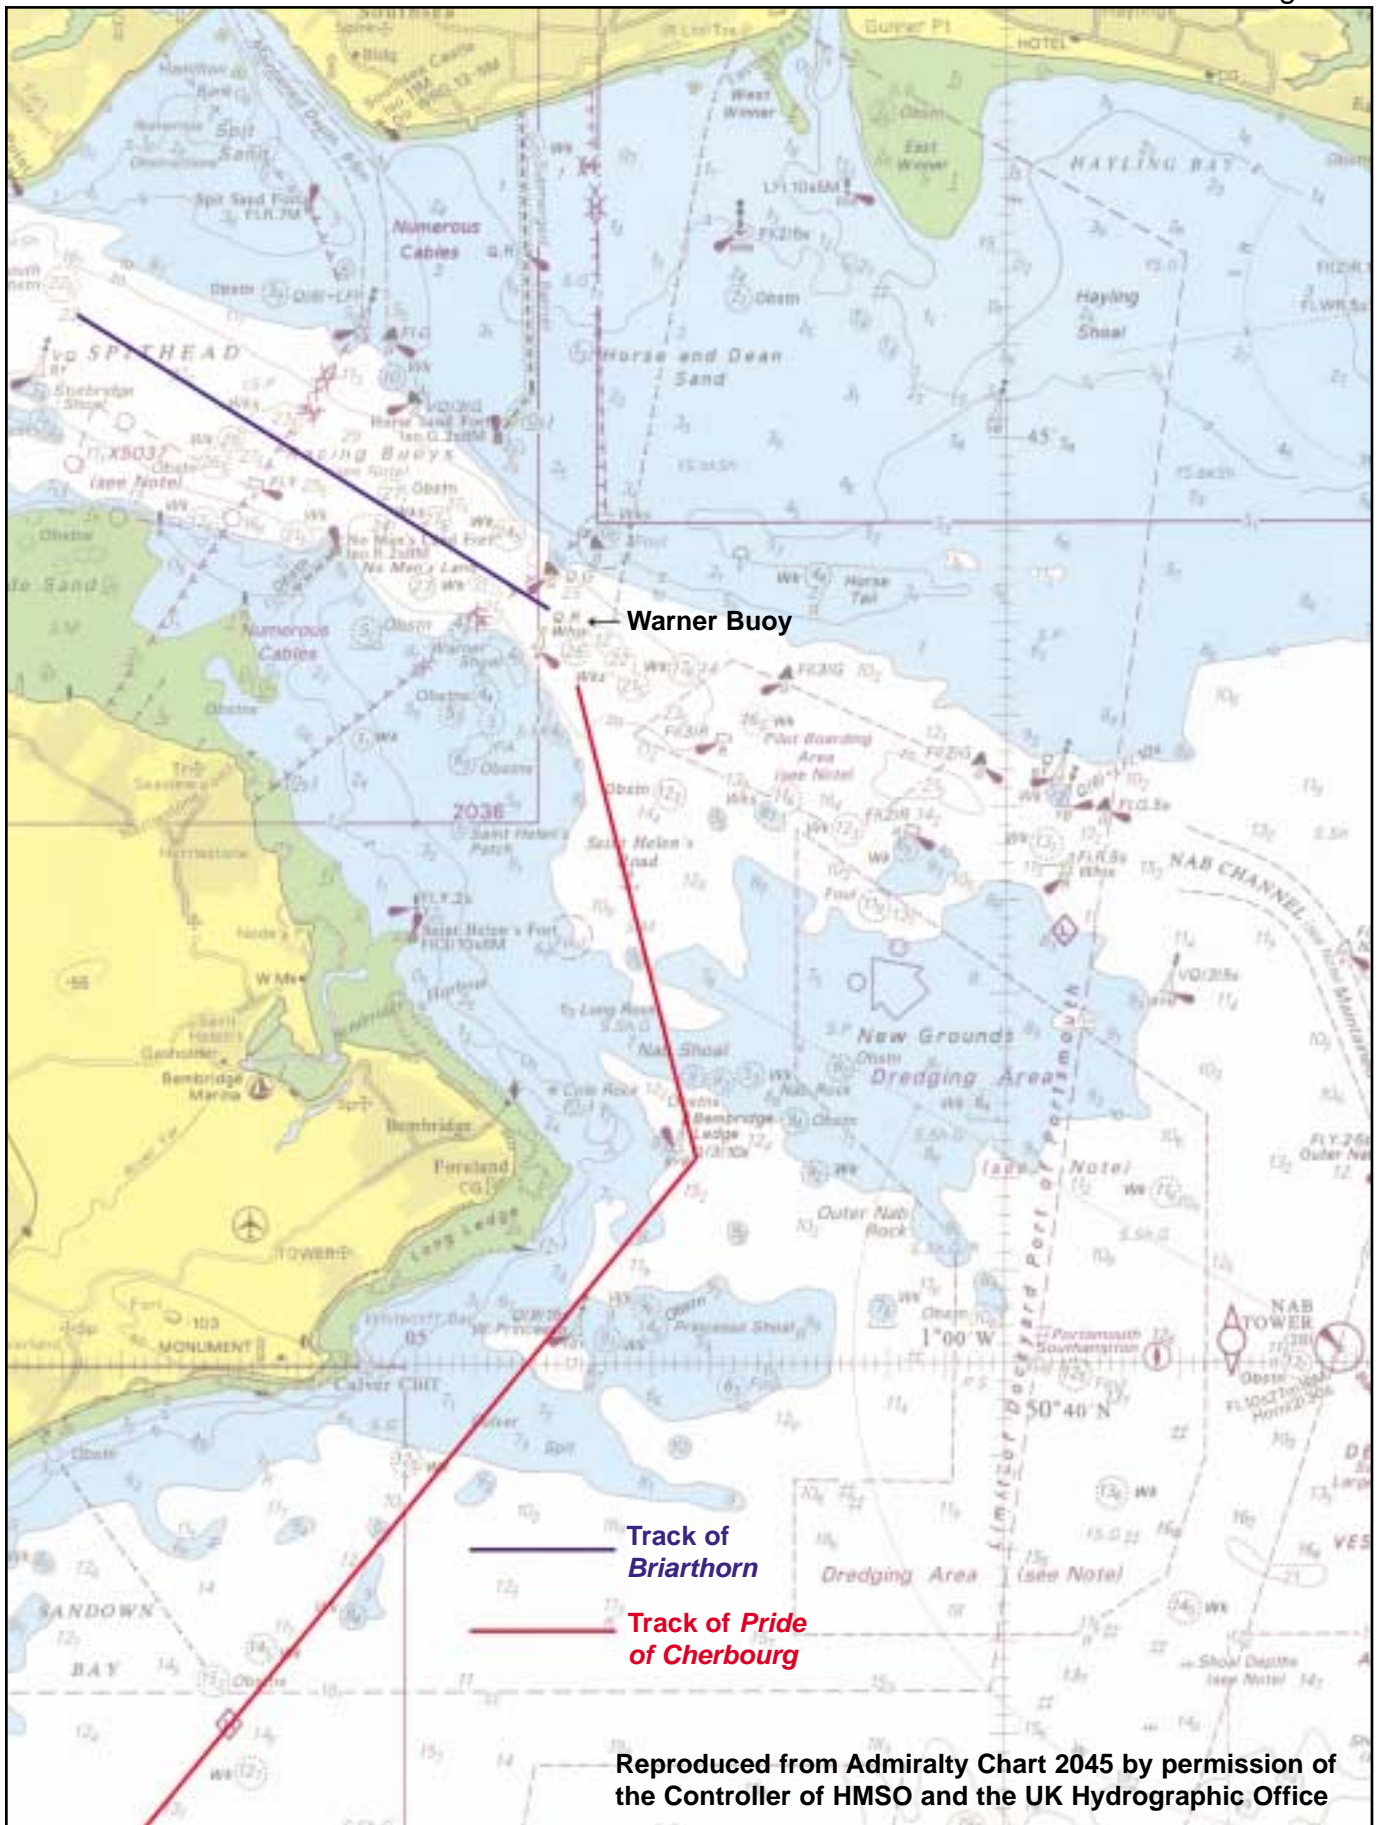
Figure 1

The Portsmouth-Cherbourg route was a busy service with each vessel usually making three round trips each day. The distance between the two ports is about 76 miles, and takes about 5 hours during the day and 7 hours at night to fit in with schedules. The passage crosses the central part of the English Channel. The Cherbourg vessels do not, usually, use the Nab approach or the New Grounds passage as normally used by the majority of vessels bound to and from the Eastern Solent. Instead, after departing Portsmouth, the vessels leave the main channel at the Warner buoy, pass across St Helen's Roads, to the east of Bembridge ledge, west of the West Princessa buoy and across Sandown Bay. This is the normal route for ferries and some other vessels bound to or from Cherbourg or the Channel Islands. When bound to Portsmouth the reciprocal route is followed. This saves about 2 miles instead of using the New Grounds passage and about 5 miles instead of using the Nab approach (**see Figure 1**).

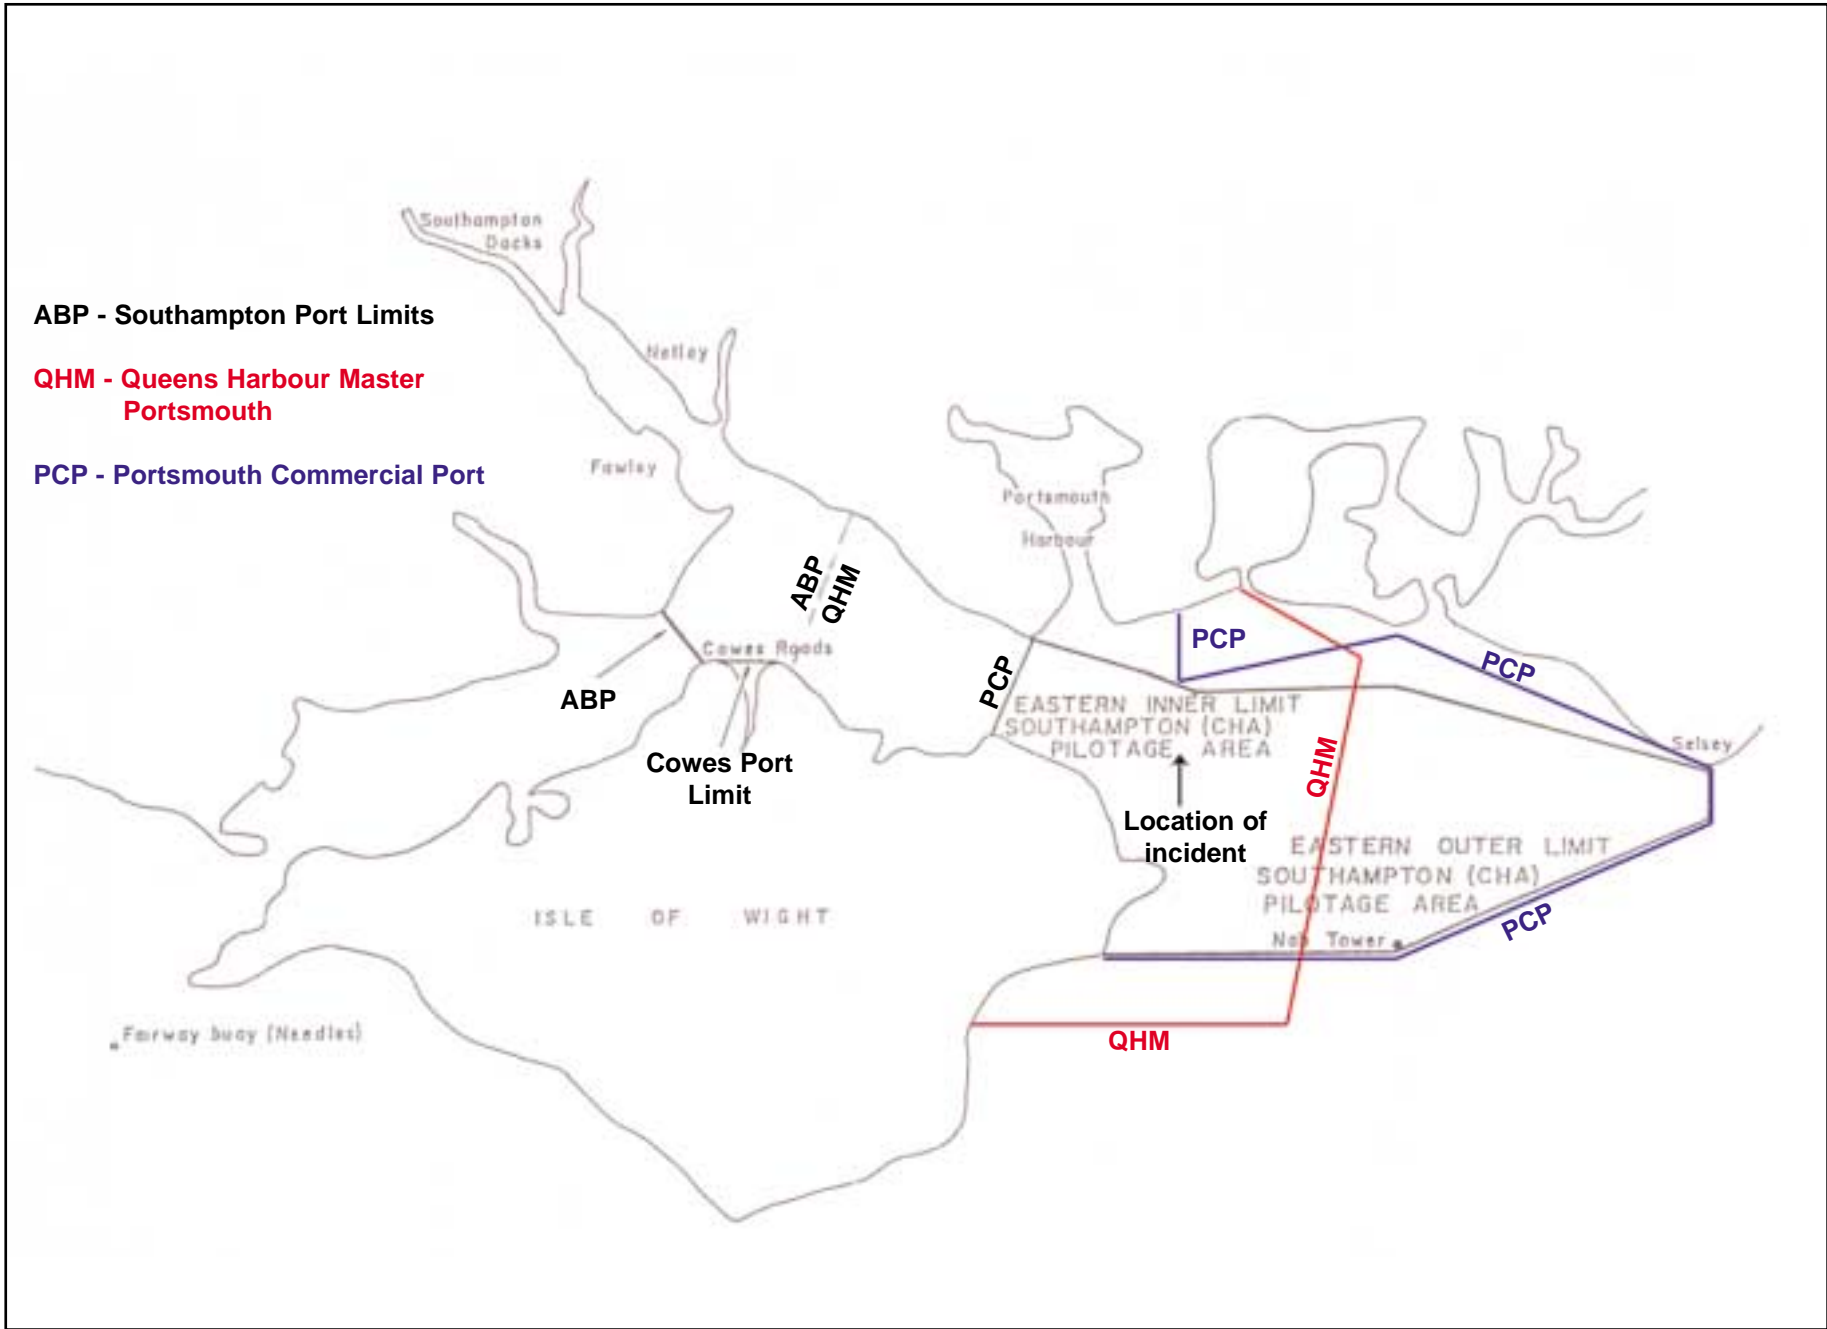
Figure 12

The Eastern Solent falls within the remit of four authorities, namely, Portsmouth naval port, Portsmouth commercial port, Cowes port and Southampton port (**see Figure12**).
