Report on the investigation of
the grounding of
Happy Lady
off Shoebury Ness,
Thames Estuary
21 January 2001

Report No 21/2001

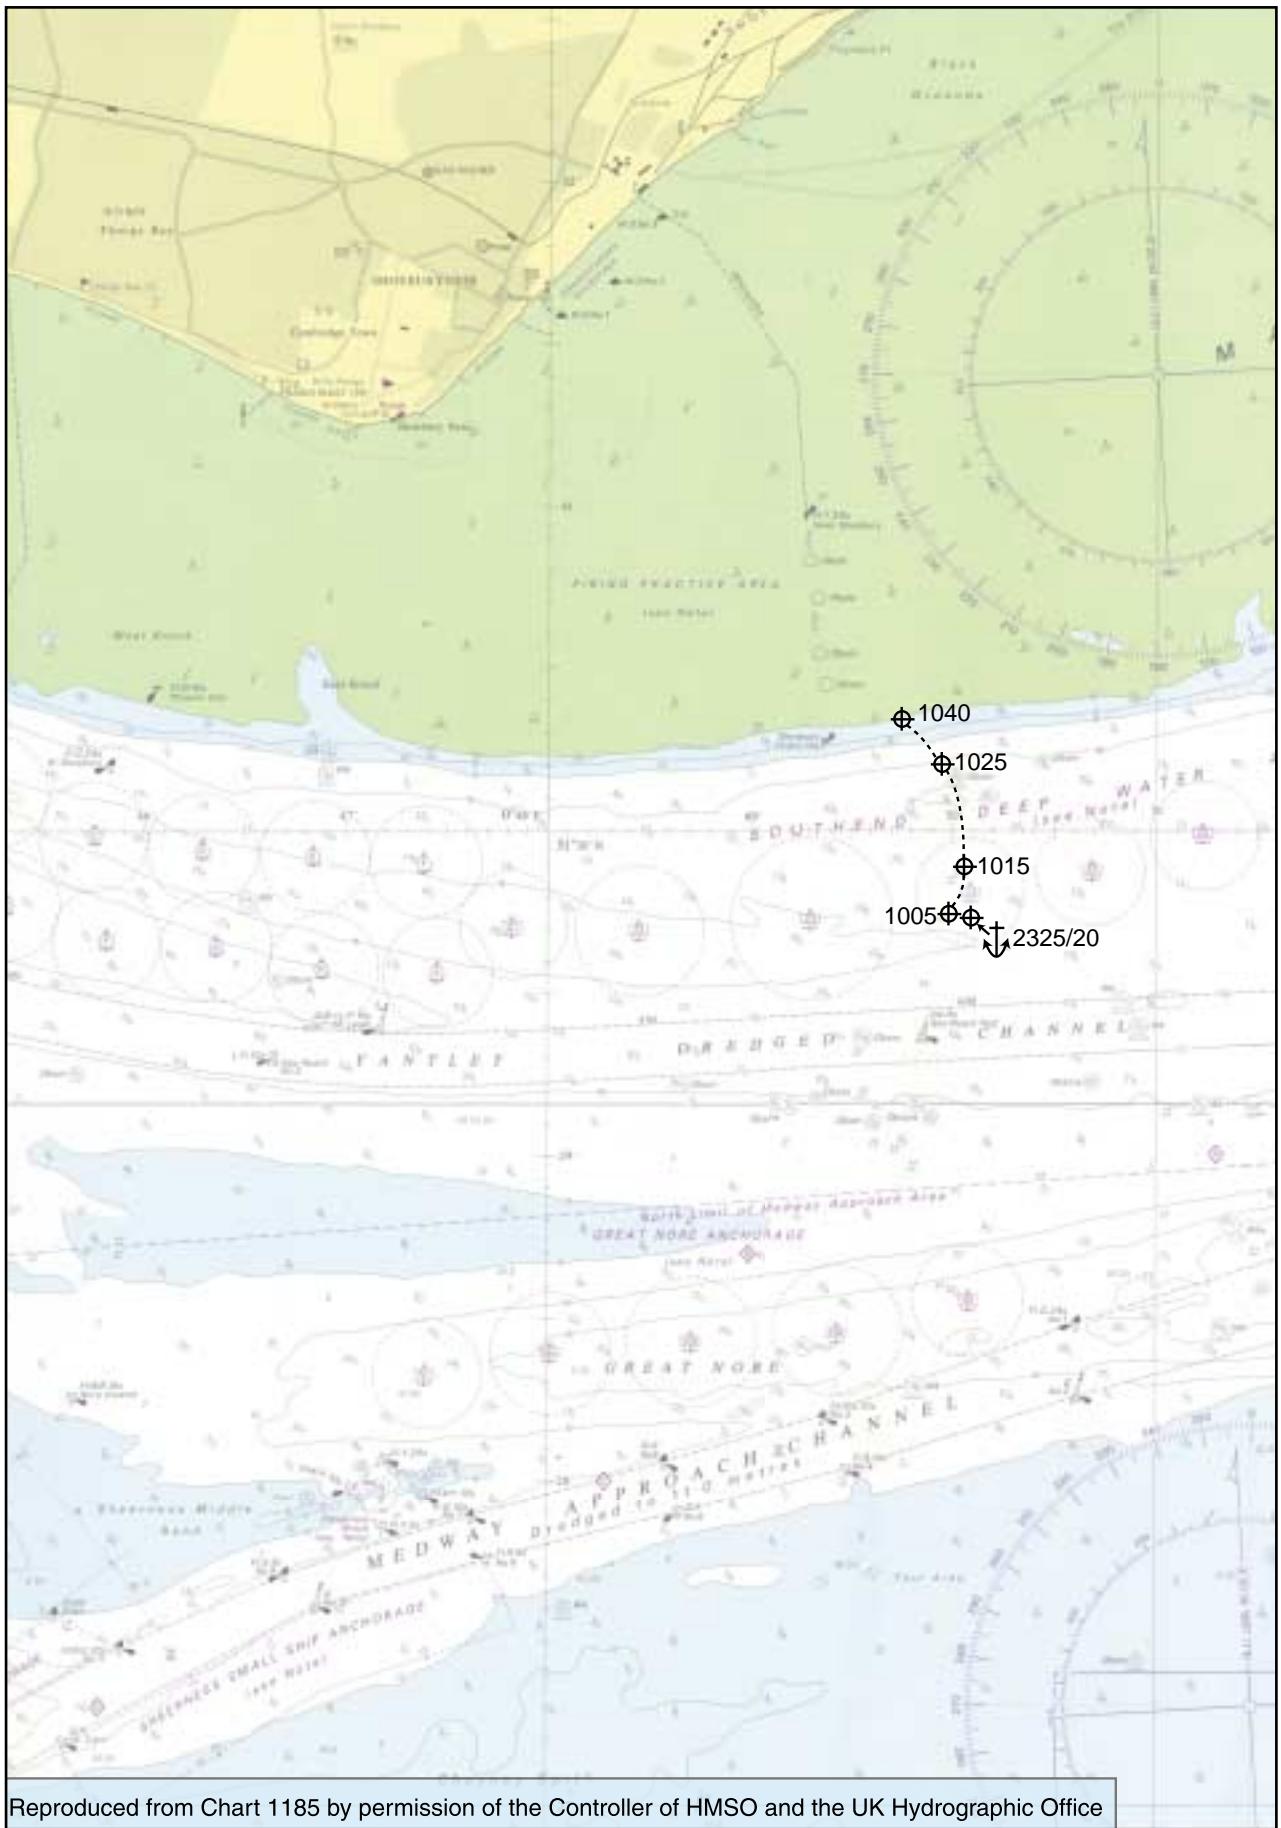
Figure 7

The drift of the vessel towards the sandbank was recorded both on the vessel's GPS recorders and the PLA VTS's radar system (**Figure 6 PLA plot**). It is clear that *Happy Lady* dragged her anchor steadily at about 1.25 knots in a north-northeasterly direction between 1015 and the time of grounding at about 1040 (**Figure 7 Chart Extract**). During this time the master was trying to clear the anchor cable which was leading over the bulbous bow and around the raked stem. The bell book reveals that the master used various ahead and astern engine movements in addition to the bow thruster and the rudder. He was unable to clear the anchor cable from the bulbous bow. The bow thruster was having little or no effect, and the master had stopped using it by the time the vessel's head had reached about 300°.

PLA plot
