Report on the investigation of  
a collision between  
***Nordsee and Poole Scene***  
in the River Clyde on  
27 December 2000

**Report No 40/2001  
December 2001**

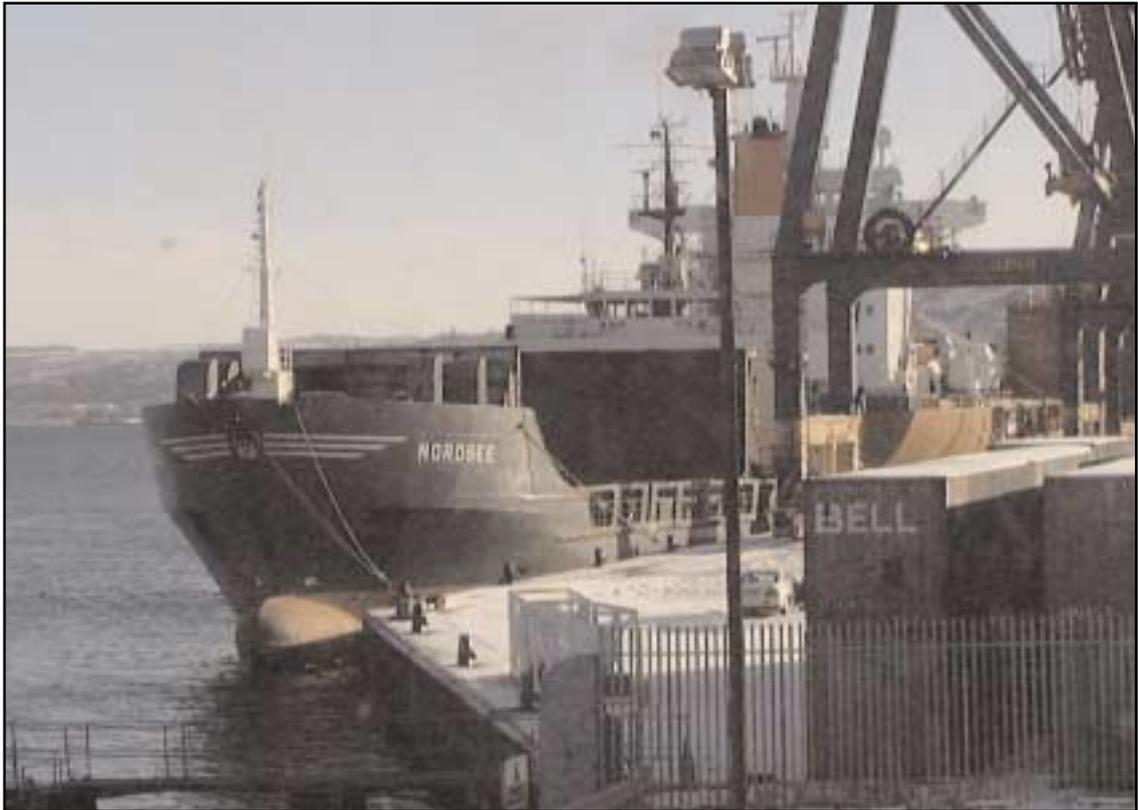
Figure 1

*Nordsee*

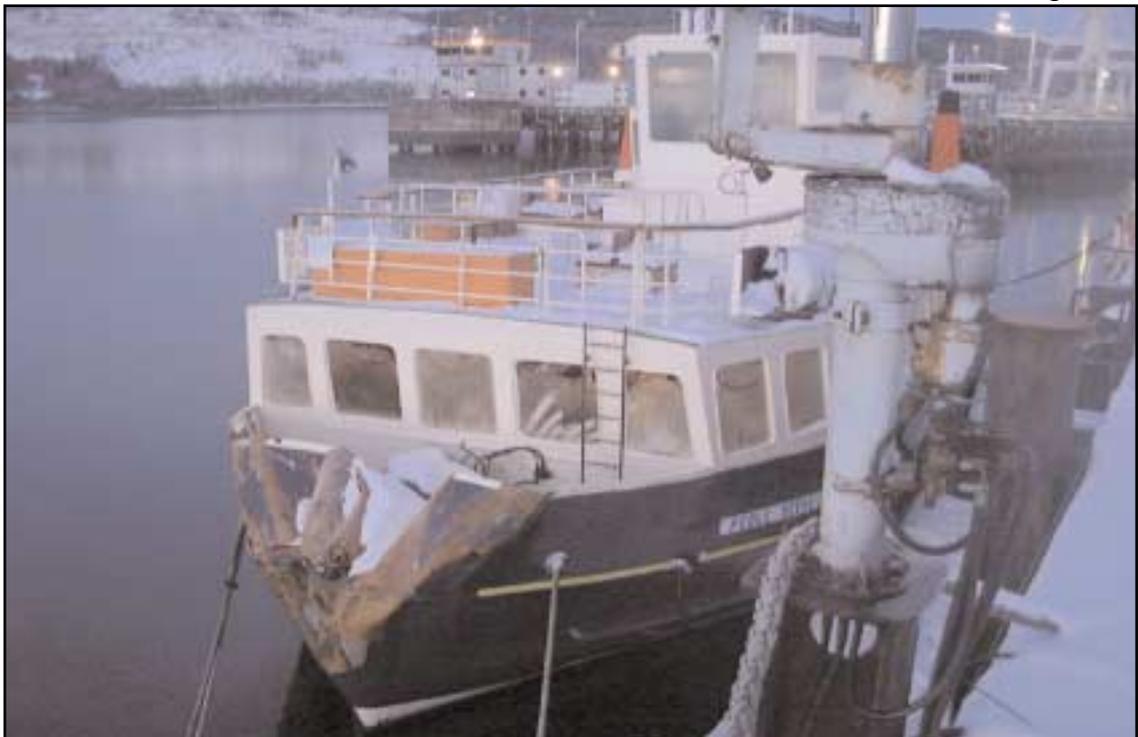
Figure 2

*Poole Scene*

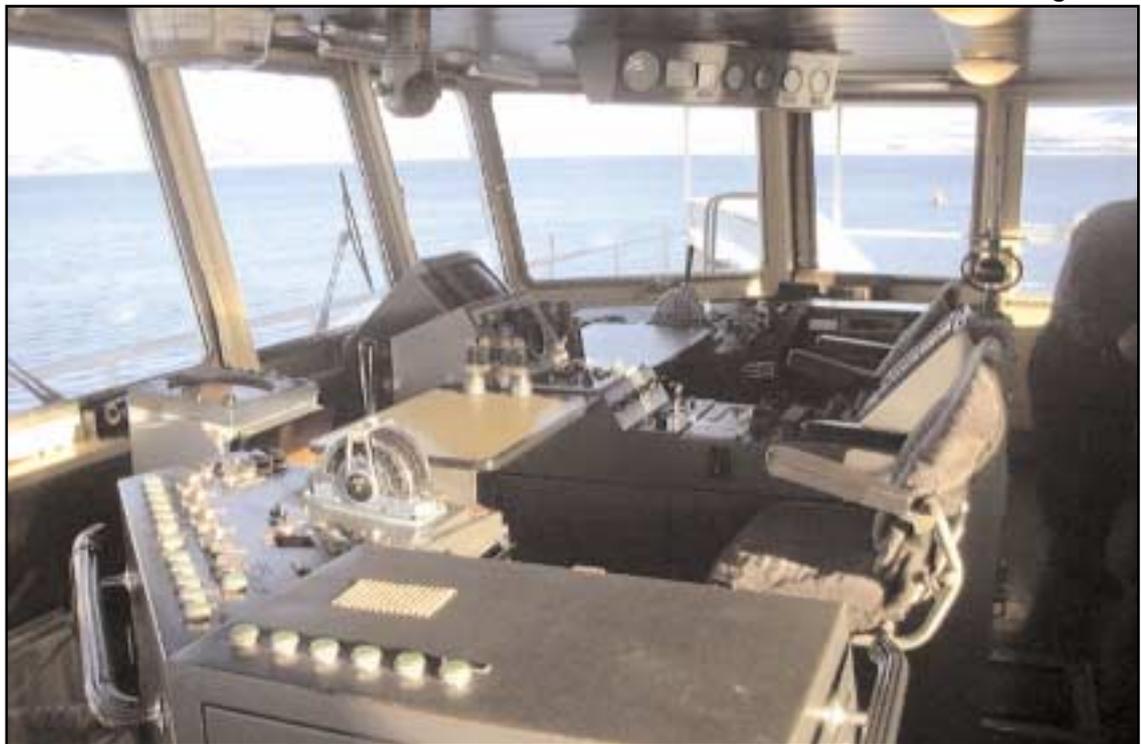
Figure 3

The majority of the navigational equipment was strategically housed in an operating console, positioned centrally forward on the bridge. The wheel, tiller and two bridge chairs were behind the console (**see Figure 3**).

*Nordsee* - bridge

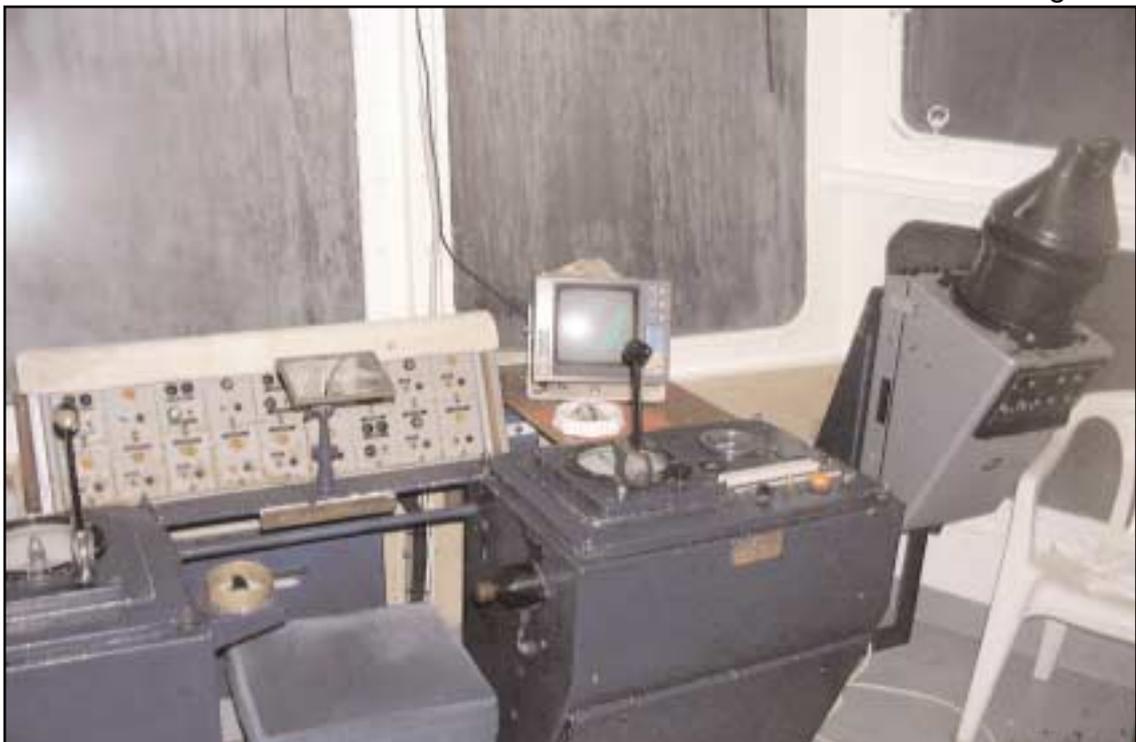
Figure 4

*Poole Scene* was fitted with the following navigational equipment: a standard magnetic compass, which was housed in the deckhead and visible through a mirror mounted centrally at seating height in the wheelhouse, VHF radio, echo sounder and two relative motion radars, of which one was not normally used (**see Figure 4**). The radar in use did not incorporate an integrated plotting facility, and there was no legal requirement for one to be fitted.

*Poole Scene* - wheelhouse
