Report on the investigation of  
accident to lifeboat and fast rescue craft from

***European Highway***

in Zeebrugge on 1 December 2000

**Report No 1/2002  
January 2002**

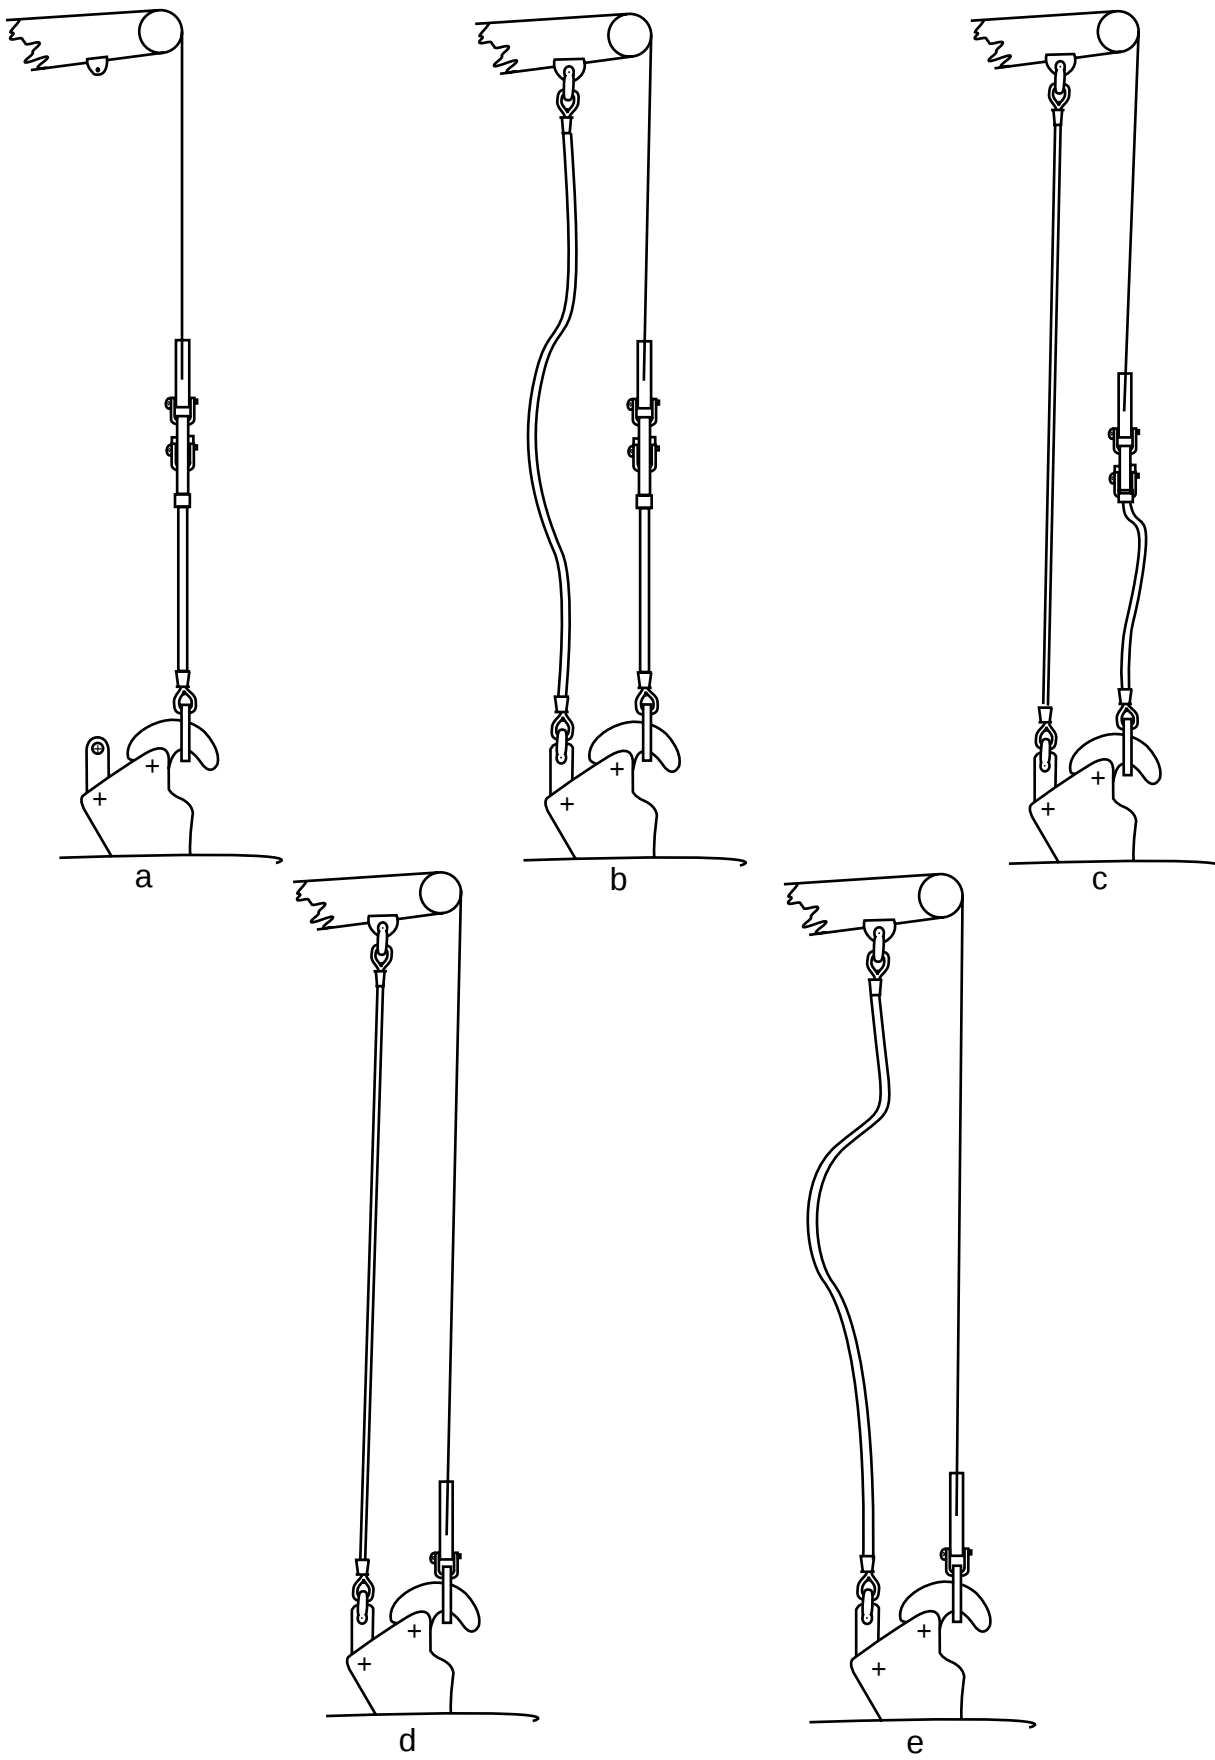
When recovery pendants are used to lift a lifeboat clear of the water, before attempting to transfer the boat's weight on to the lower block suspension plates, the hanging-off pendants must be connected between the davit heads and the hanging-off lugs on the suspension hooks (**Figures 7a & b**).

Once these are connected, the winch may be paid out until the hanging-off pendants are taking the boat's weight and the falls are slack (**Figure 7c**). The suspension rings of the recovery pendant can then be released from the suspension hooks and, after paying out the winch slightly, they can be replaced by the lower blocks' suspension plates (**Figure 7d**).

The winch can then be hoisted until the falls take the boat's weight and the hanging-off pendants are slack (**Figure 7e**). The hanging-off pendants can then be released from the boat's hanging-off lugs and secured in their stowage clips on the davit arms. The boat can then be fully stowed.

Sequence for transferring load from recovery pendants to lower blocks

When recovering the lifeboat from the water using the foul weather recovery system, the recovery pendant becomes free only after the hanging off pendants are attached to their lugs (**Figure 7d**). The lifting rings of the recovery pendants are thus not free and available to be connected to the hanging off pendants.

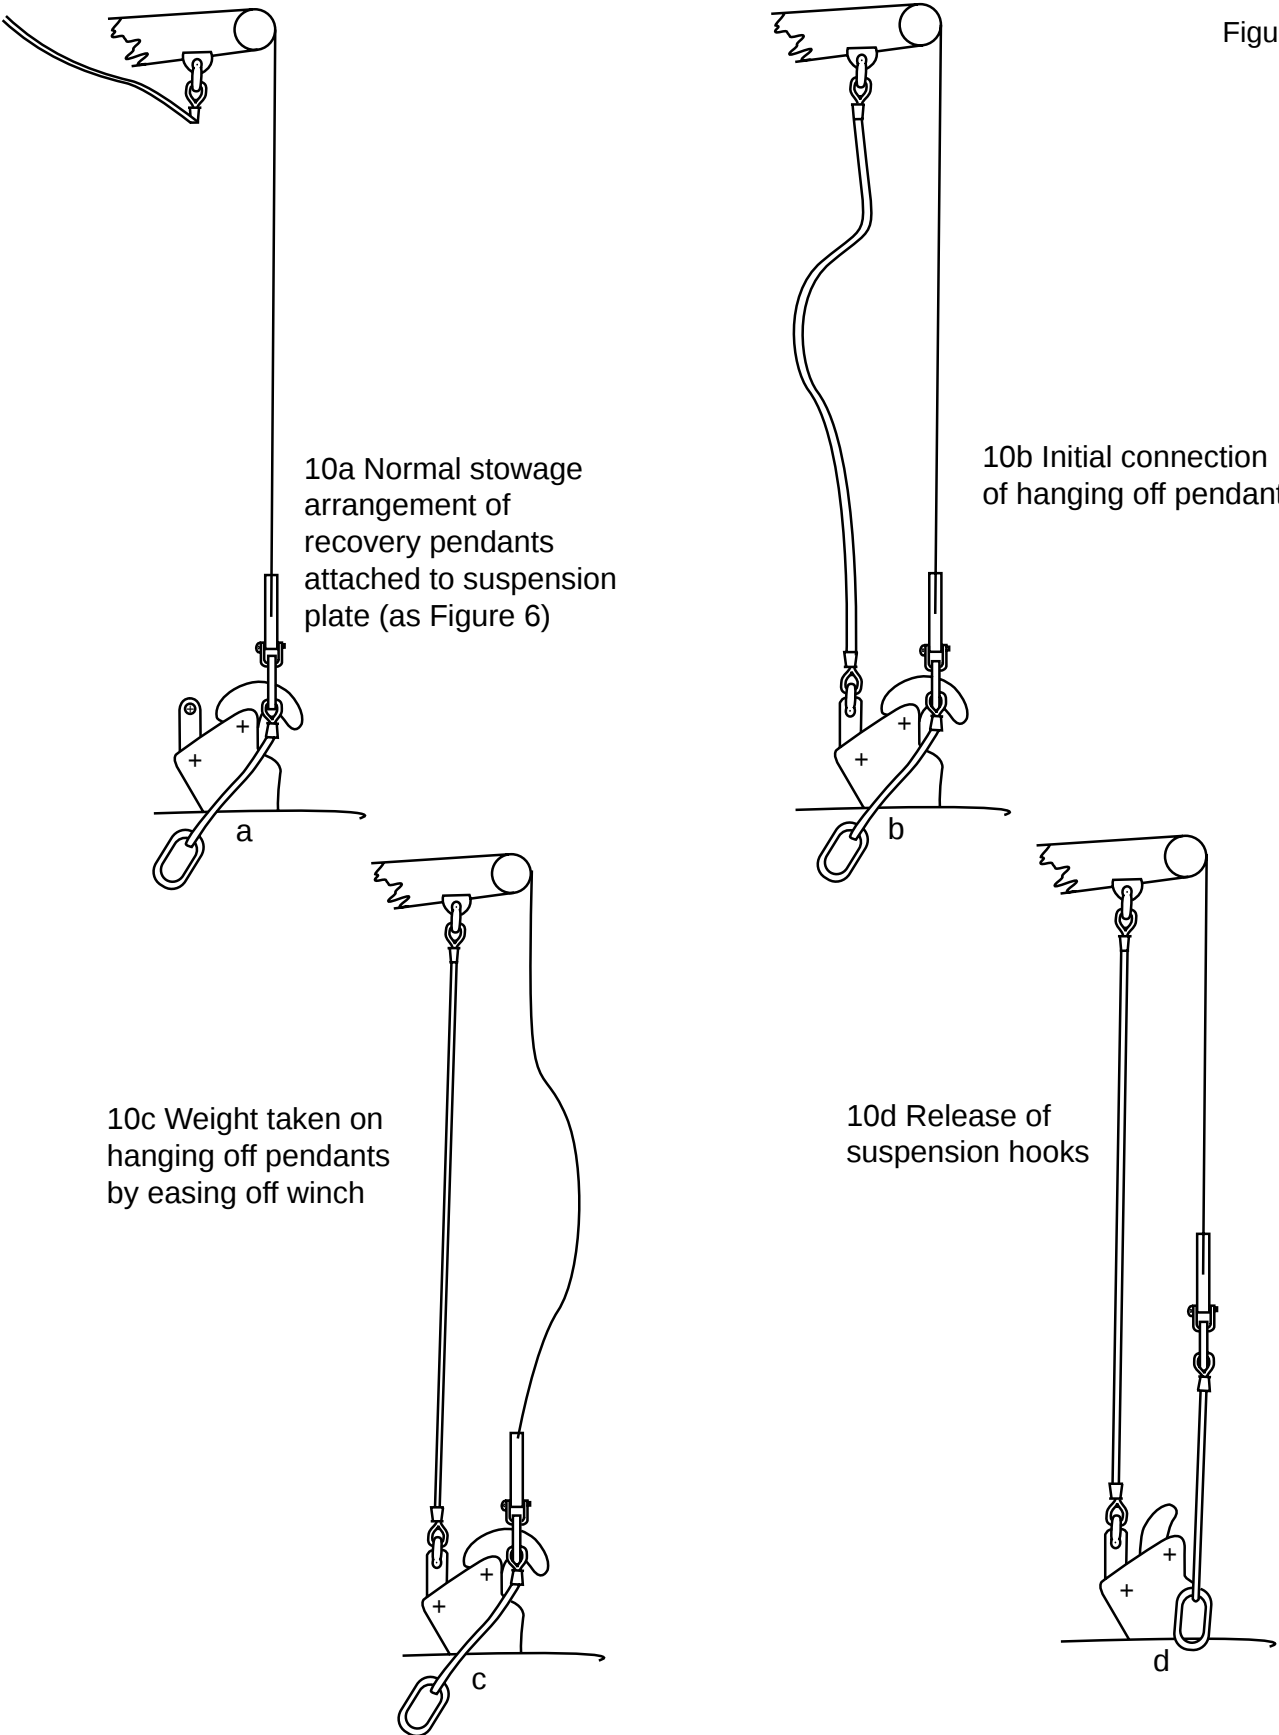
Figure 10a-d

The arrangement required for hanging off to maintain the hooks is shown in **Figure 10d**. This was the state the carpenter intended to achieve. The steps necessary to achieve this, when the lifeboat is in the stowed position, **Figures 10 a - d**, are not shown in the instructions.

Sequence to support lifeboat on hanging off pendants after swinging out davits from stowed position
