Report on the investigation  
of a man overboard incident from  
***Atlantic Princess H90***  
in the English Channel  
on 23 November 2000

Marine Accident Investigation Branch  
First Floor, Carlton House  
Carlton Place  
Southampton  
SO15 2DZ

**Report No 32/2001**  
**August 2001**

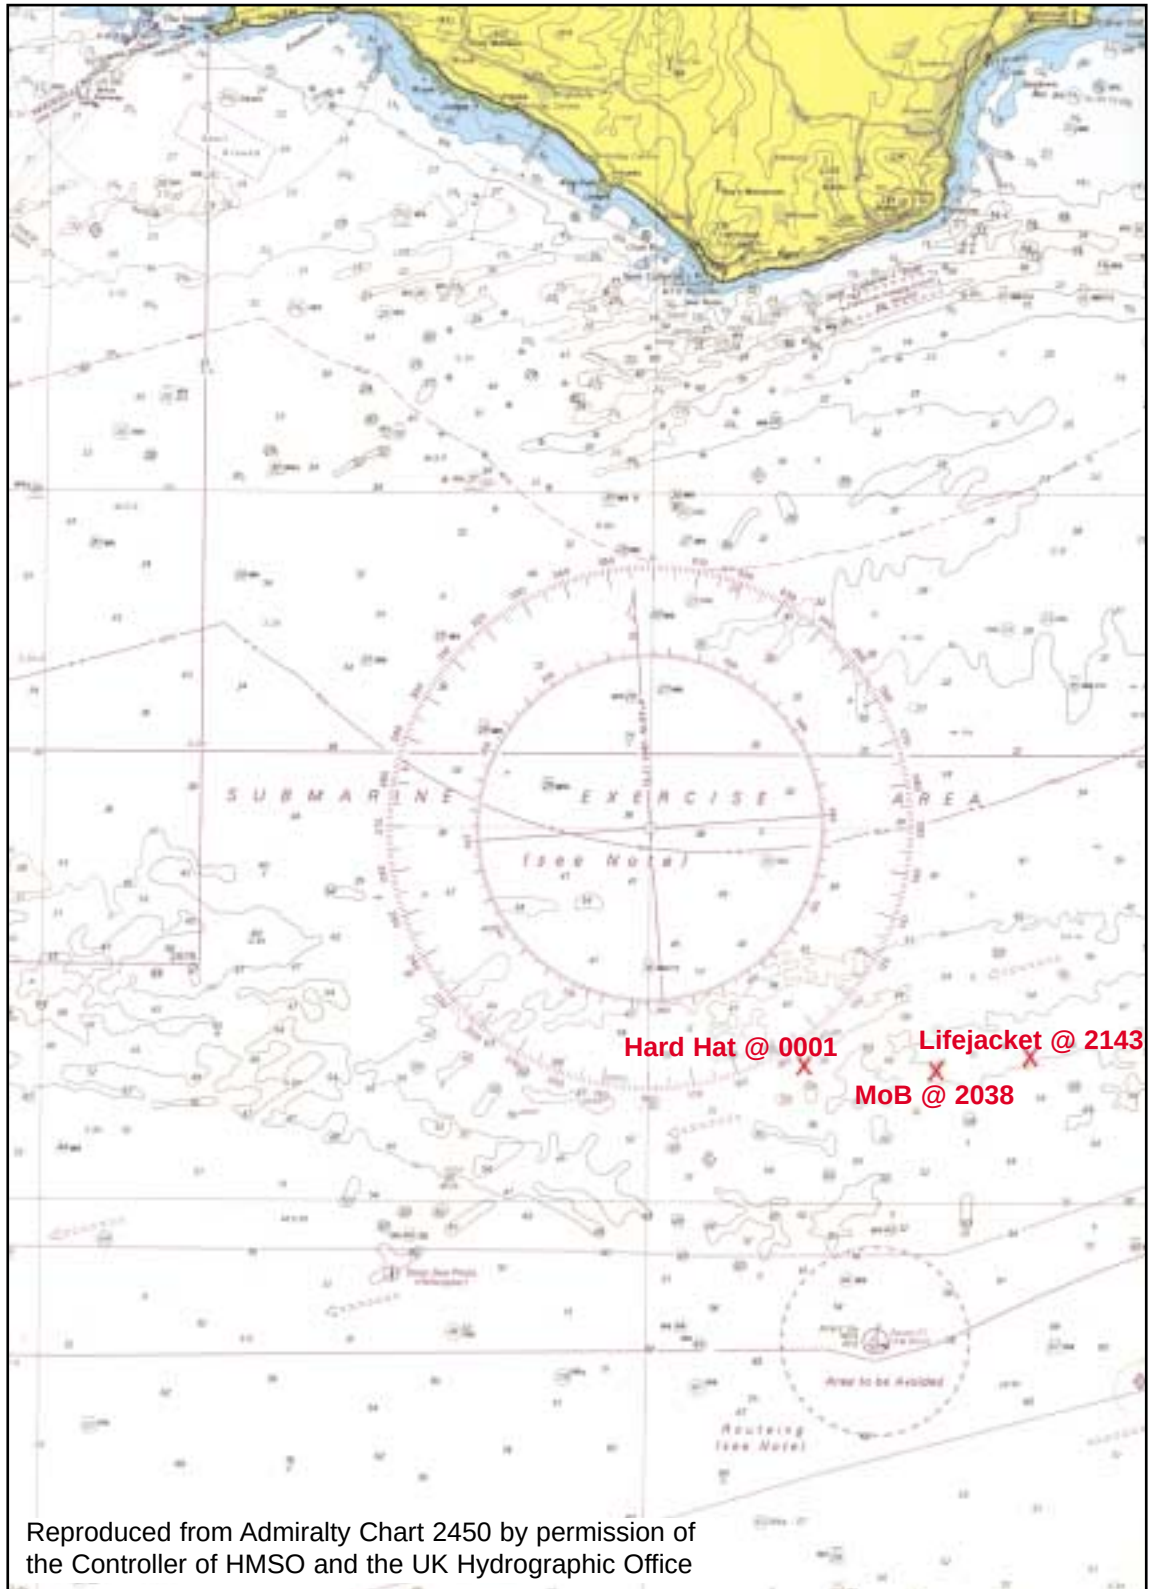
Figure 6

The recorded positions of lifejacket, hard hat and the original man-overboard report are, within a quarter of a mile, on the same latitude (**Figure 6**). This is consistent with the observations that the tide was running either to, or from, the east throughout the SAR operation. There is no reason to suppose that the tidal

stream affected the missing crewman any differently to the lifejacket and hard hat. Thus the latitude of the man-overboard report and the lifejacket sighting gave a very good datum for the search. In spite of this line being searched by several units, including helicopter IJ, no sign of the man was found. It is assumed that by that time he had drowned.
