Report on the investigation of

# European Tideway and Vrouw Grietje

in the North Sea

> Report No 25/2001 25 May 2001

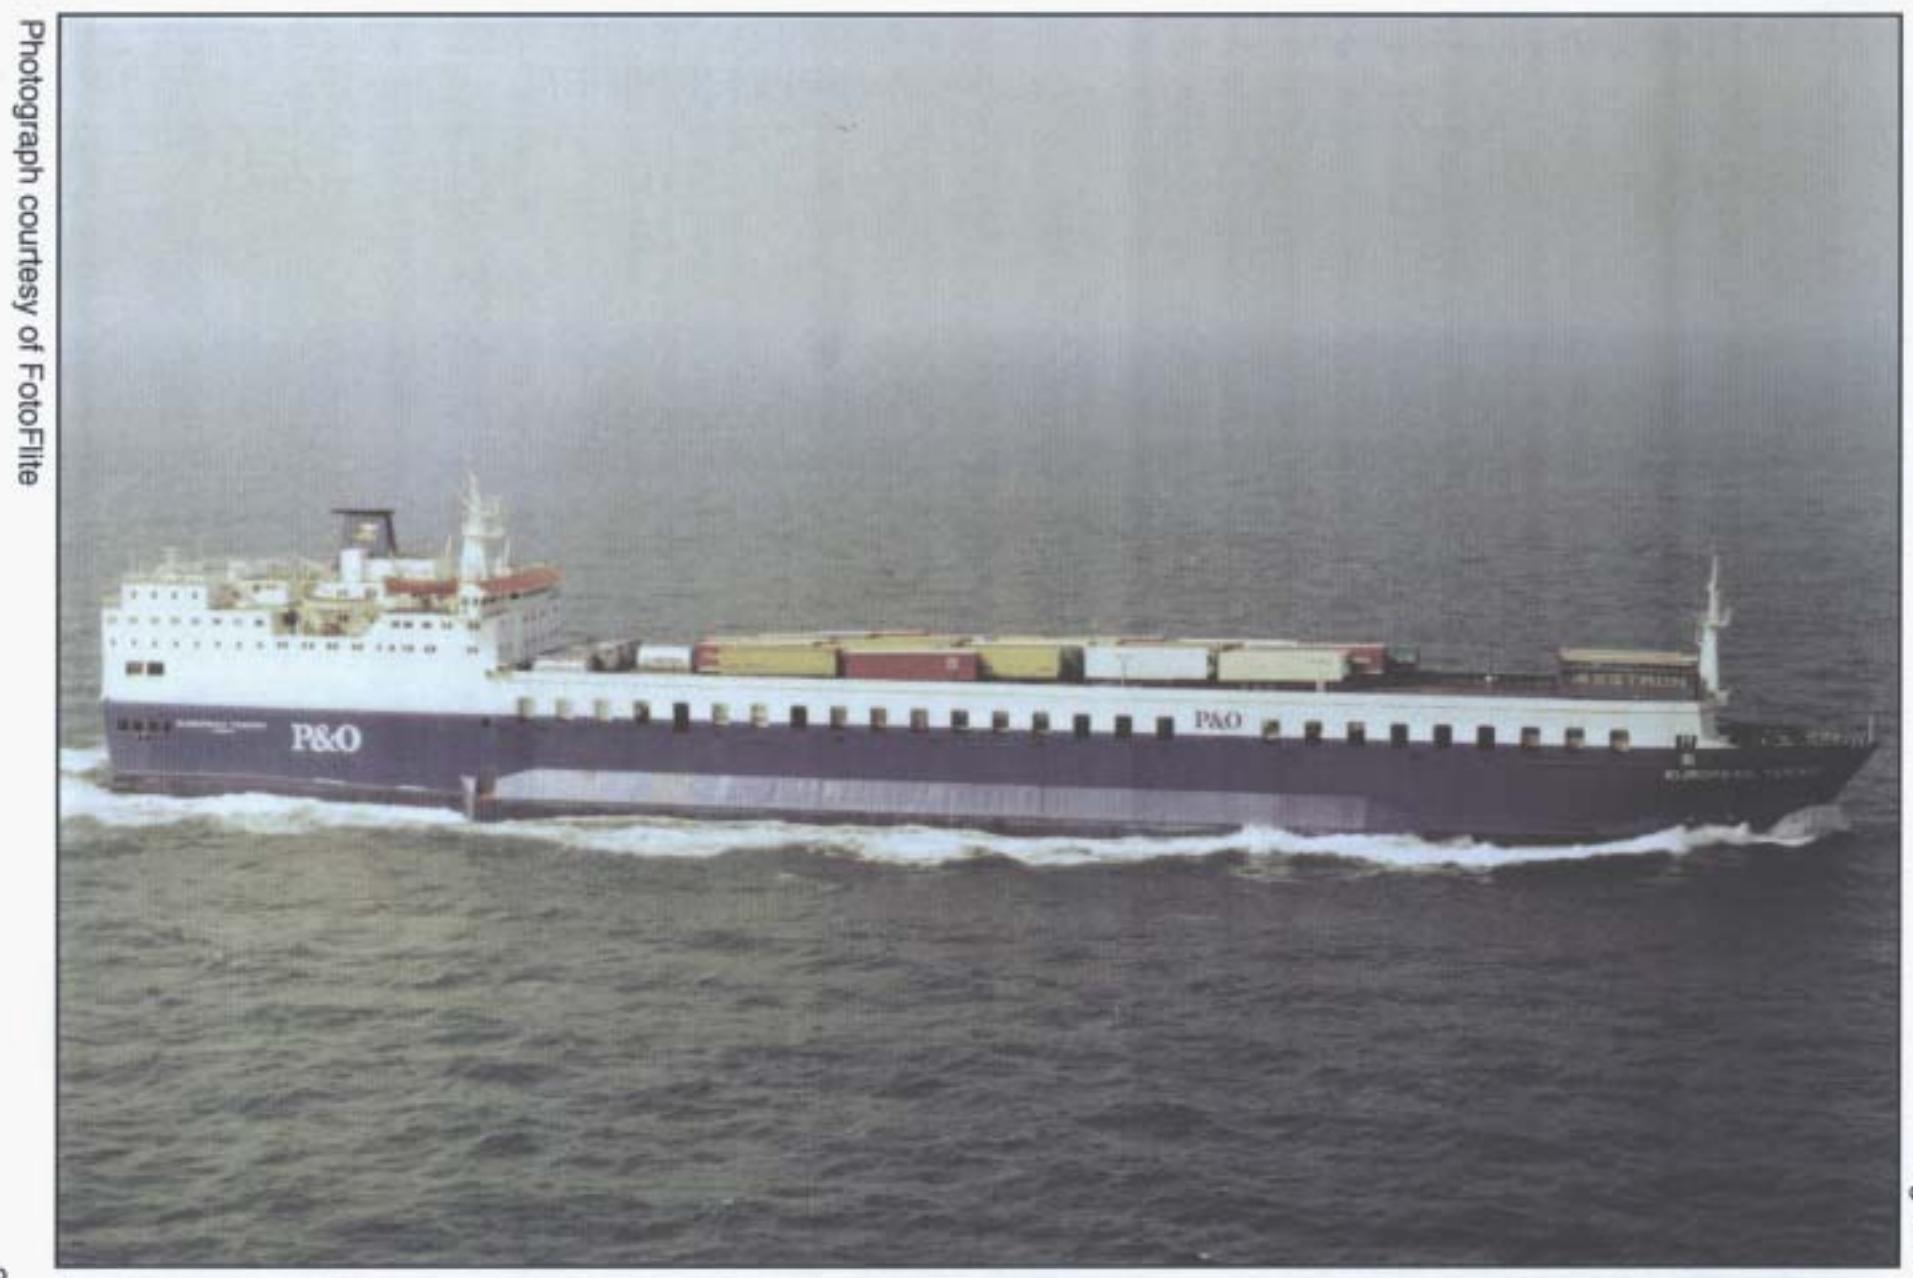
Figure 1

European Tideway

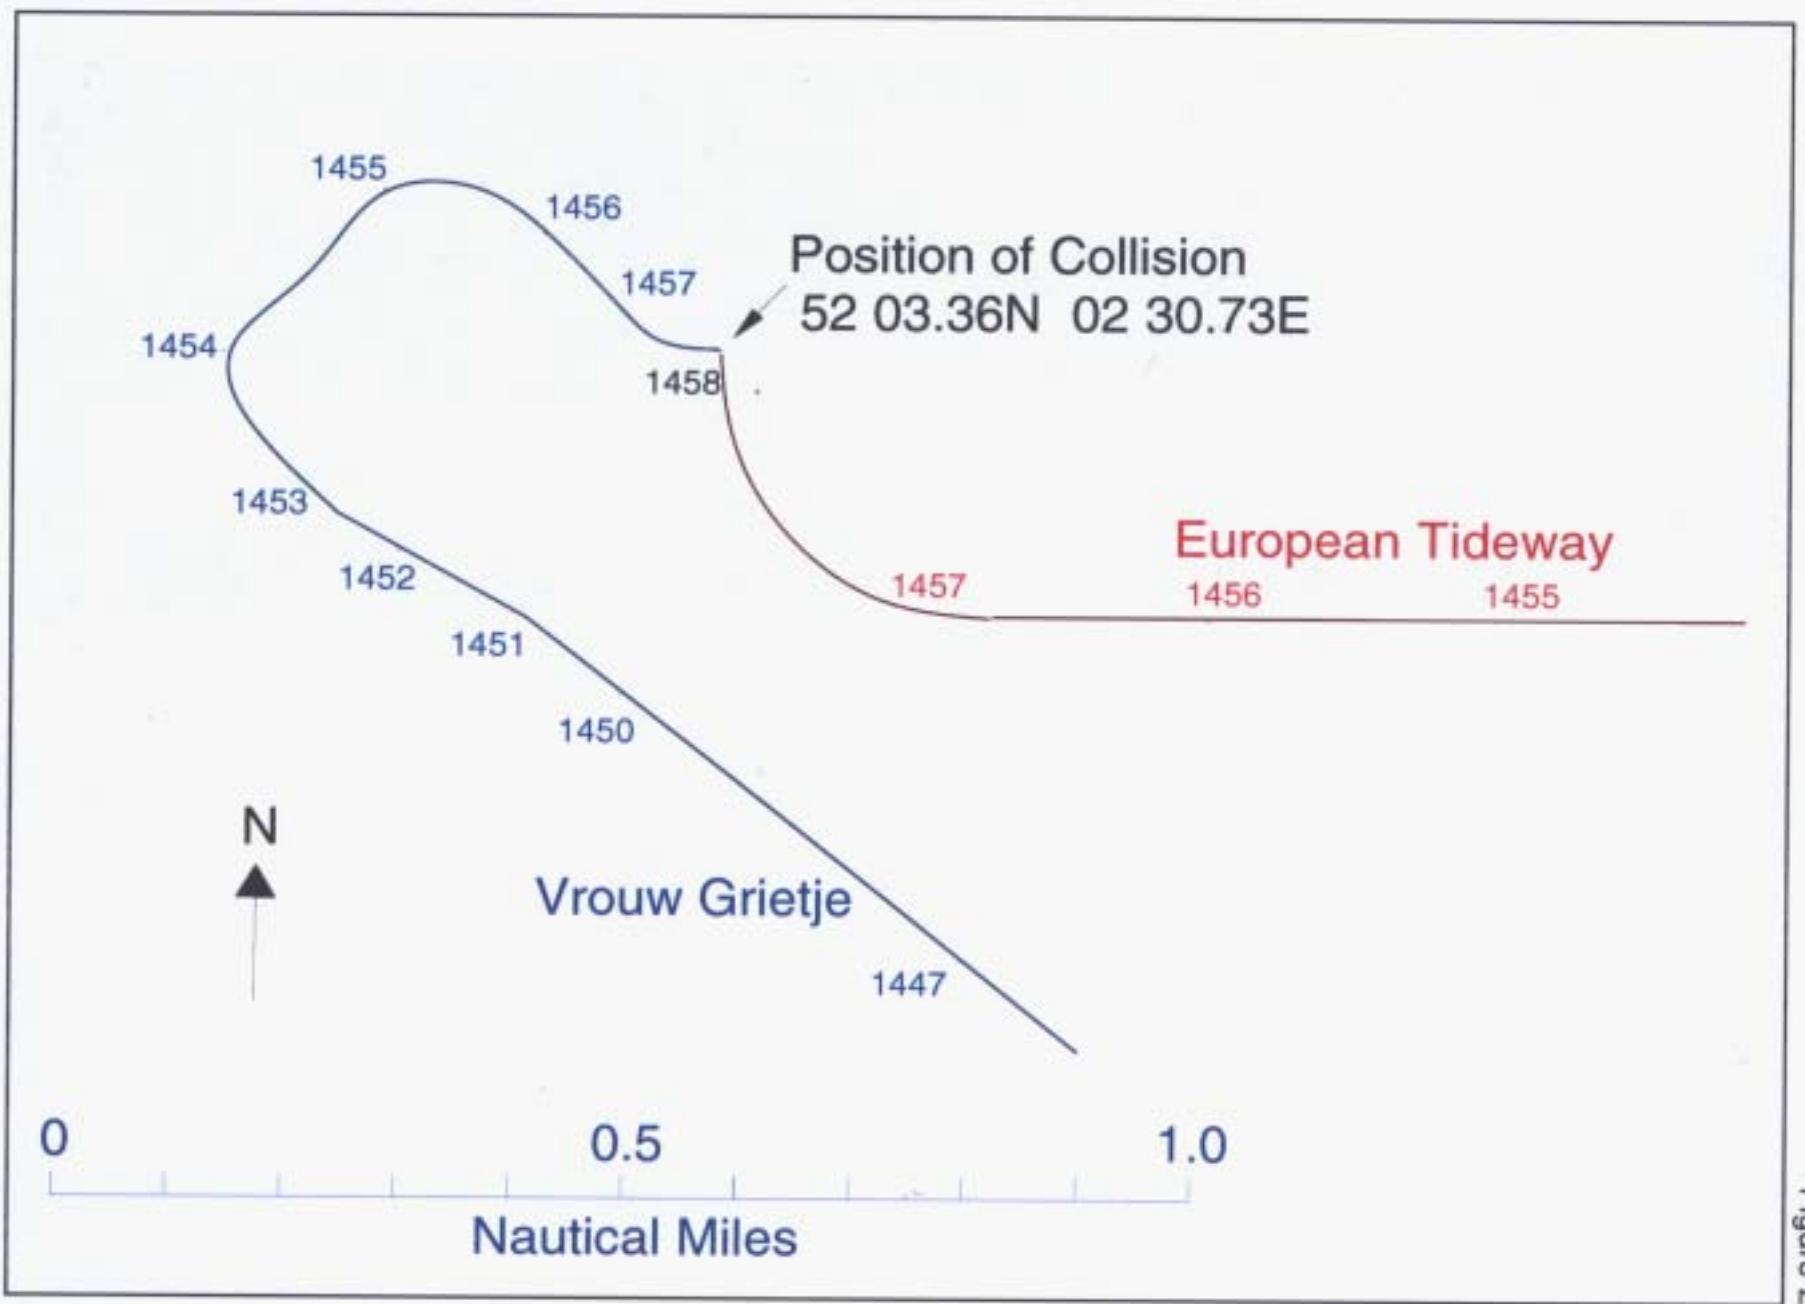
Figure 2

*European Tideway* could not have been expected to take action to avoid a collision, as required by the collision regulations, any earlier than she did due to *Vrouw Grietje*'s alteration at close range, causing risk of collision to exist. By Rule 7, time is required to assess the situation and, if in doubt, risk of collision should be deemed to exist. The ferry's alteration was, therefore, appropriate in the circumstances despite visual bearings not being taken with the azimuth mirrors. With reference to **Figure 2** it can be seen if *European Tideway* had, in
