Report on the investigation of
the grounding and total loss of
the United Kingdom-registered fishing vessel

Arosa (M321)

on Doonguddle rock
off the west coast of Ireland
with the loss of 12 crew members

**Report No 41/2001
December 2001**

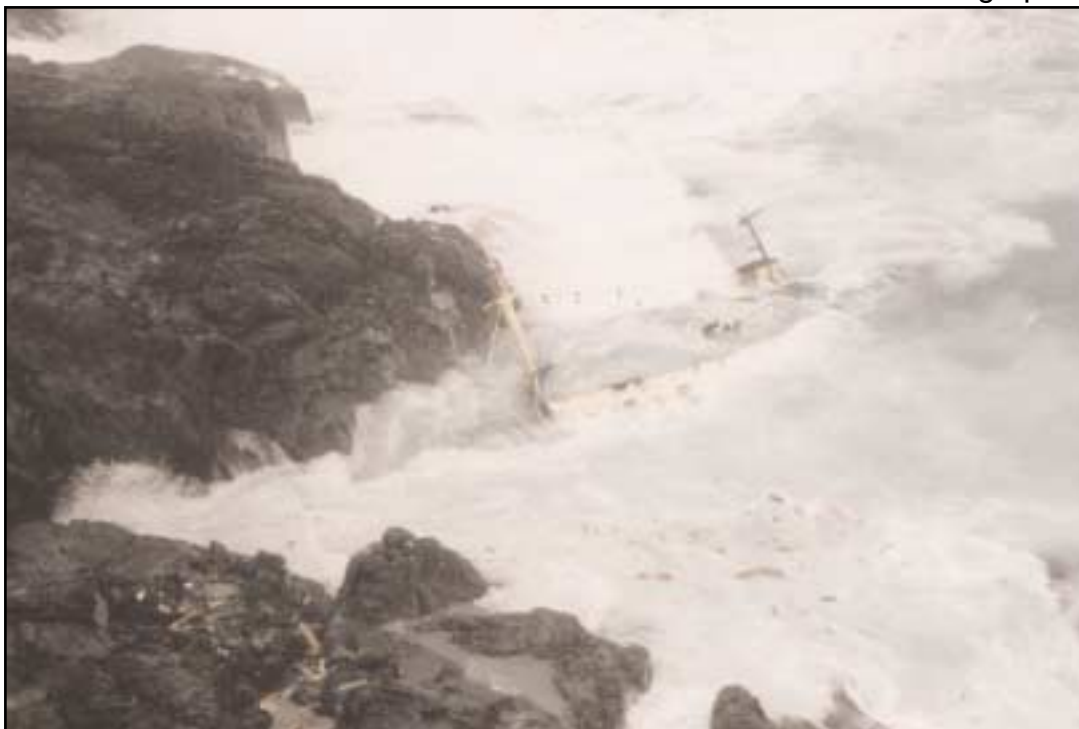
The weather was deteriorating further, and it was decided that only one helicopter should search the area at a time, to be relieved when necessary by the others waiting in Galway. The visibility had reduced to 1 mile. The wreck of *Arosa* was visible, but she was almost submerged under the waves (**see photographs 3, 4 and 5**). The vessel was facing south-east and was on the western side of Doonguddle.

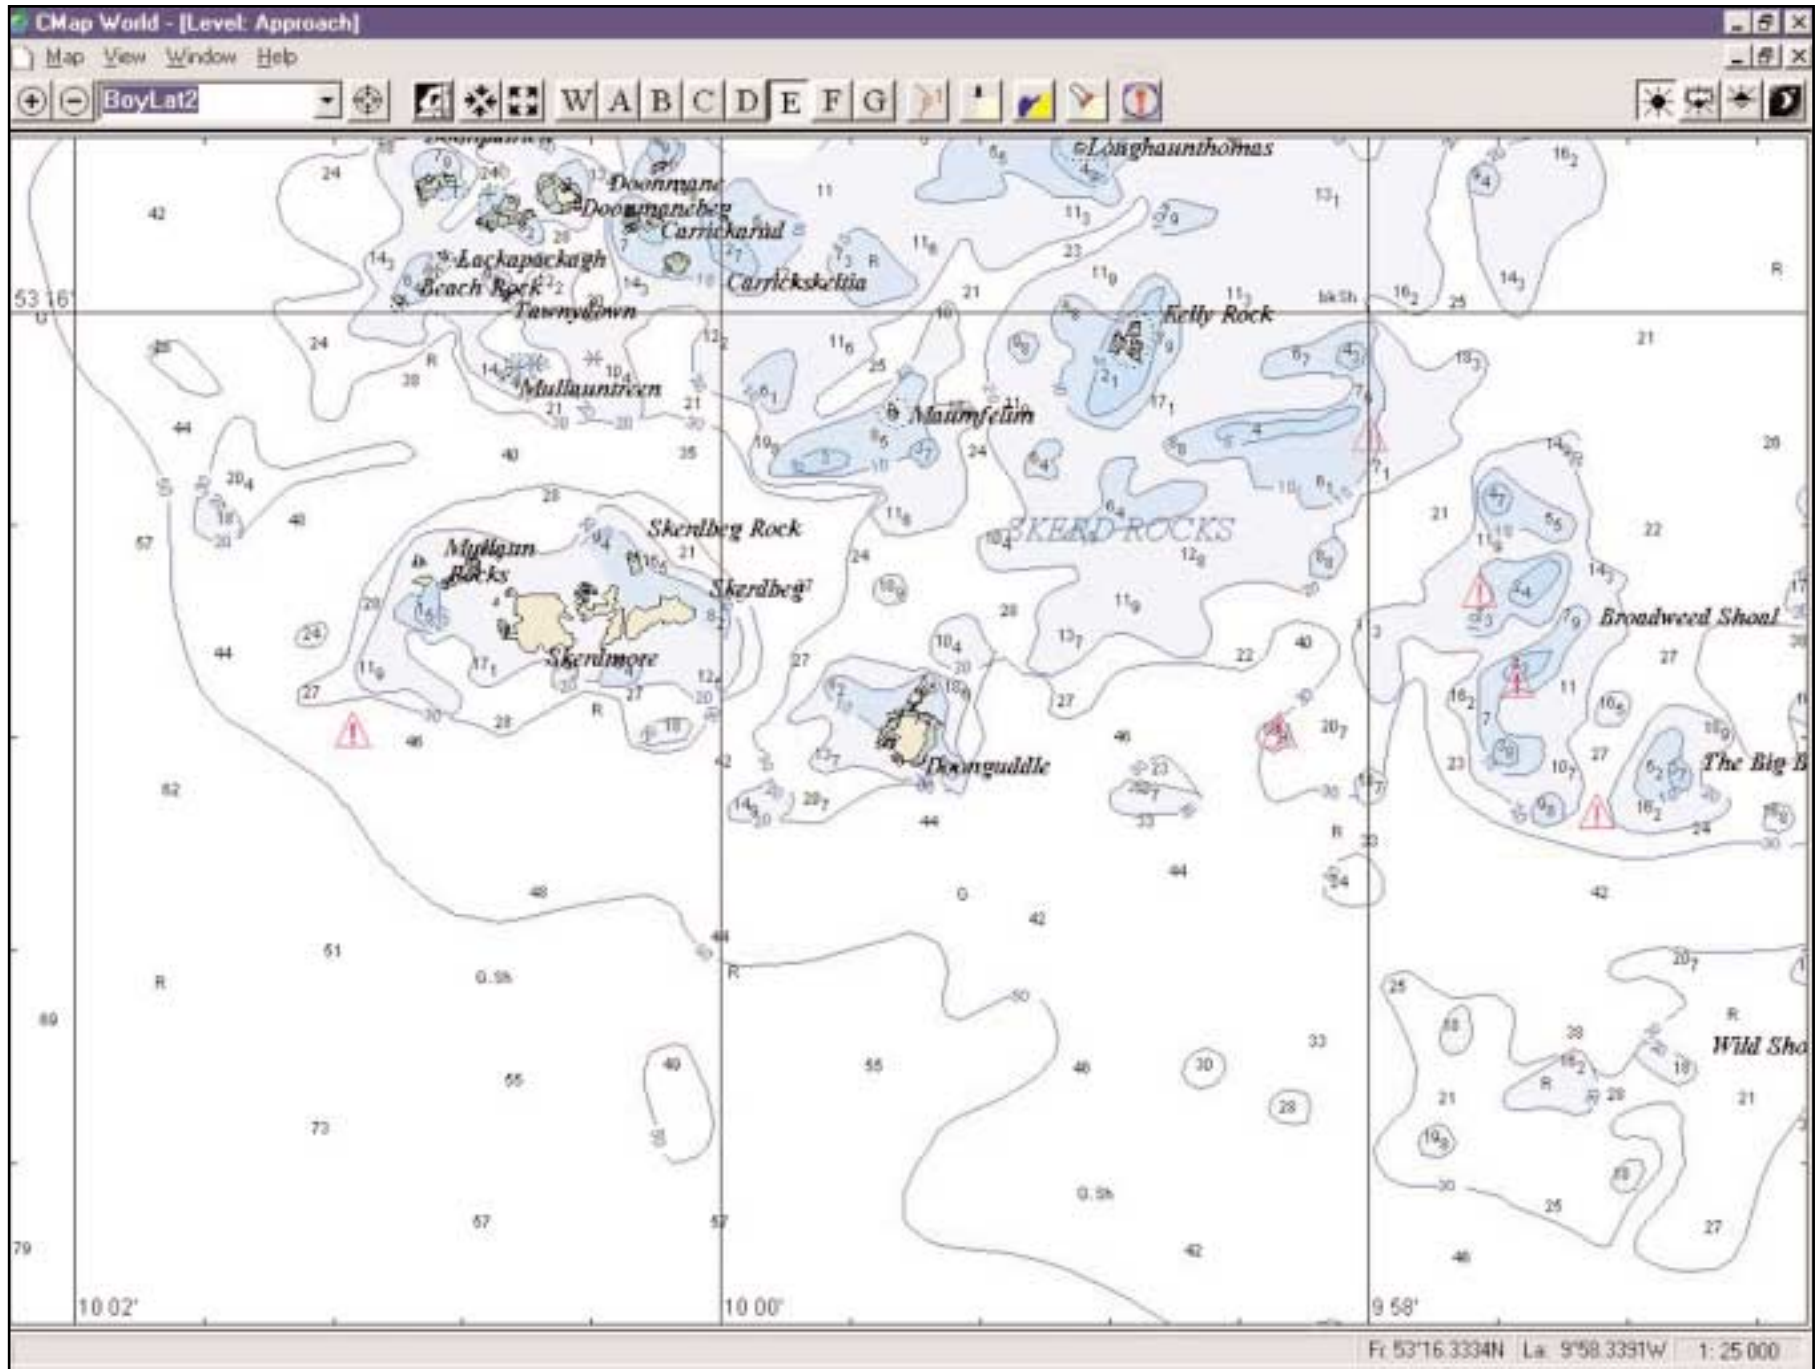
Chart Extract 6 - The new C-MAP electronic navigation chart
