**Report on the investigation  
of three persons falling overboard  
from a rigid inflatable boat  
in the River Test  
during the Southampton International Boat Show  
on 22 September 2000  
with one fatality**

Marine Accident Investigation Branch  
First Floor, Carlton House  
Carlton Place  
Southampton  
SO15 2DZ

**Report No 28/2001  
August 2001**

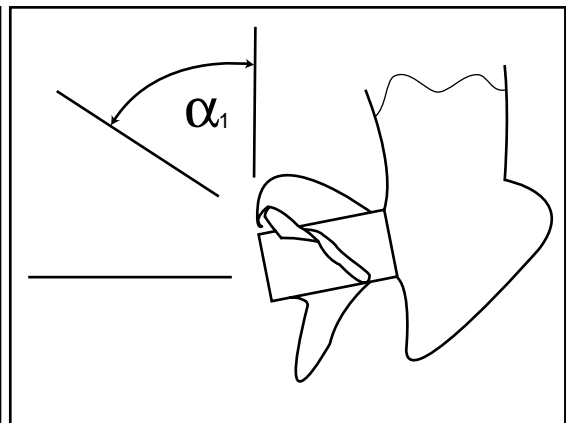
Figure 9b

When an engine and propeller are trimmed in, with the propeller's axis sloping upwards from aft to forward, the downward moving blades of a clockwise rotating propeller will present a larger angle of attack to the water than the upward moving blades (**Figure 9b**). These blades are to starboard of the propeller's centreline and, within limits, these downward moving blades will generate a greater thrust than the others. The nett propeller thrust is thus offset towards these downward moving blades, which is towards starboard on a clockwise rotating propeller.
