Report on the investigation of
an explosion on board
fv Fleur de Lys
which then foundered
18 miles south-east of Portland Bill
on 16 April 2000

Marine Accident Investigation Branch
First Floor, Carlton House
Carlton Place
Southampton
United Kingdom
SO15 2DZ
Report No 36/2001
October 2001

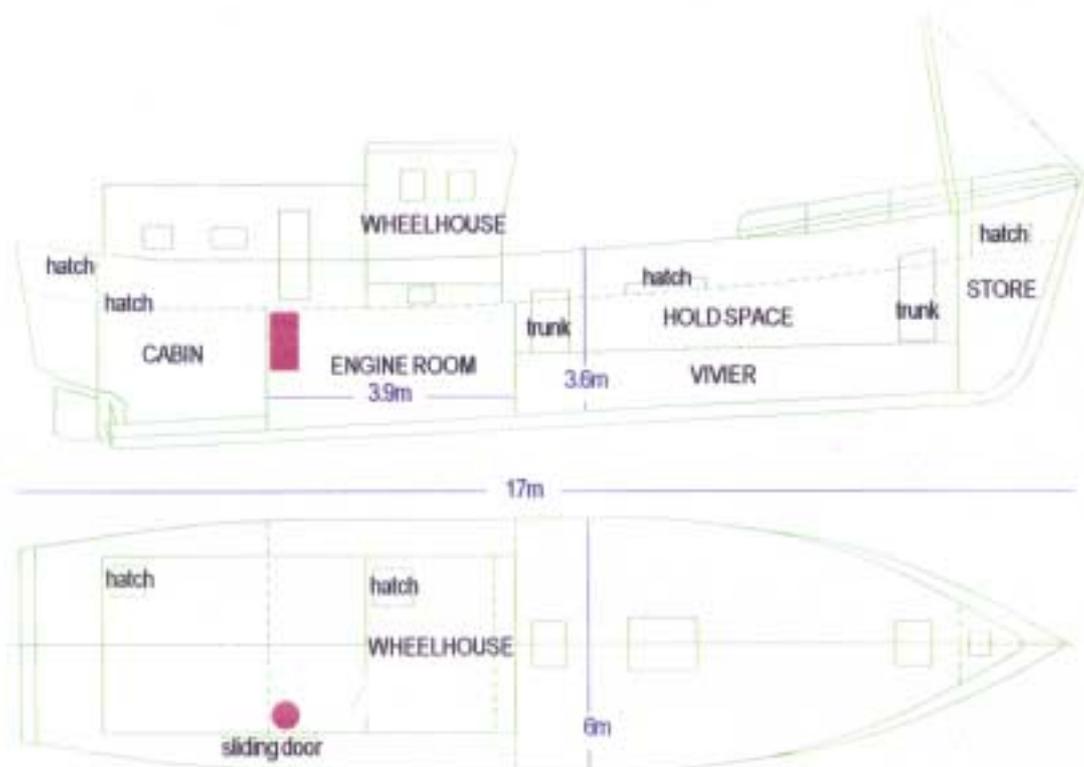
The first of these drawings is redrawn below with the location of the hot water cylinder indicated in red. The location has been identified from the description, "High against the aft bulkhead of the engine room, starboard side, was the hot water storage cylinder".

The drawing is not to scale but some principal dimensions are included (in blue). Using the drawing, the engine room would have the approximate dimensions of 3.9m fore to aft 4.2m width with a height of 2.5m.

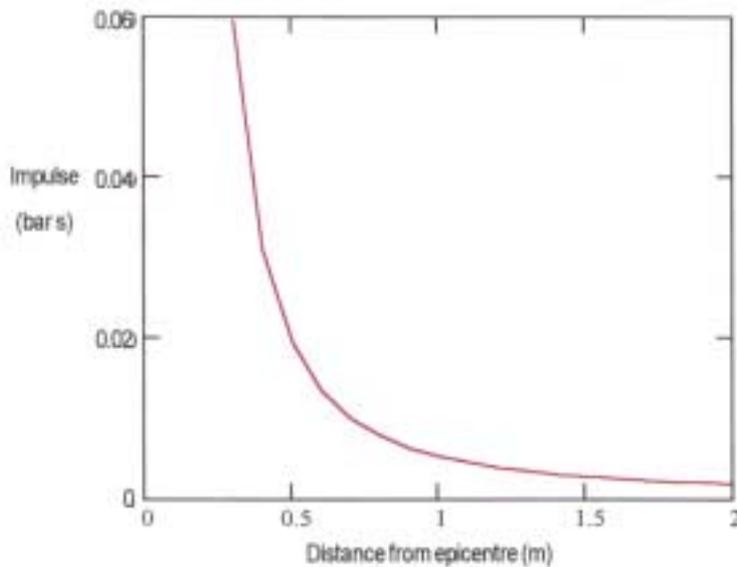
the explosion epicentre for this explosive energy is shown below. The maximum value close to the water cylinder perimeter is 0.06 bar s.

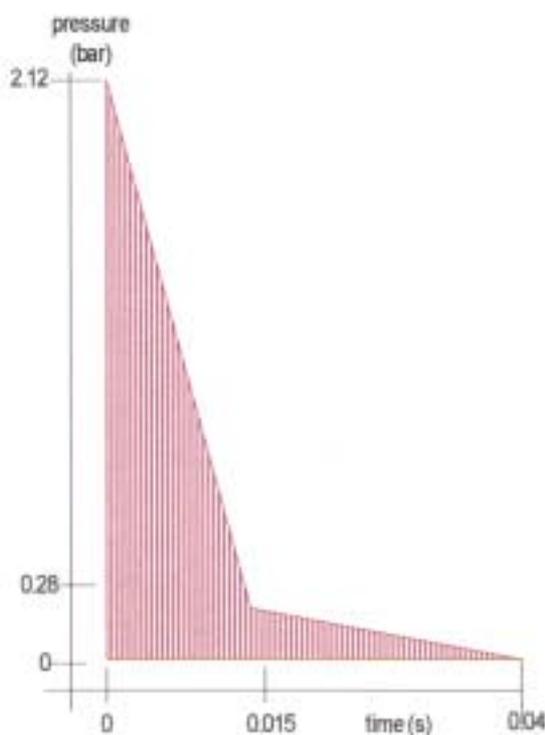
The load applied to the structure consists of a peak blast wave overpressure of 2.12 bar (multiplier of 2) with a duration of 0.015 s (obtained from the blast impulse of 0.06) and a quasi-static over pressure of 0.28 bar applied for 0.04 s. The load transient is shown on the right.

The effective load therefore possesses a peak value of 2.12 bar and an impulse (the shaded area under the transient curve) of 0.0215 bar s.

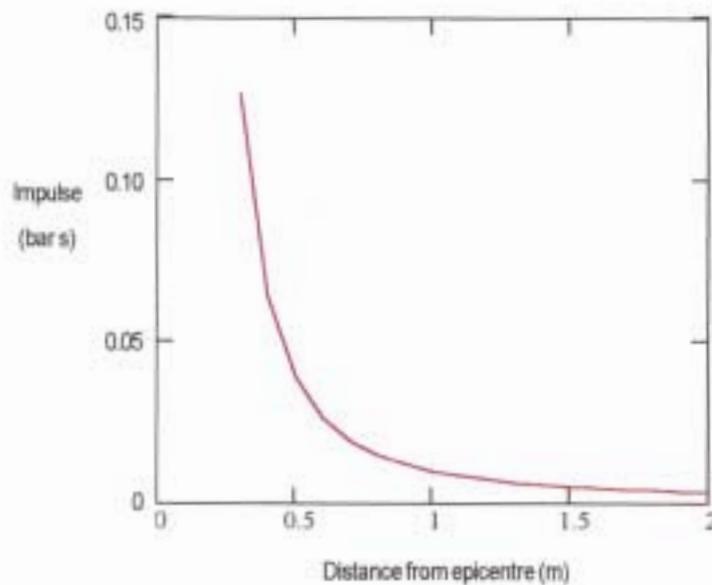
The appropriate graphical result relating blast impulse as a function of distance from the explosion epicentre for this explosive energy is shown below. The maximum value close to the water cylinder perimeter is 0.13 bar s.

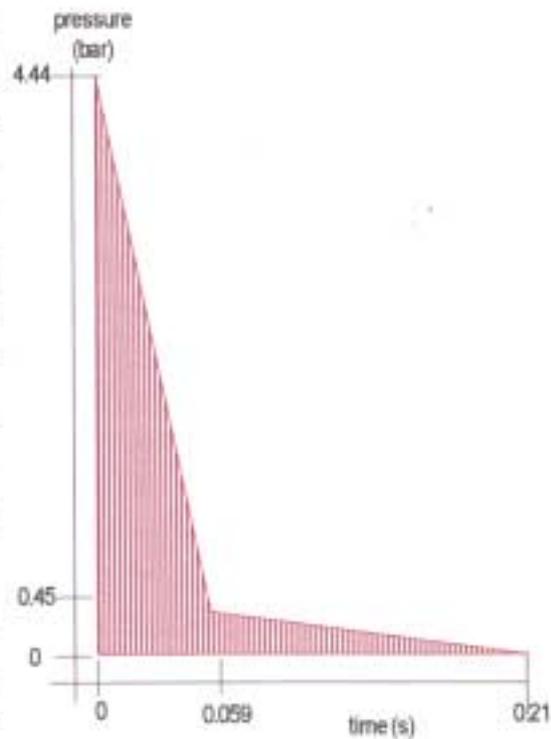
The effective load therefore possesses a peak value of 4.44 bar and an impulse (the area under the transient curve) of 0.155 bar s.

The velocity of the water cylinder body acting as a missile from the explosive forces is calculated to be 254 m/s.
