Report of the Investigation
of a man overboard fatality from
mfv Opportune (WK171)
35 miles east of Wick
on 23 February 2000

Marine Accident Investigation Branch
First Floor Carlton House
Carlton Place
Southampton
SO15 2DZ

Report No 33/2000

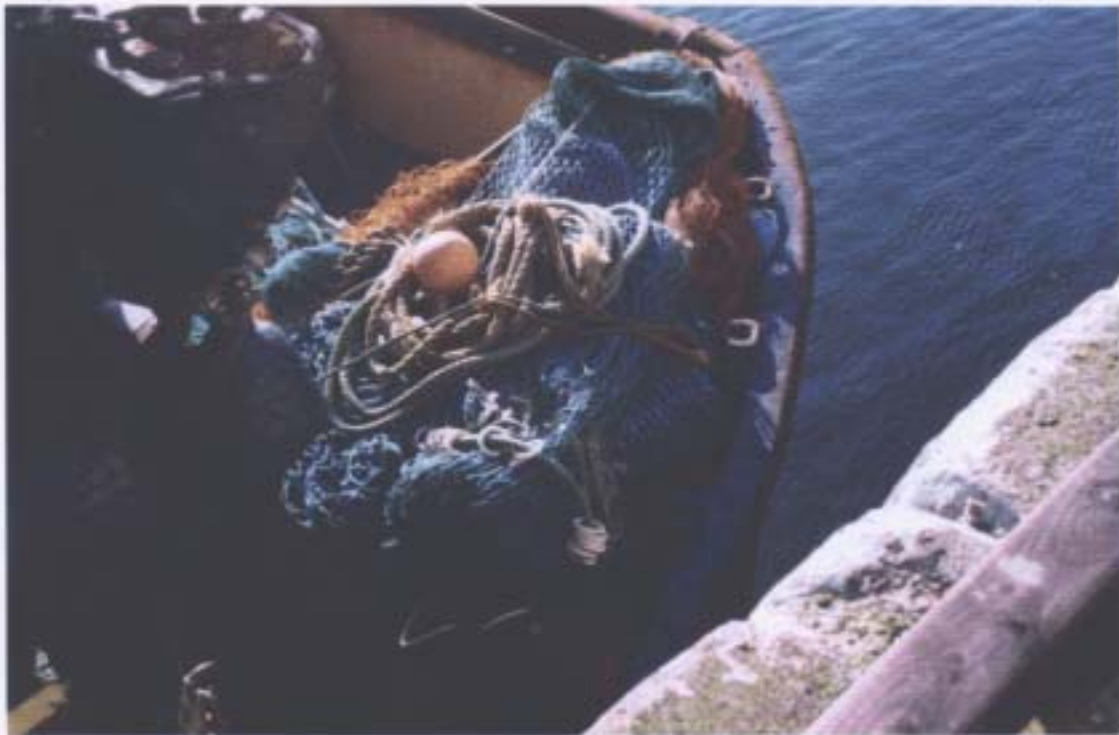
Figure 4

Opportune - net secured in bin

With the lashings released and the vessel rolling in the prevailing conditions, it is likely that some of the net spilled out of the bin and began trailing overboard. In an attempt to retrieve the net and prevent any more falling outboard, he probably climbed on to the top of the net in the bin to haul it back and secure it down. While attempting to do this, he fell overboard.
