Investigation of the capsized
and sinking of the
fishing vessel

***Solway Harvester* BA794**

11 miles east of the Isle of Man
on 11 January 2000
with the loss of 7 lives

**Report No 1/2006
20 January 2006**

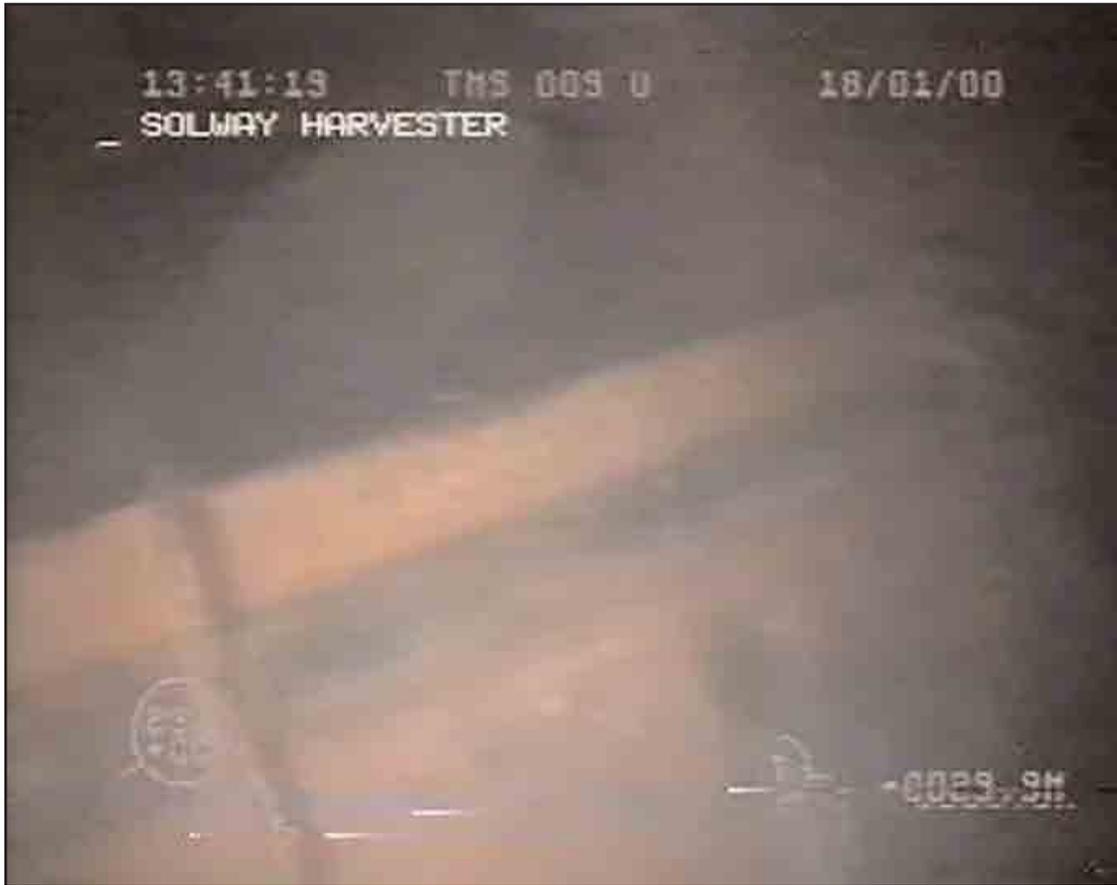
Figure 5a

Upper half of rudder stock

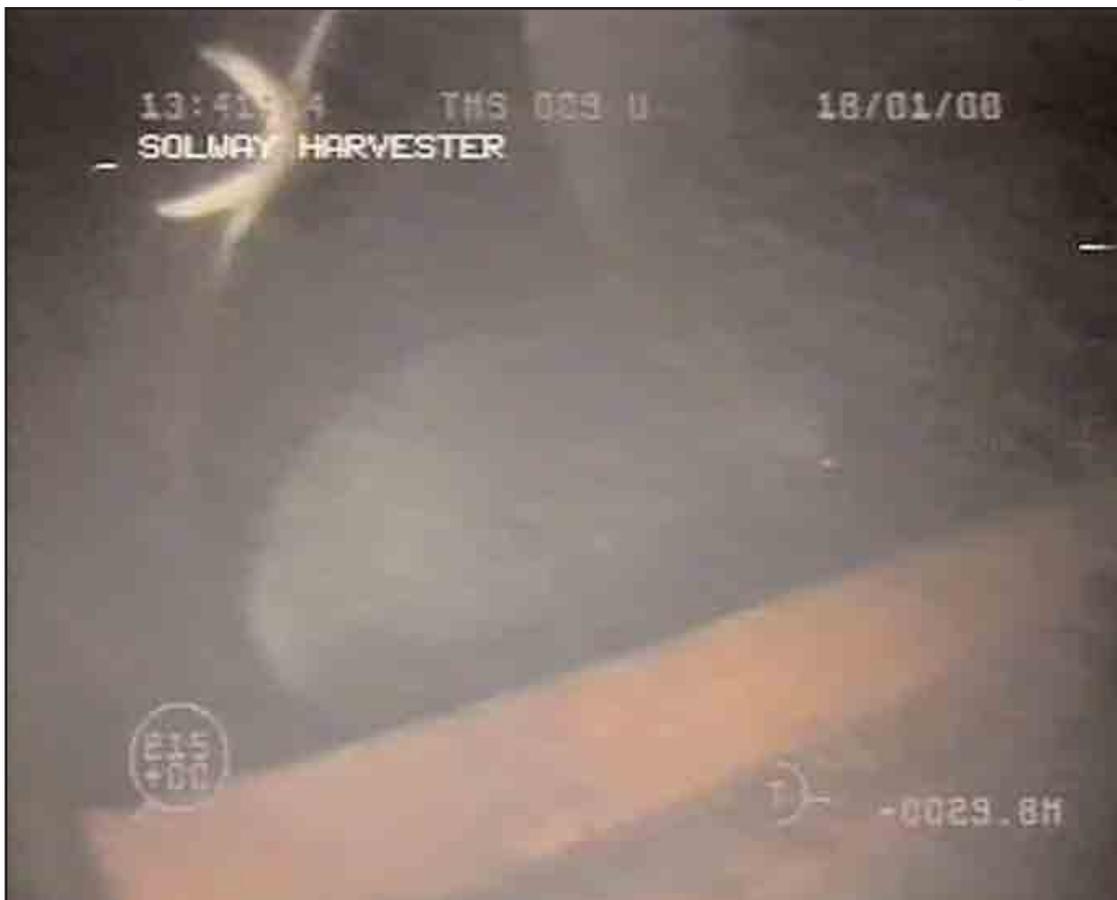
Figure 5b

Lower half of rudder stock

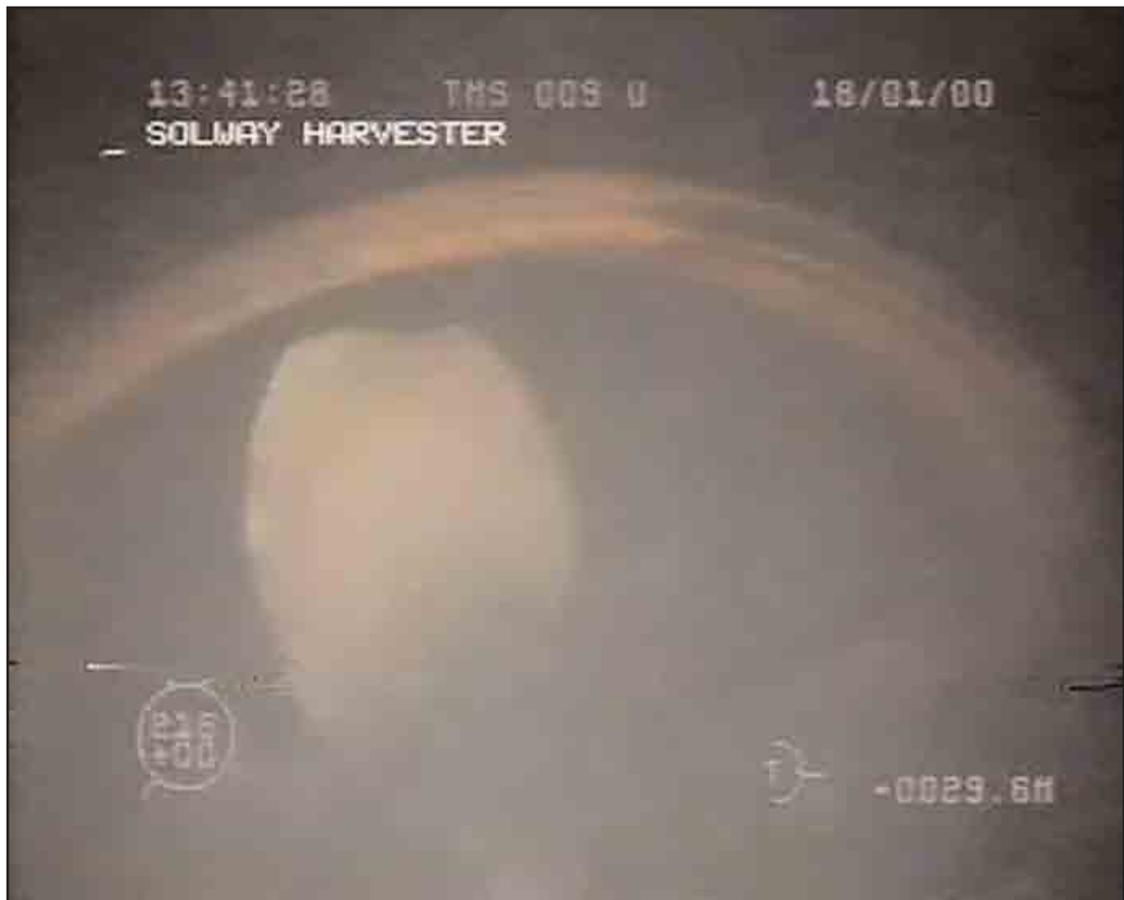
Port side of kort nozzle

Also, in marked contrast to the obvious bow damage, there was a complete lack of any sinking damage to the transom, rudder or Kort nozzle.

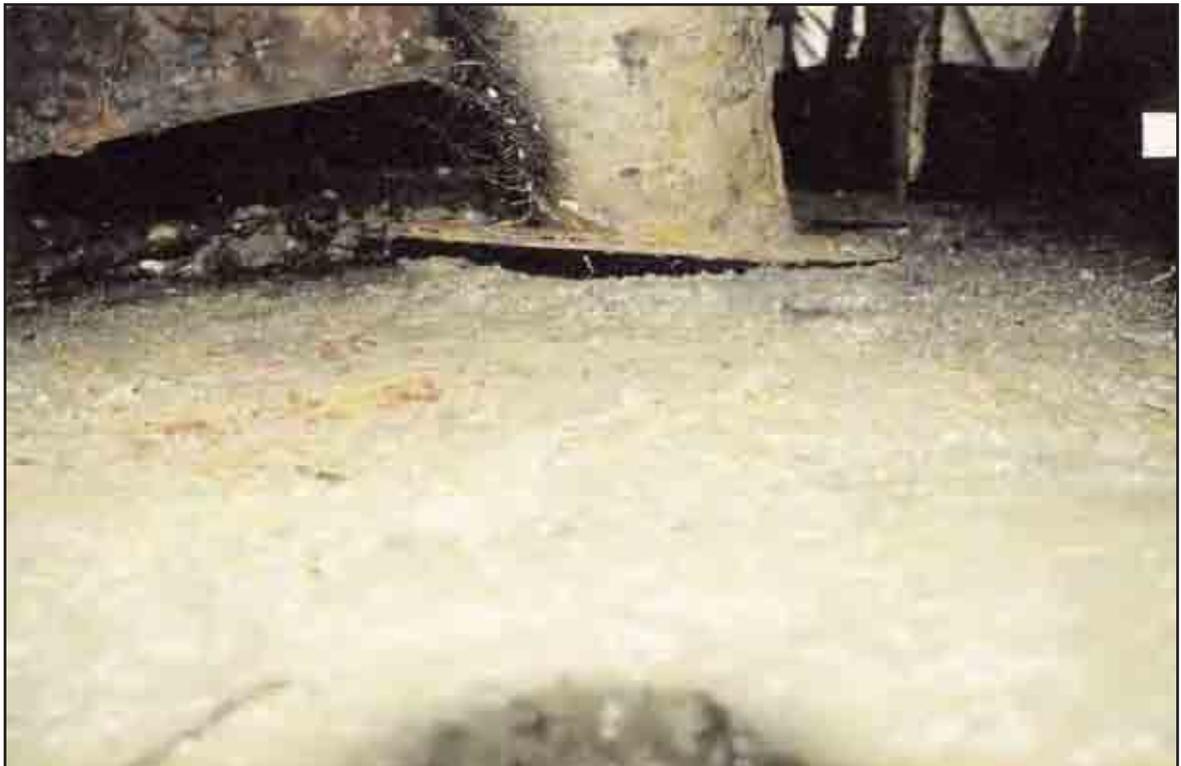
Figure 9a

The starboard shaker and picking tray were moved back into position. The fit between the picking tray's pipe and the ice scuttle showed a 30mm gap between the pipe's flange and the deck at its outboard edge. At the inboard edge it rested on the deck (**Figure 9**). This could not be done for the port side.

Looking to port

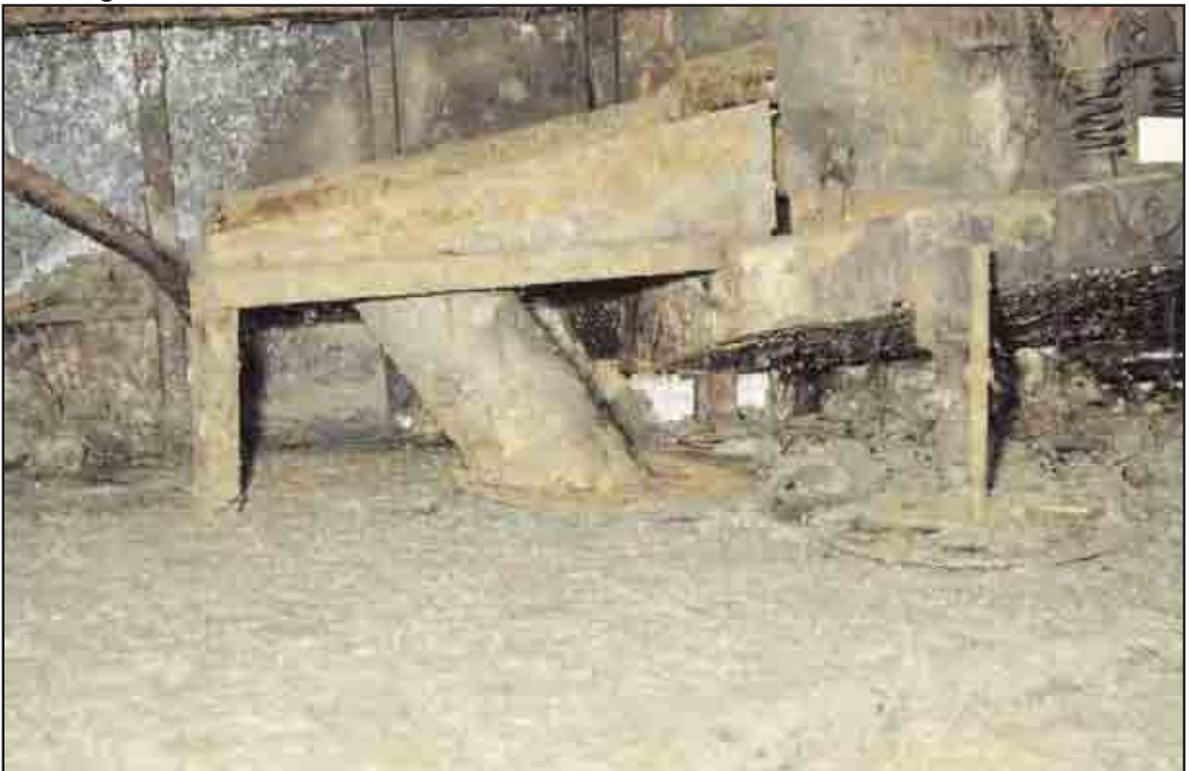
Figure 9c

Looking to starboard

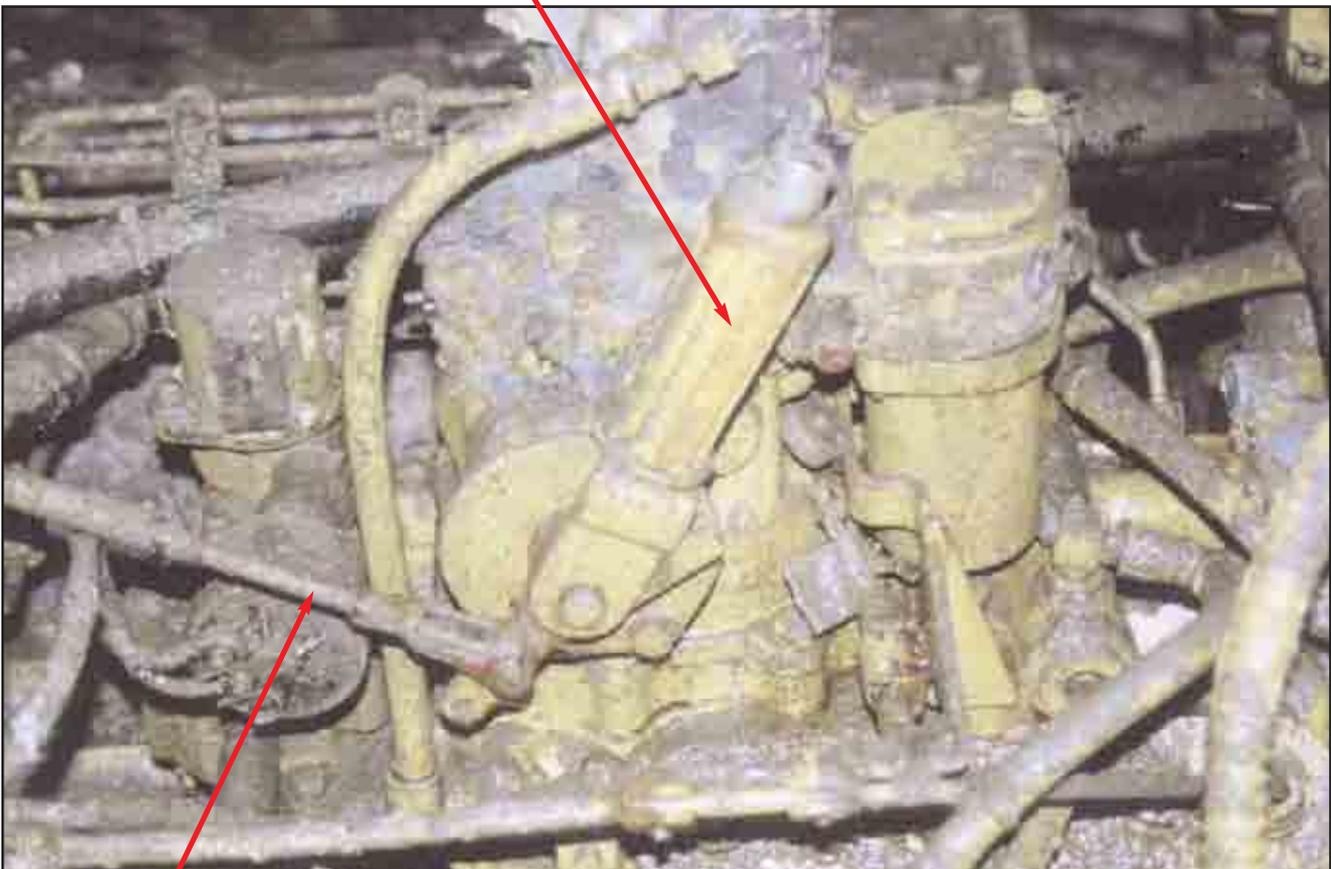
Figure 14

Moving the main engine throttle/gear lever in the wheelhouse had no effect on the governor control lever on the engine, so the only means of adjusting engine speed was from inside the engine room. It was found in this mode with the governor control lever 60% of the way between idle and maximum (**Figure 14**). Wheelhouse control was regained by lifting the governor control lever, and rotating it about its own axis through 180°. Once this adjustment had been made the throttle and gearbox control cables, and their links, were fully operational from the wheelhouse.

The governor control lever on the main engine

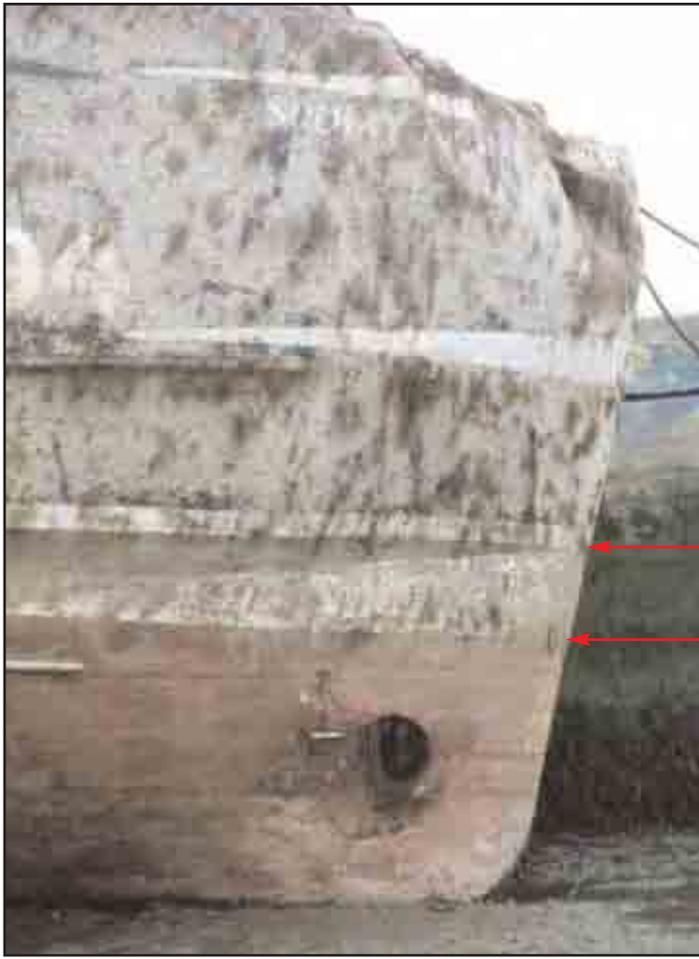
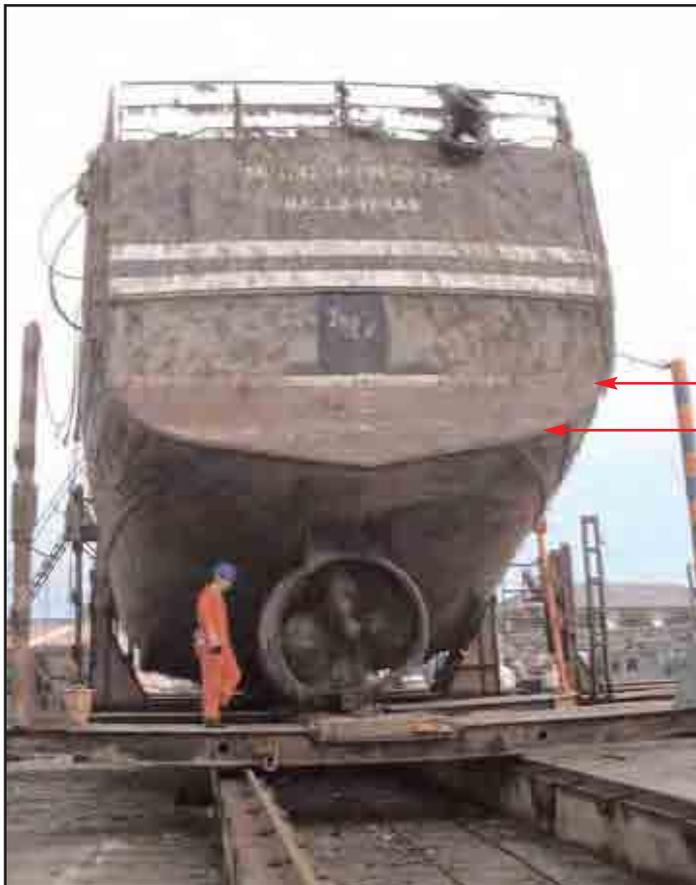
Figure 20

The original waterline had, at some time, been painted over to raise it by about 0.6m (**Figure 20**).

Final waterline

Original waterline

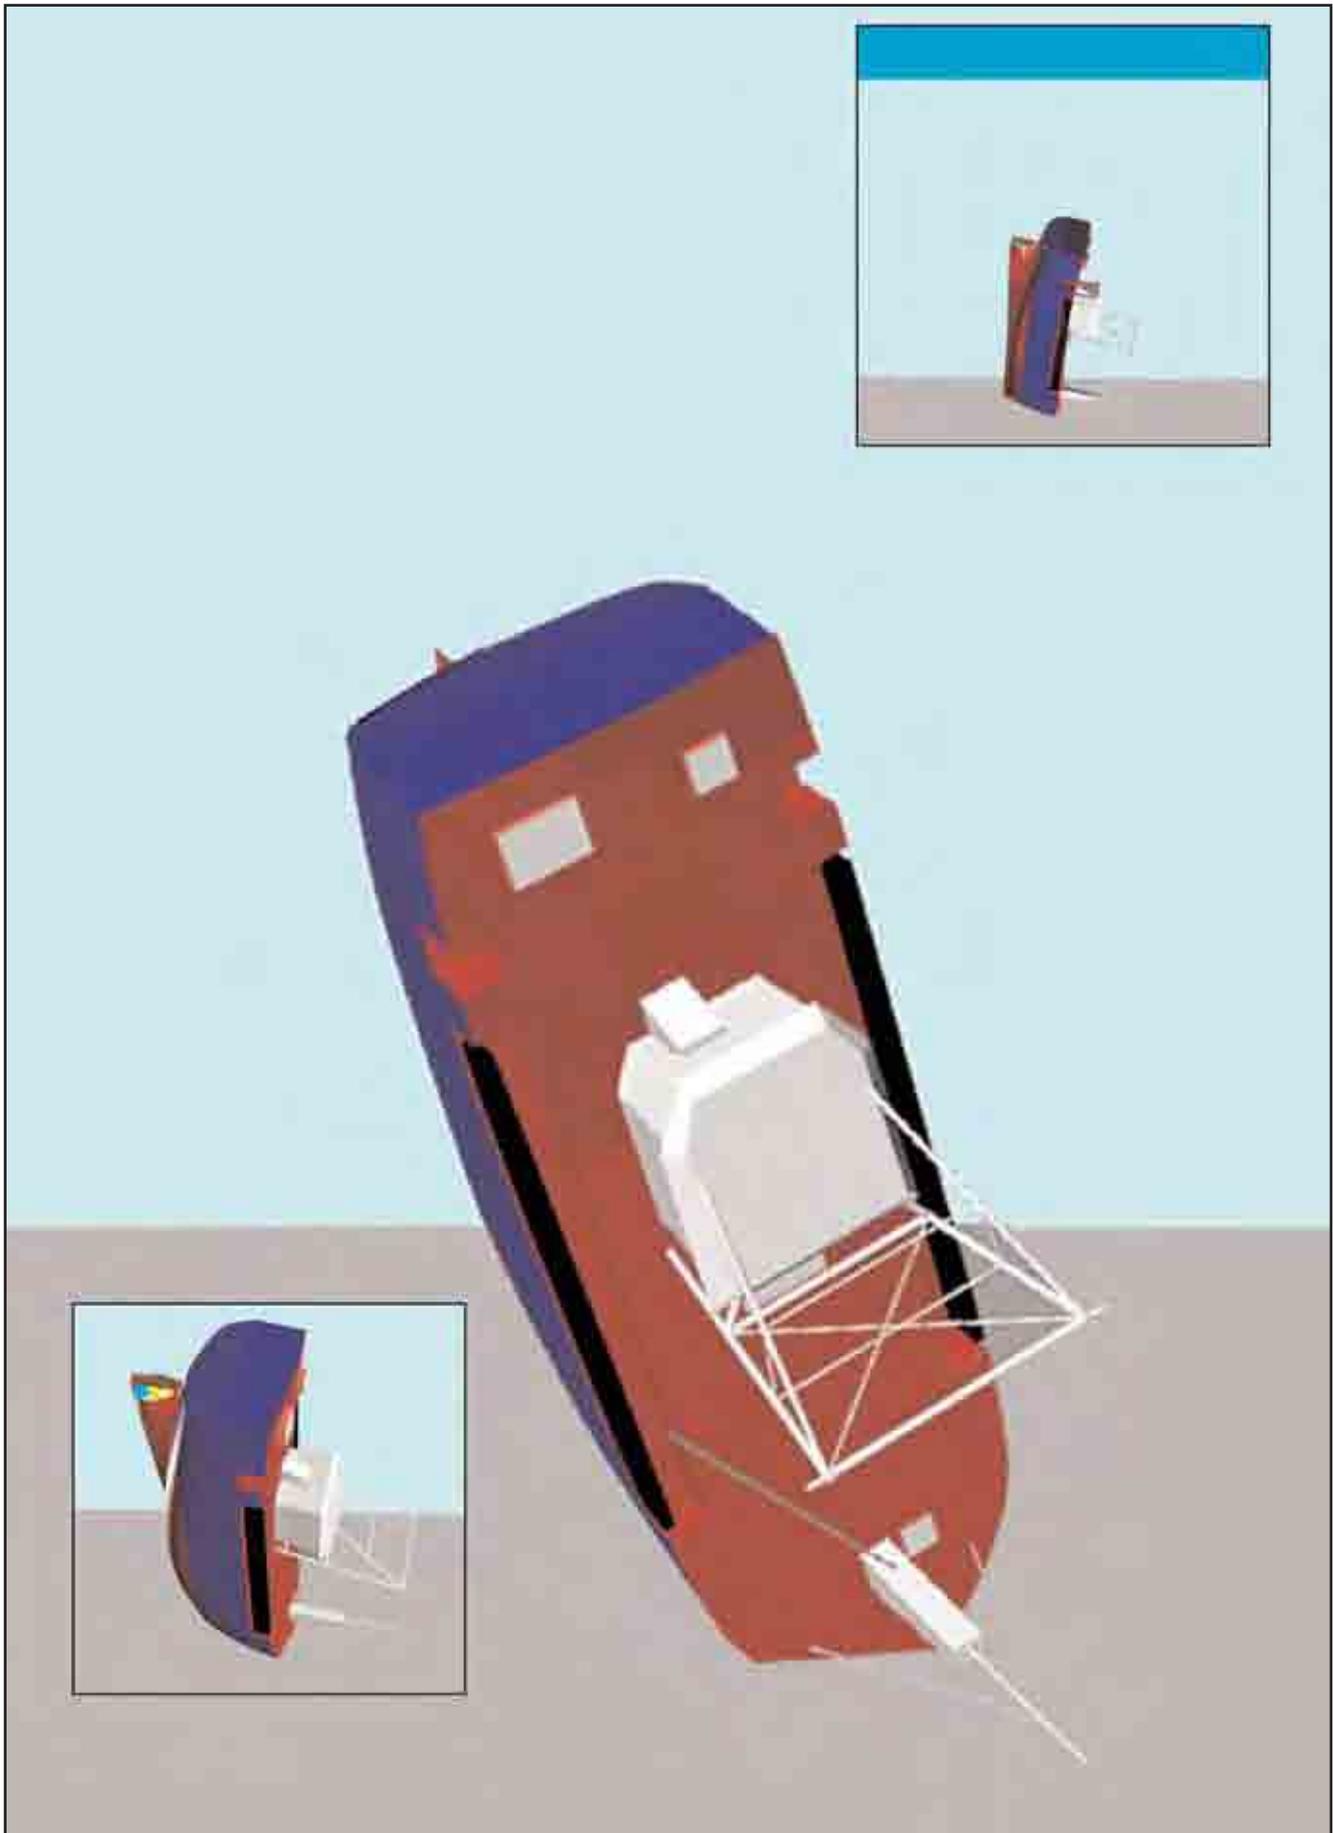
capsized, led the investigation to conclude that the only feature which could have caused it was the seabed, and that the damage occurred on impact, when *Solway Harvester* was in a near bow down attitude (**Figure 26**). Supporting this conclusion was the total lack of evidence of a contact with any other steel vessel or object.

The orientation of *Solway Harvester* as she hit the seabed

It is concluded that *Solway Harvester* hit the seabed bow-first, just to starboard of her centre-line, inclined about 10° off the vertical with her deck facing the seabed (**Figure 25, 26, 27 and 28**). As a result, the forward part of the shelter deck was buckled, canting the foremast aft. Following the initial impact, she fell on to her starboard side, buckling part of the gilson frame in the process (**Figure 27**).

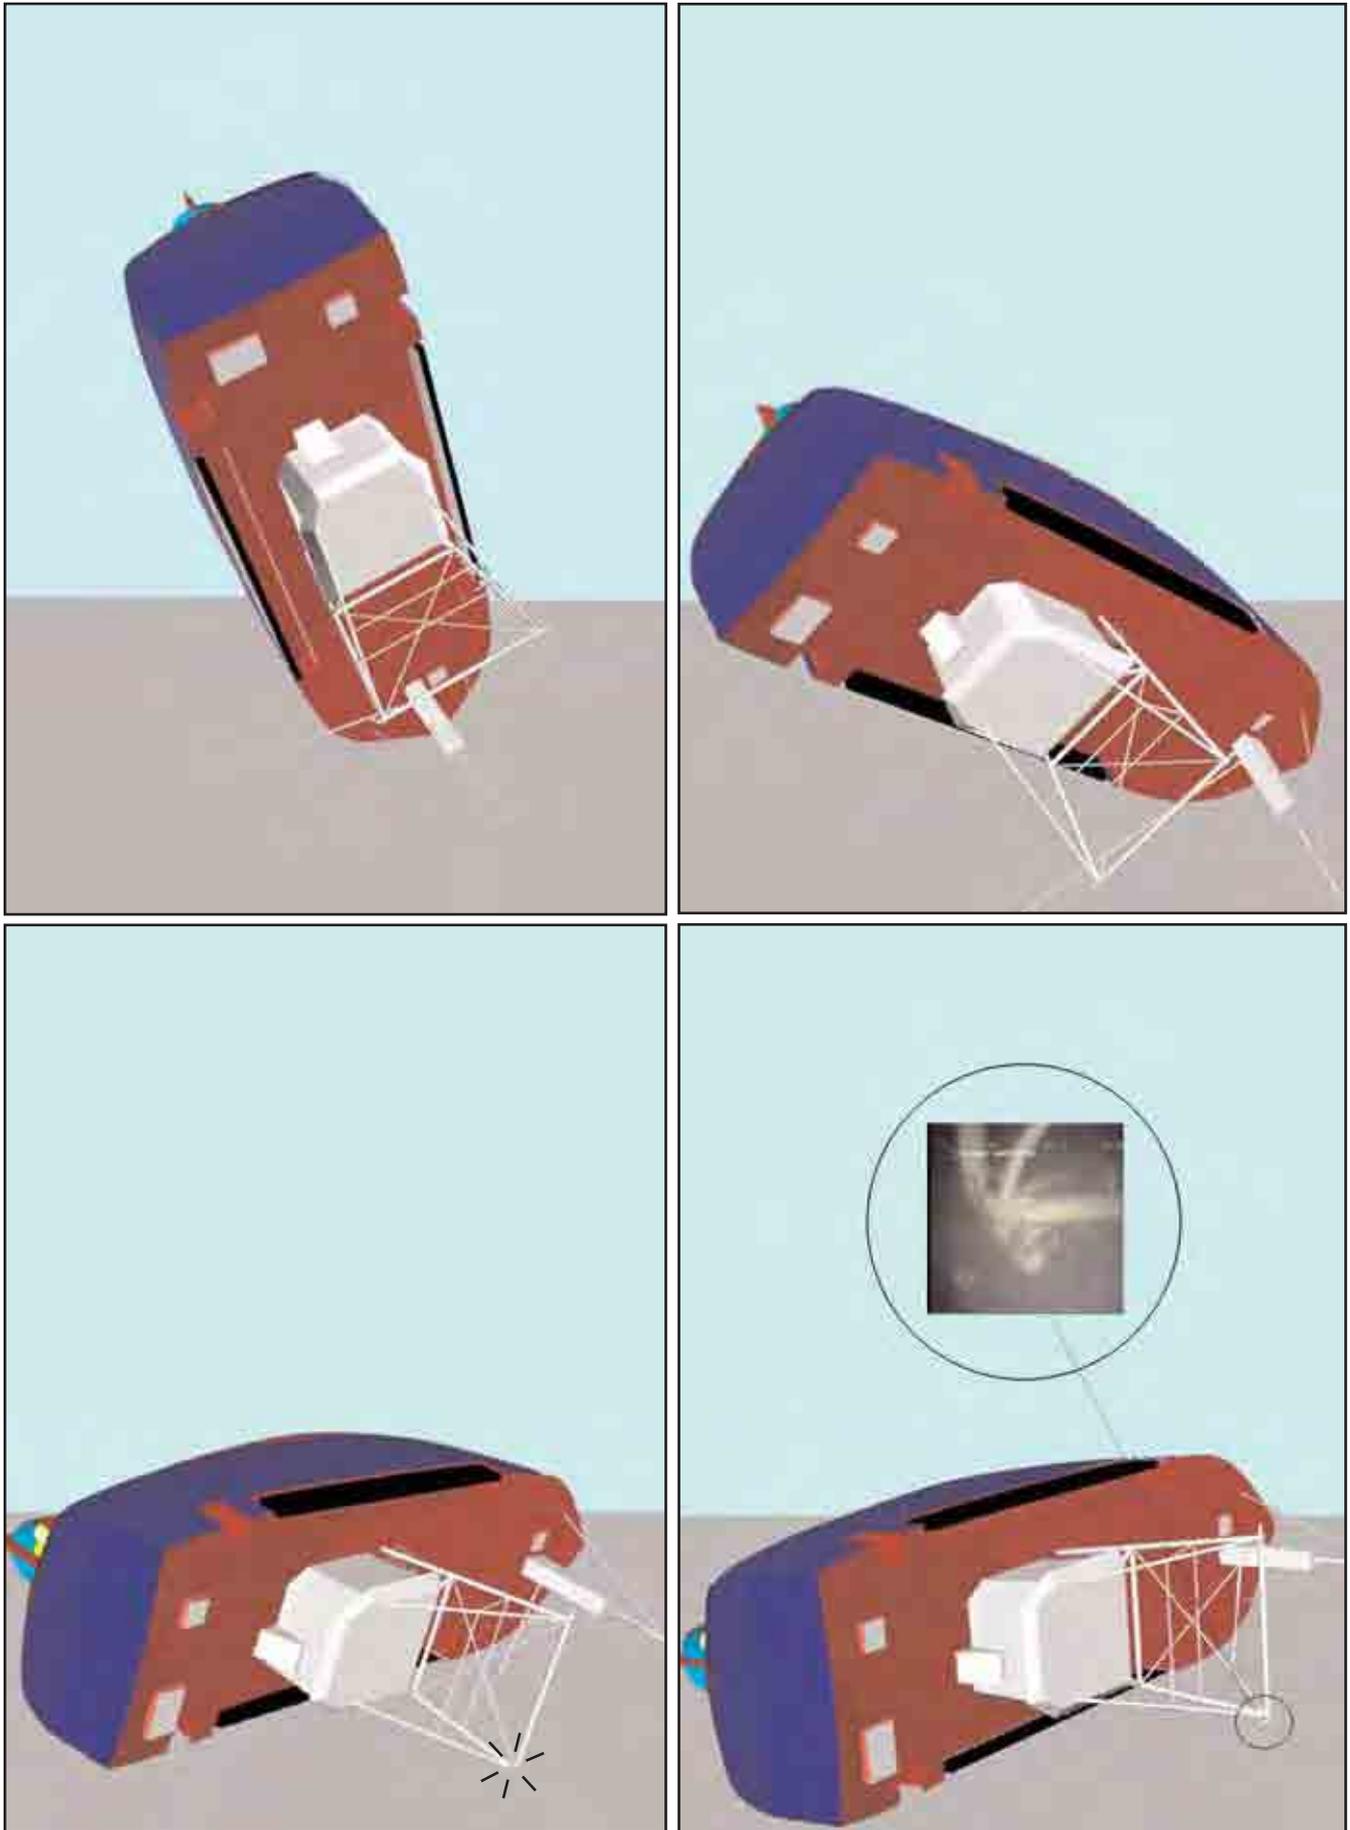
Solway Harvester coming to rest on the seabed

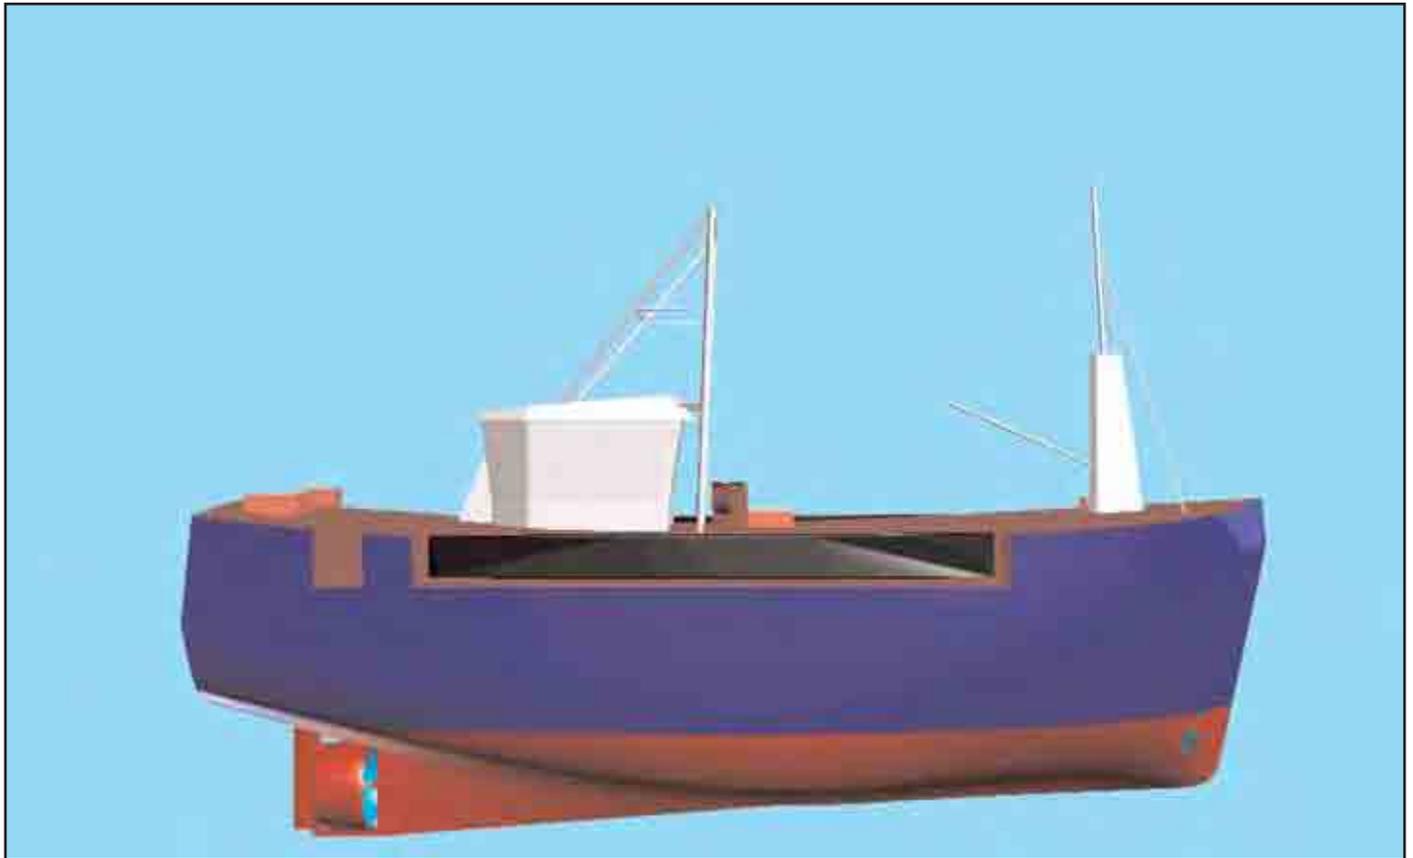
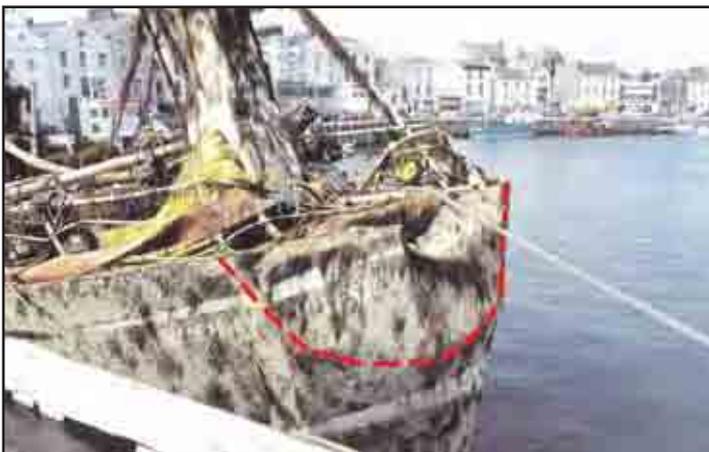
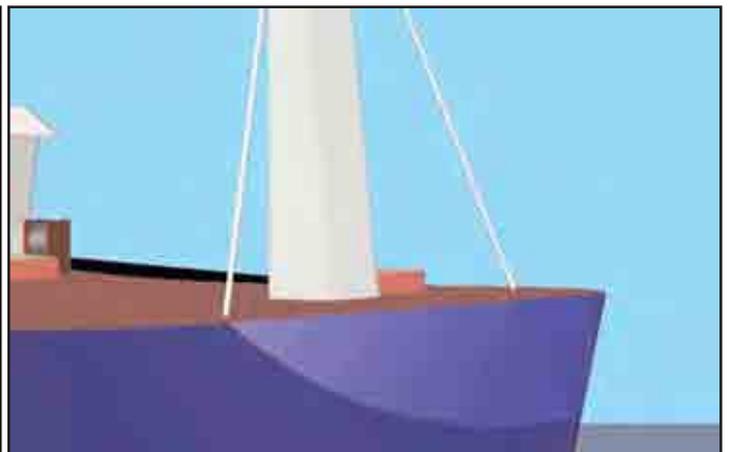
It was still necessary to determine what had caused the bow damage. Examination showed it was roughly a flat surface. Its orientation was about 57° to the wreck’s centre-line in plan and sloping about 10° past the vertical (**Figure 25**). Because the shaped steel of the bow had been flattened so conspicuously, the only viable explanation was that it had been caused by an impact with a flat surface. This, and knowing the damage had occurred after the vessel had

Comparison between the photographed bow damage and 3D model

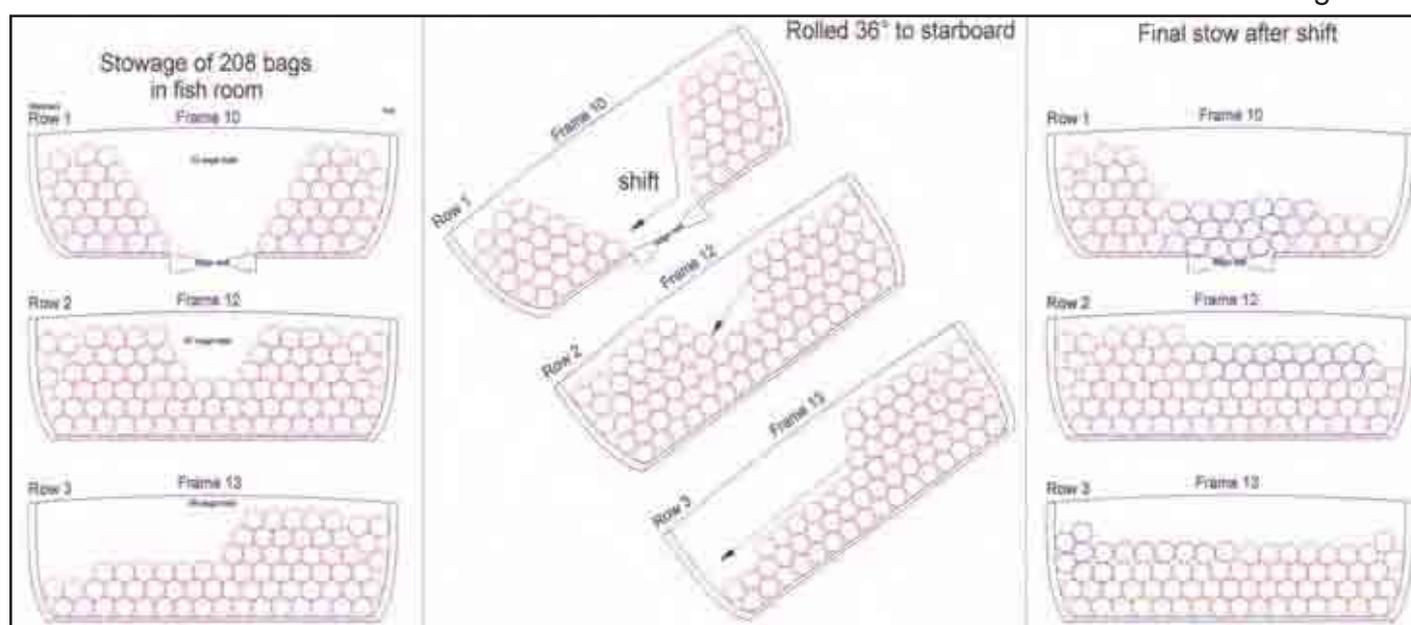
Figure 29

Assuming that *Solway Harvester* was rolled 35° to starboard by a large wave on her port side, then the worst foreseeable movement of the cargo was levelling off involving about 50 bags in the stow (**Figure 29**). This would have shifted the centre of gravity of the whole stow about 0.5m to starboard, causing the vessel to list 3°. On its own, this is insignificant. This analysis is supported by the experiences of the scallop fishermen interviewed during the investigation who collectively had over 100 man-years in the industry. Several recalled occasions when bags fell from the stack after a large roll, but this had never placed their vessels in any danger.

The worst foreseeable movement of scallop bags in the fish room

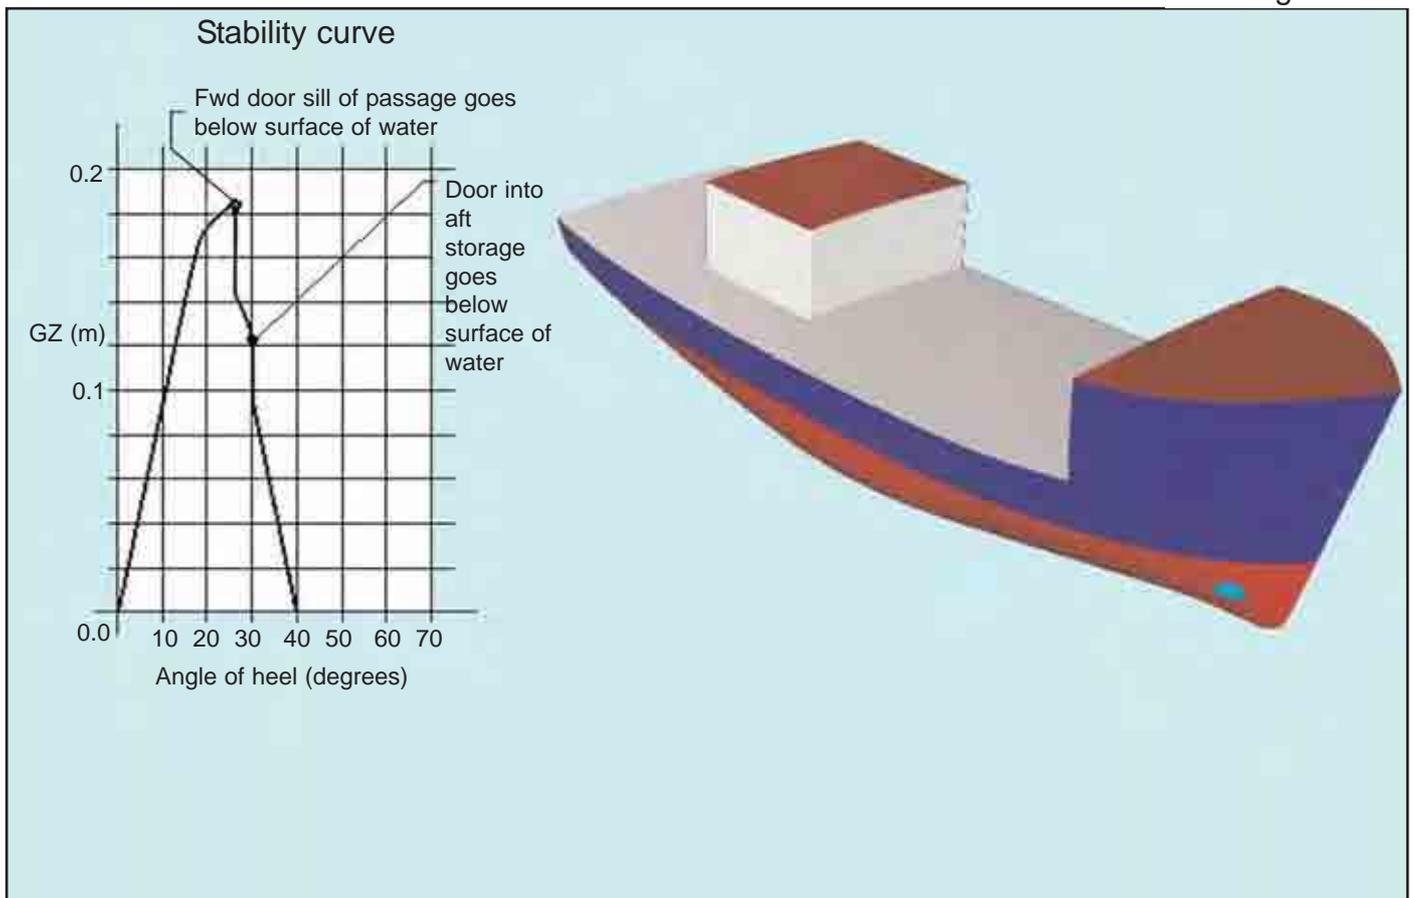
Figure 30B

Each of these weathertight doors, if open, led to a loss of reserve buoyancy, and substantially reduced her resistance to capsizing (**Figure 30B**). However, the results of the model tests and computer simulations with all three doors open, convinced the MAIB that the vessel would not have capsized unless some other factor was involved.

Effective buoyant spaces when heeling to starboard up to 40°

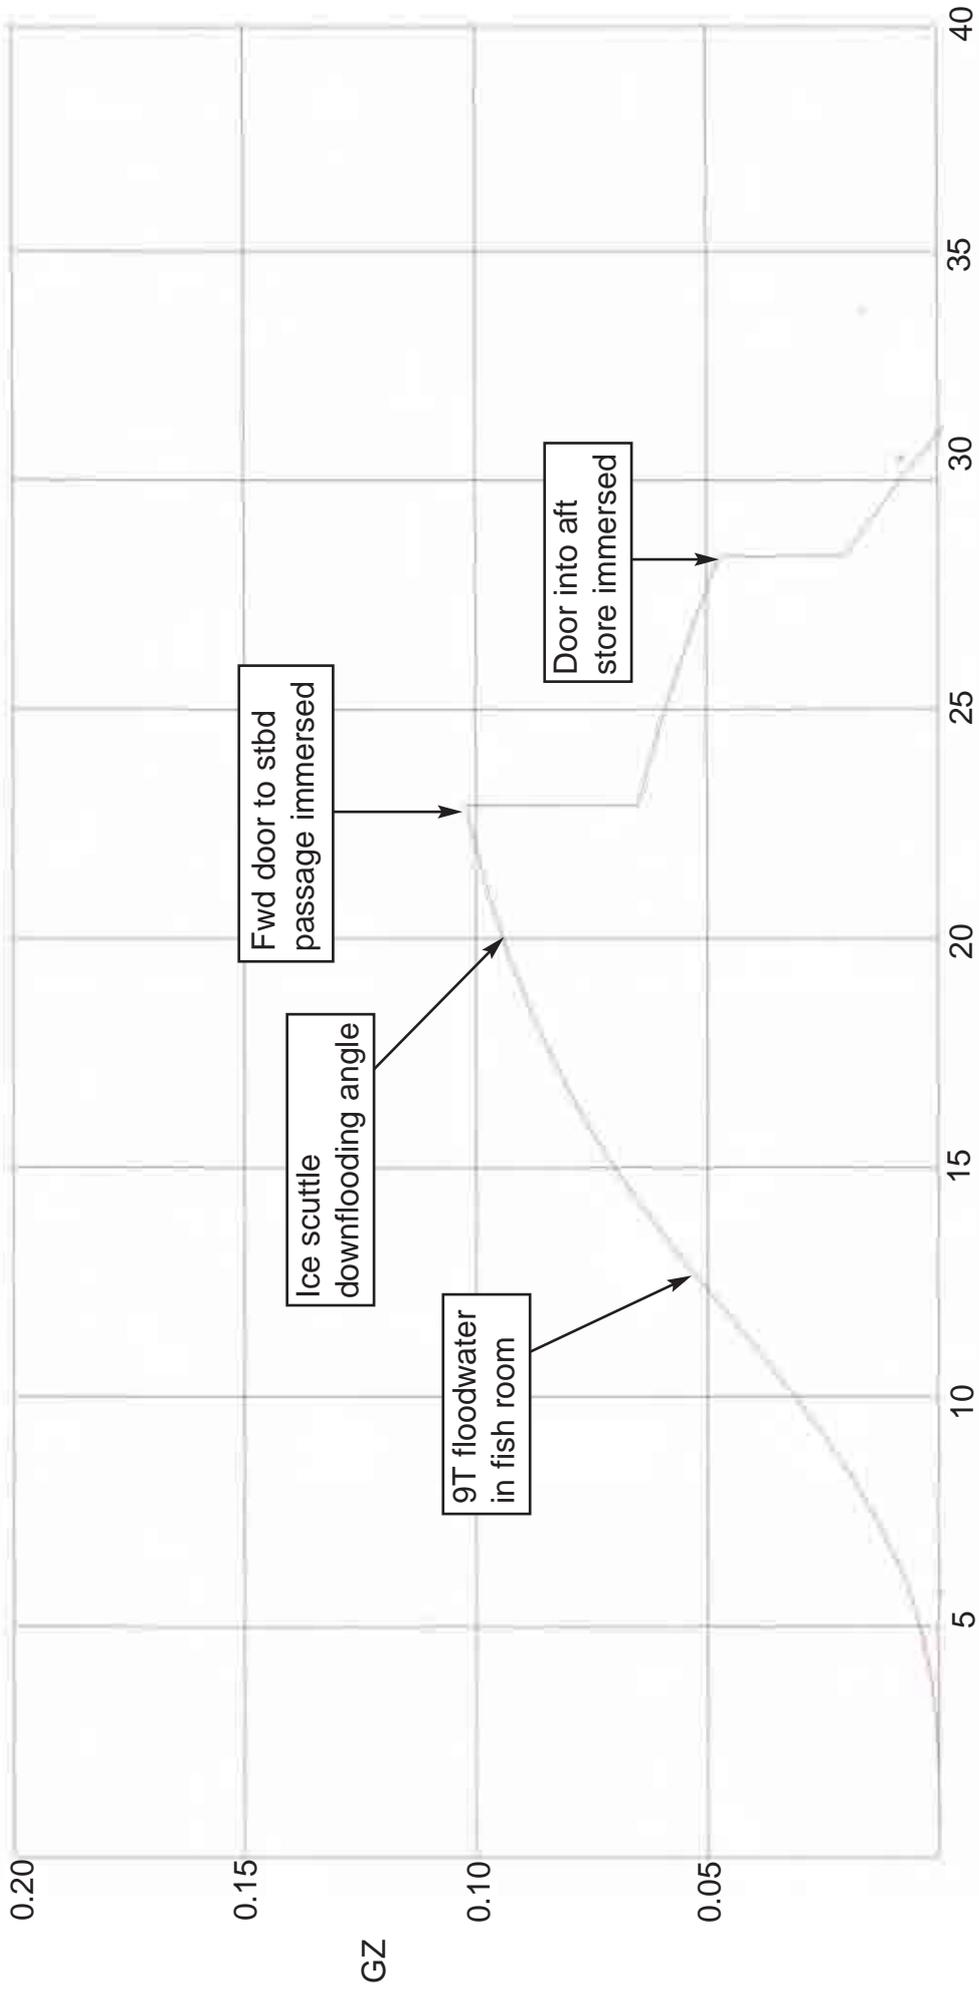
Figure 31

Solway Harvester's fish room extended, unobstructed, across her full breadth and 40% of her length. The presence of even a relatively small depth of water in such a large space would have the ability to substantially reduce, or even destroy, the vessel's stability (**Figure 31**).

The effect of fish room flooding on stability

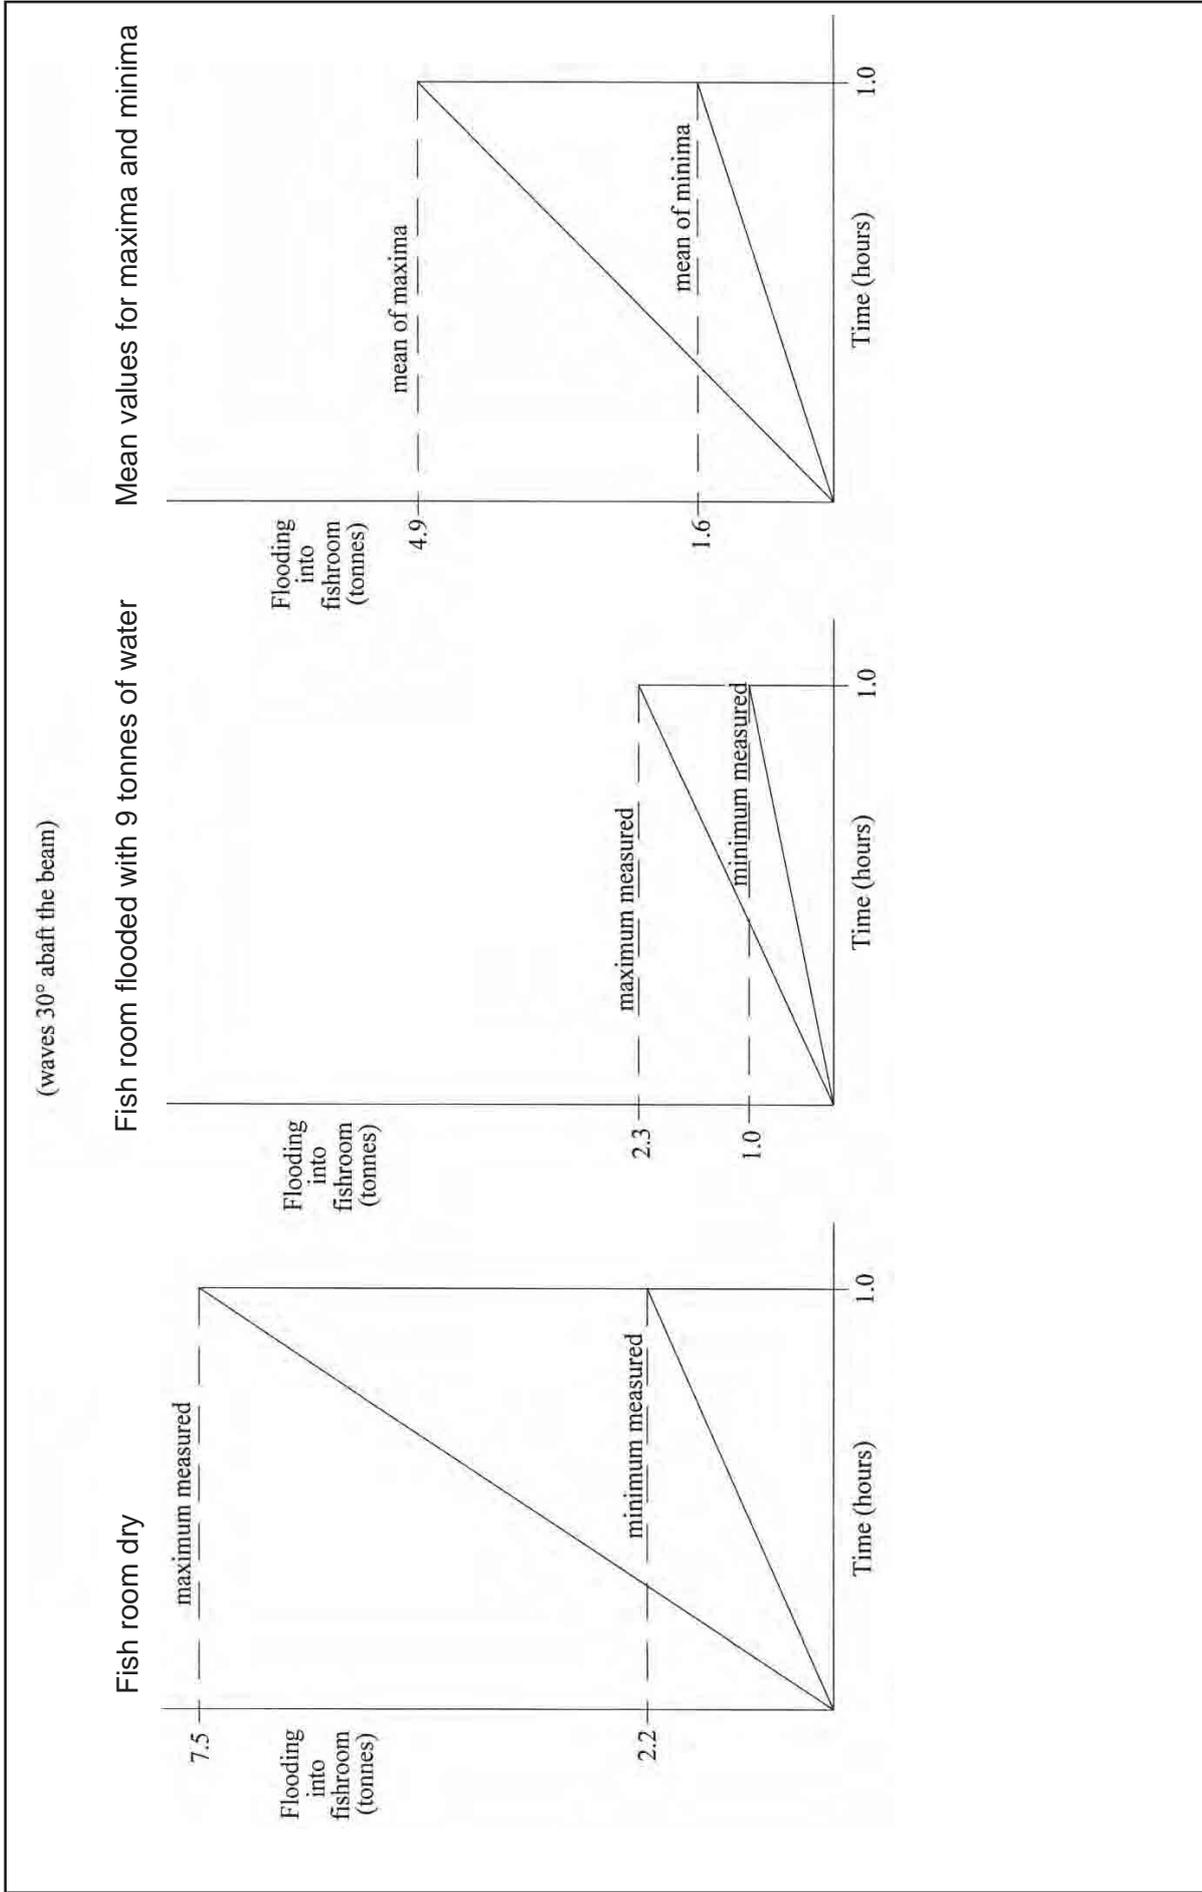
Full-size downflooding tests on the wreck showed that water could drain off the deck into the fish room, through the gap under the starboard picking tray flange, at rates of up to 36 tonnes/hr (72 tonnes/hr for both scuttles), before the picking tray flange was immersed impeding the flow. Rates of over 55 tonnes/hr (110 tonnes/hr for both scuttles) were possible with the picking tray in place. But while these tests gave an indication of the ease with which water could drain off the deck into the fish room, they could not replicate the intermittent flow of water surging through the forward freeing ports on to the deck near the ice scuttles. This was investigated at model scale, and by video recordings taken on board the sister vessel *Tobrach-N*.

Flooding rates through ice scuttle openings measured in model tests
