Investigation of the capsized
and sinking of the
fishing vessel

***Solway Harvester* BA794**

11 miles east of the Isle of Man
on 11 January 2000
with the loss of 7 lives

**Report No 1/2006
20 January 2006**

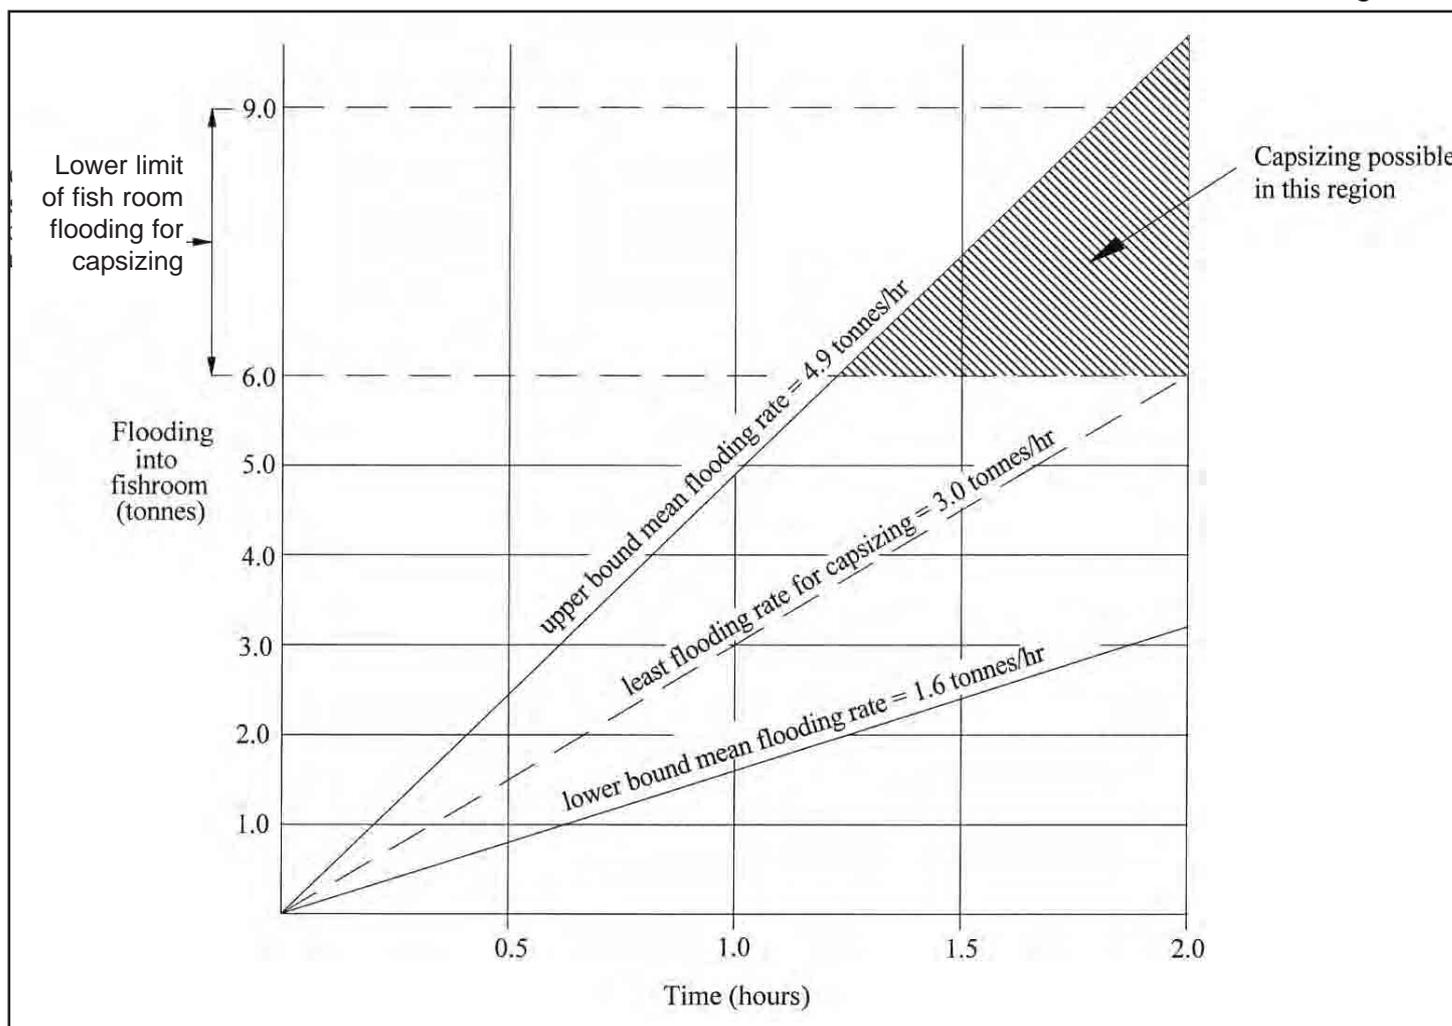
Flooding of the fish room - equating possible flooding rates and time frames

This assessment required an estimate of the likely maximum flow rates through the ice scuttles. Since the windward and leeward ice scuttles were seen to be immersed only 6% and 3% of the time, the water actually flowed into the fish room over a total time of only 3.6 and 1.8 minutes per hour for the windward and leeward ice scuttles respectively. Thus, the maximum flow rate was substantially greater than the calculated hourly average flow rates. Using these figures, it was estimated that the likely maximum flow rates at one ice scuttle were approximately 33 tonnes/hr if the mean flooding rate to the fish room was 3 tonnes/hr, and 54 tonnes/hr if the mean was 4.9 tonnes/hr. The full-size downflooding tests showed that these rates were within the discharge capacity of the gap between the starboard picking tray flange and the ice scuttle ring. It was concluded that the presence of the picking trays would not have made a substantial difference to the rate of flooding of the fish room from water spilling on to the main deck from the sea.

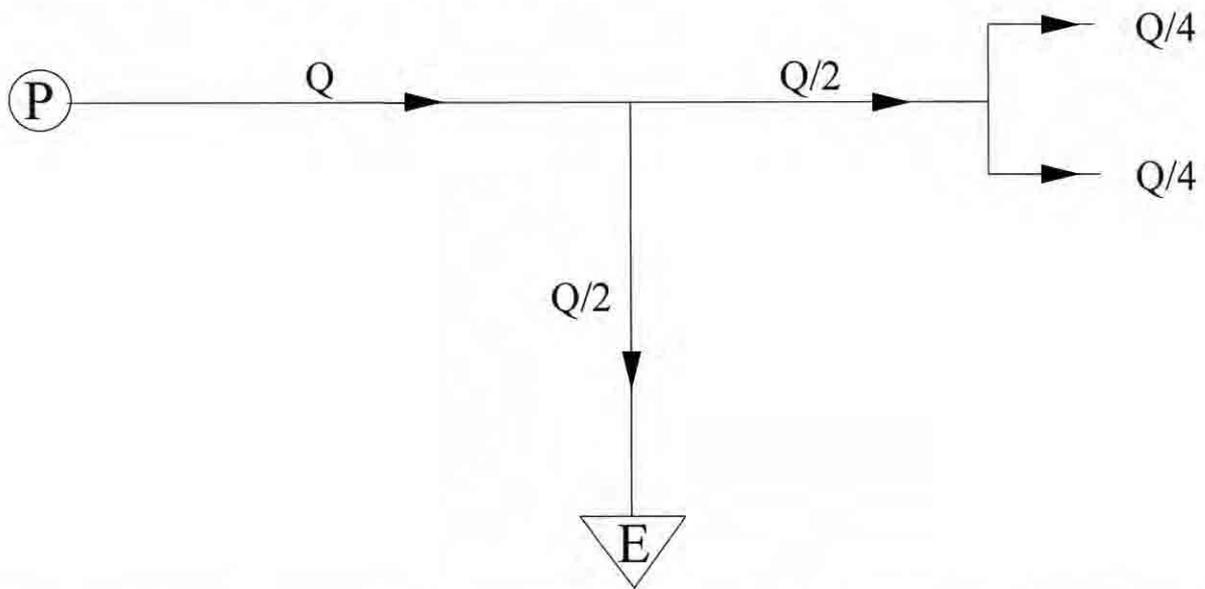
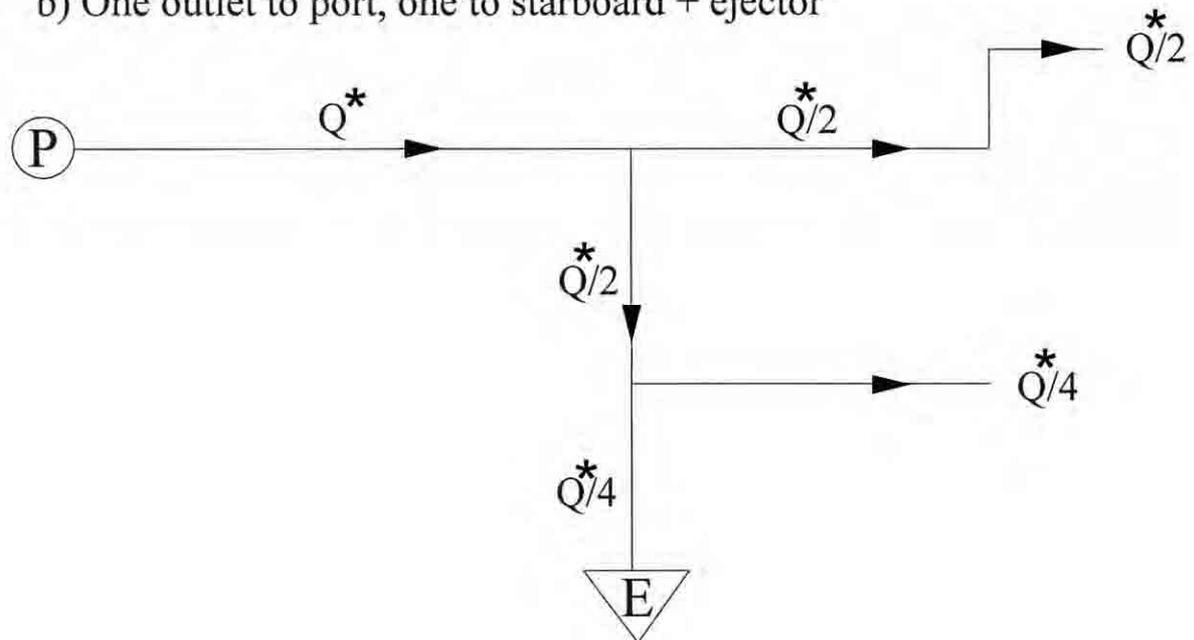
It is concluded that, because the port Desmi pump was supplying other outlets, in addition to the bilge ejector, the discharge rate from the slush well was negligible. This meant that instead of the water being pumped out as it should, had the full suction been available, nothing was happening and the fish room was steadily filling.

a) Two outlets on port side + ejector

b) One outlet to port, one to starboard + ejector
