**Report of the investigation into  
the capsizing of the fishing vessel**

***DONNA M***

**off the coast of the Orkney Islands with the loss of two lives**

**on 31 August 1999**

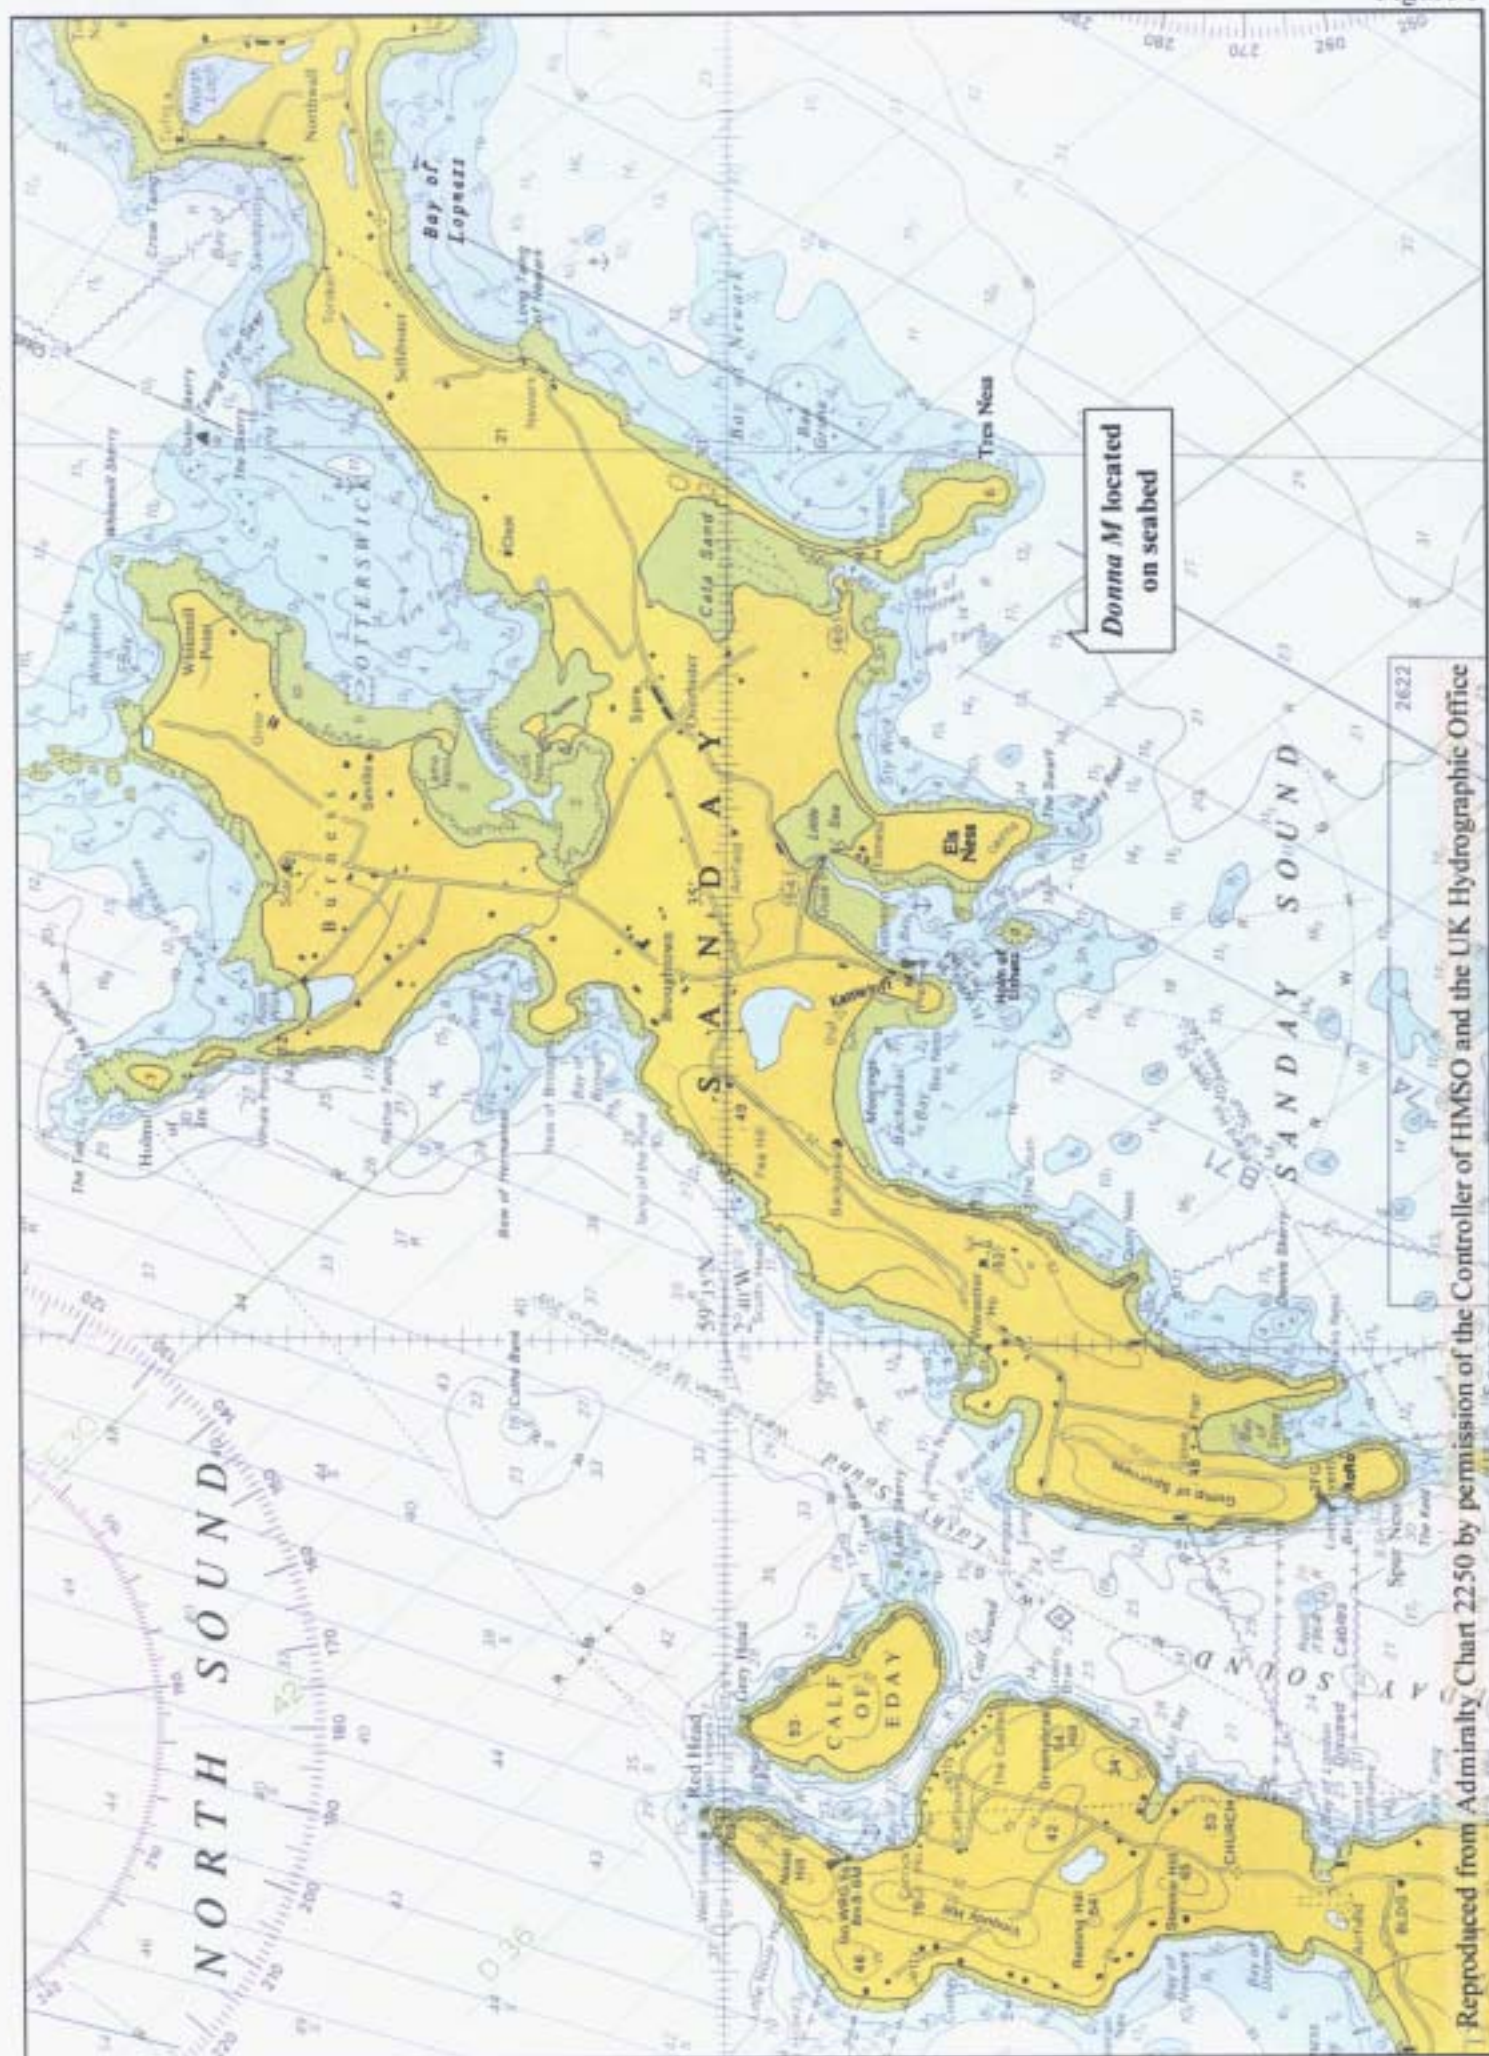
Figure 3

*Donna M* left the island of Sanday at about 1430 on 31 August 1999 to creel for lobsters and crabs. When the vessel got underway from Kettletoft pier, witnesses noticed the stern was low in the water. She first motored to the east side of Els Ness (**Figure 3**), where a rope of creels was laid. *Donna M* then went to a position southeast of the Holm of Elsness where the rope of creels laid on 30 August was recovered. She then headed for the bay between Els Ness and Tres Ness (which is known as Sty Wick), where another rope of creels was laid. The crew of the fishing vessel *Loch Roag* were the last to see *Donna M* at about 1600, roughly halfway between the two headlands of Els Ness and Tres Ness.

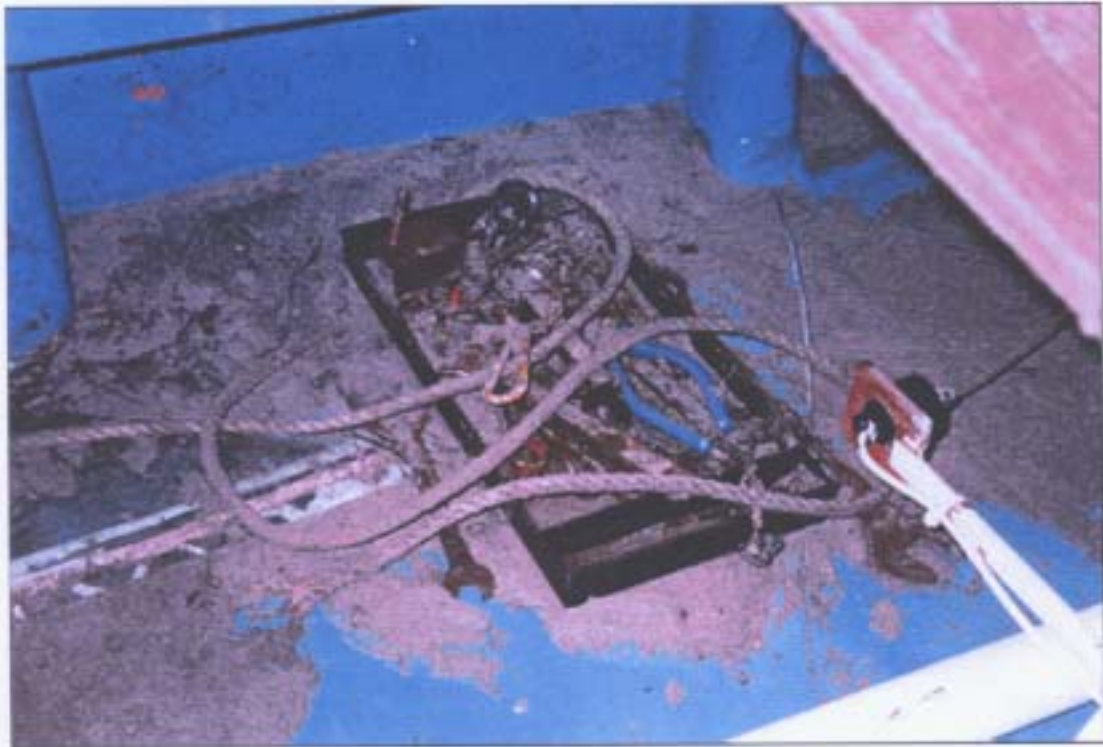
Figure 14

the accident. The cat catcher contained the basket for the anchor with its length of chain/rope. The fenders had not been taken in, and were still attached to the sides.

The manual pump was inadequate for pumping a large quantity of water. The crew then attempted to jury-rig the engine driven pump; the hoses had been removed indicating that this conversion was underway. The toolkit was found on the seabed close to *Donna M* which indicates it was on the open deck (**Figure 14**) just before the accident (the toolkit would have been needed for the work on the pump). There was no suction hose connected to the manual bilge pump when *Donna M* was inspected by the MAIB; this hose may have been removed just before the capsize, with the intention of fitting it to the engine driven pump.
