**Report on the Investigation of  
the capsize of the fishing vessel**

***FRAOCH BAN***

**off the coast of the Shetland Islands  
on 15 August 1999**

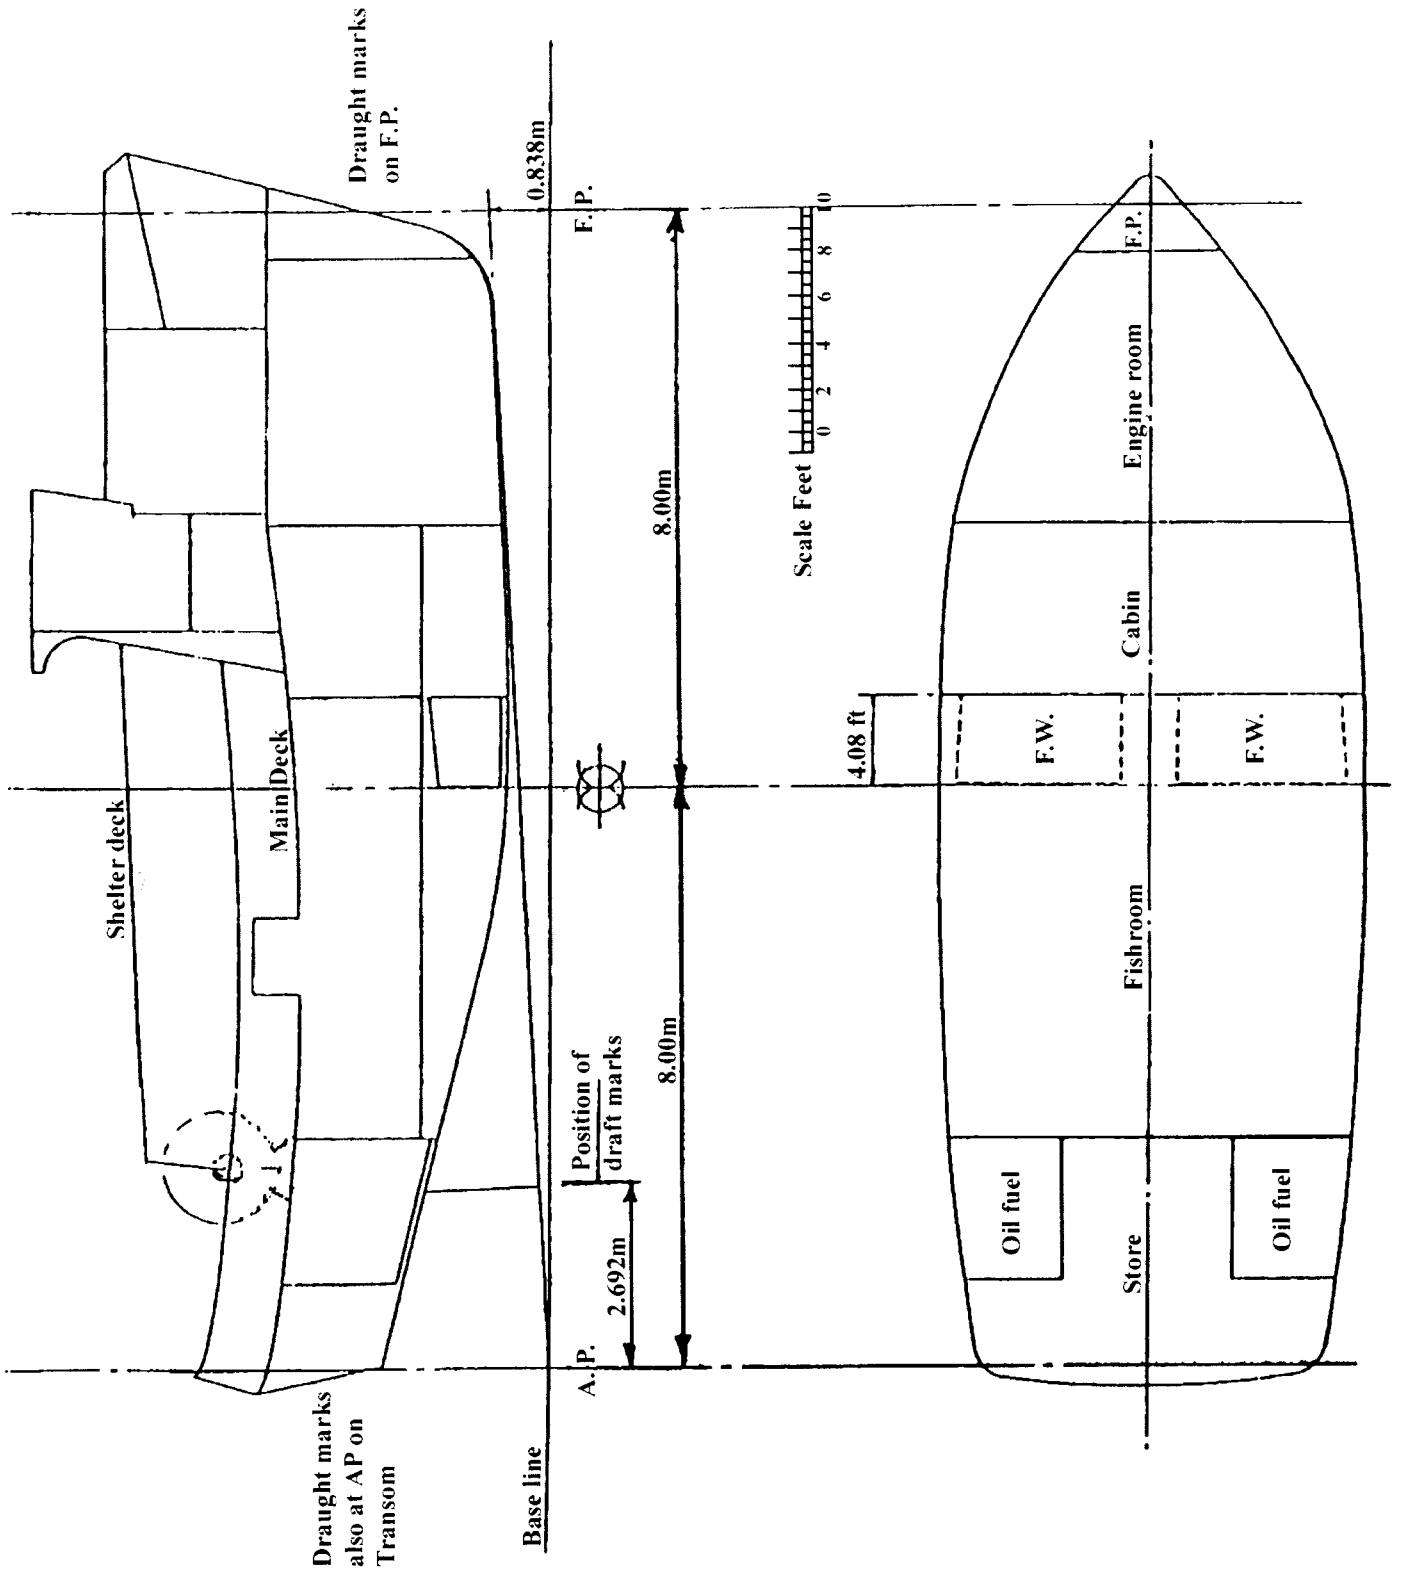
Profile and Plan

*Fraoch Ban* was fishing for sand eels, which were stowed on board in bulk. The arrangement of the pound boards in the hold did not limit the free surface sufficiently, and as a result the vessel capsized and foundered. The weather at the time was calm and it was daylight. The stability book of the vessel was not approved for the bulk stowage of fish.

While sand eels were loaded, *Fraoch Ban* became progressively more unstable due to the increasing free surface. When the catch stowed in the fish hold reached 25 tonnes this was enough to cause the vessel to capsize.

It is considered that the pound boards did not break. The crew thought that this may have been the reason for the excessive free surface, but this was caused by the gaps at the bottom.
