**Report on the investigation
of the flooding
of the UK charter fishing vessel
RANDOM HARVEST
south-west of Brighton
on 3 July 1999**

Marine Accident Investigation Branch
First Floor Carlton House
Carlton Place
Southampton
SO15 2DZ

Report No 28/2000

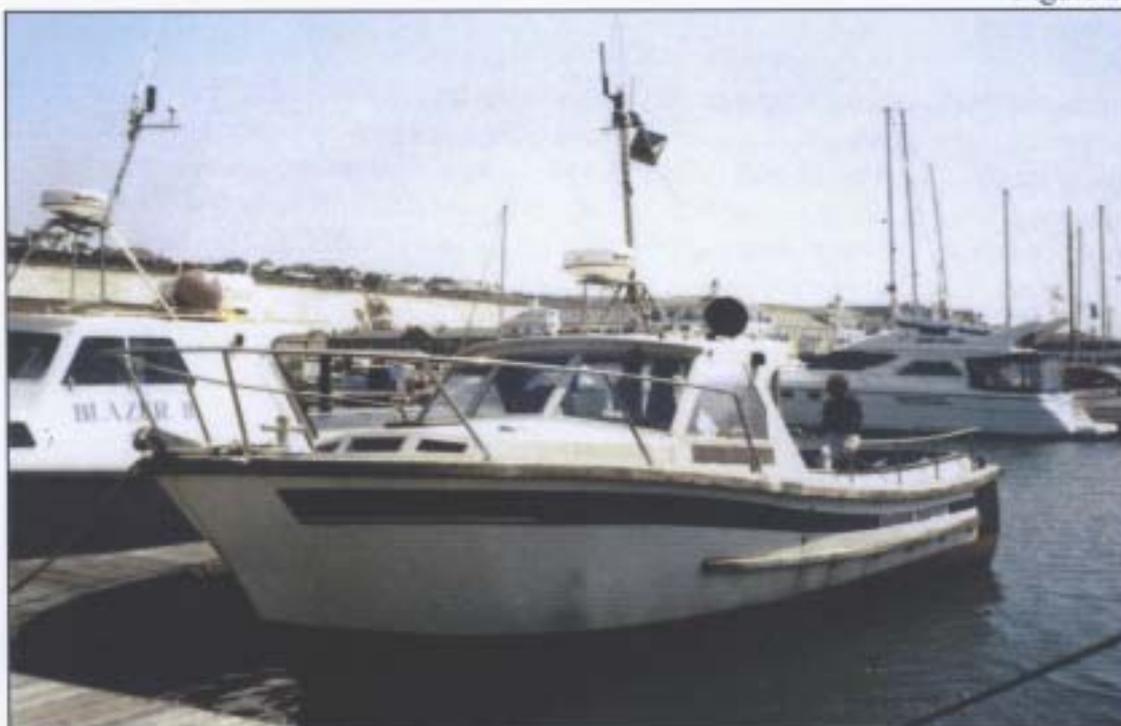
Figure 2

Random Harvest alongside in Brighton Marina

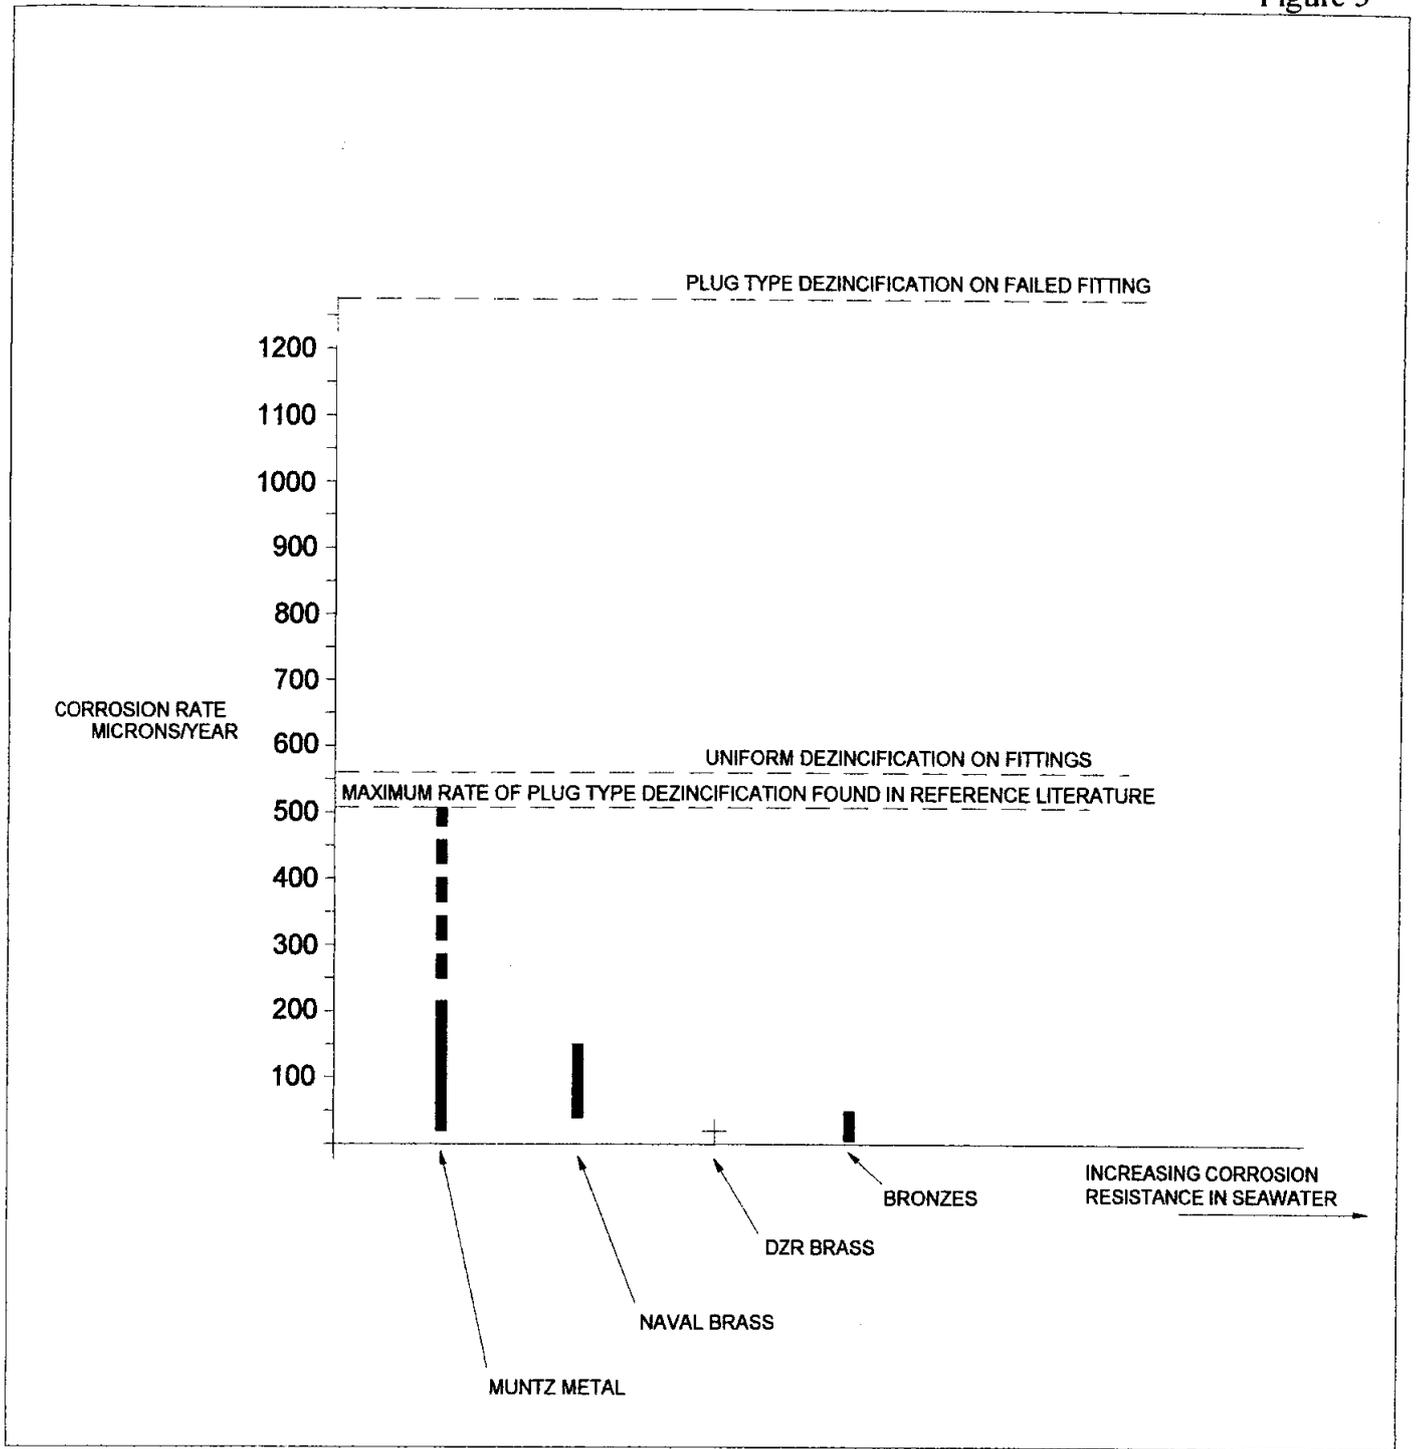
Figure 5

Data from the Copper Development Association and other sources (**Figure 5**) provides a rough guide to the rates of corrosion in seawater that can be expected of the copper alloys. It shows that some brasses can corrode at over 0.2mm/yr. There is also a report of plug type dezincification reaching 0.5mm/yr.

Expected corrosion rates of various copper alloys in seawater

The rate of corrosion on the failed fitting was about twice the maximum rate for plug type dezincification found in reference literature (**Figure 5**). High stresses under the thread roots appear to be an important factor, causing corrosion rates in these regions to be double the underlying uniform rate.

As the uniform corrosion rate itself is double the worse that could have been expected (**Figure 5**), there are probably other factors involved.

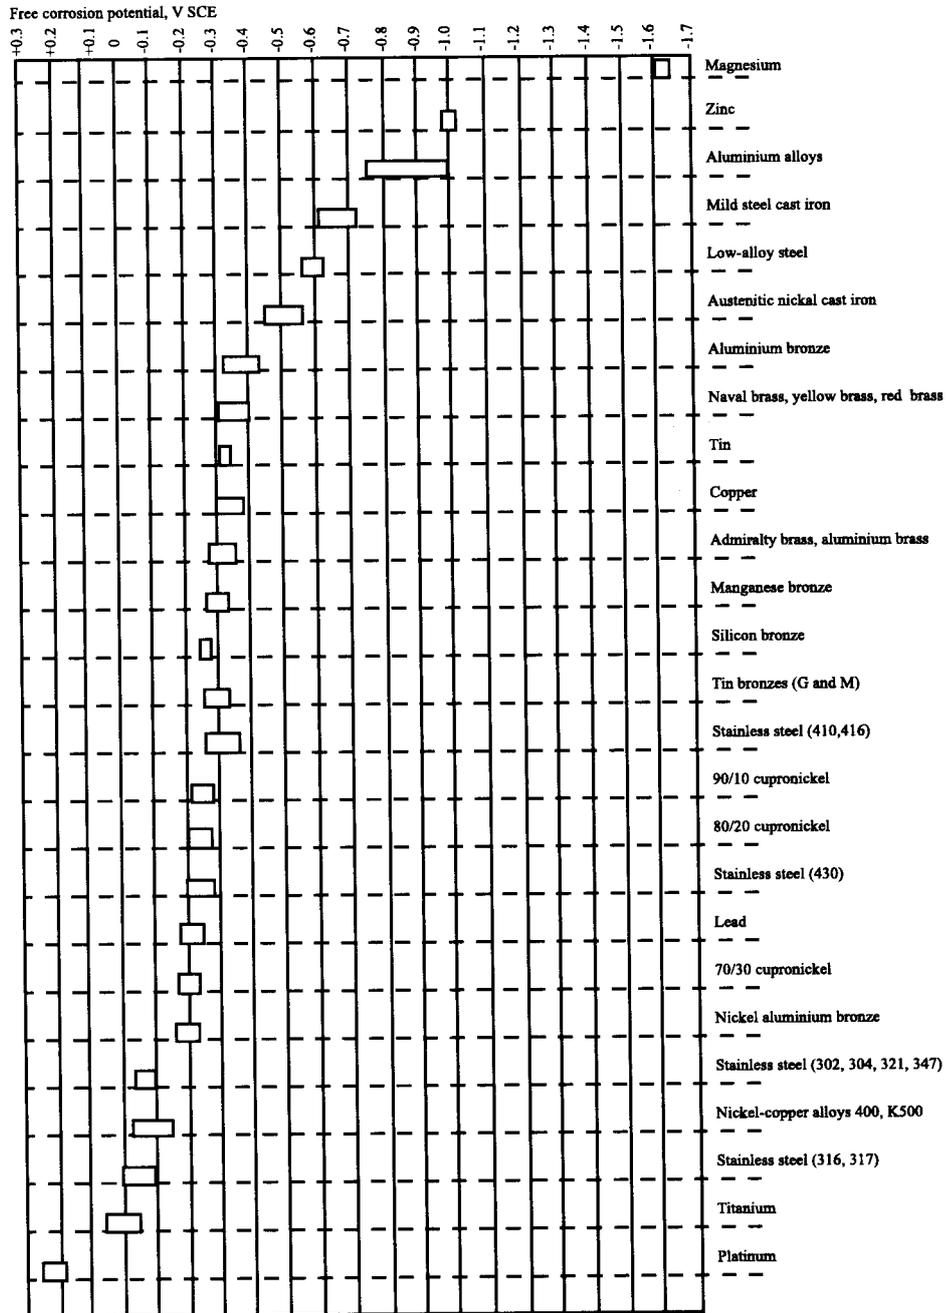
Figure 6

One possibility is galvanic corrosion due to the proximity of the fittings to the copper ground plate for the vessel's electronic equipment, to which they would probably have been connected. But, given the closeness of brass and copper in the galvanic series of metals (**Figure 6**), and the relatively small difference in exposed area between the fittings and the ground plate, this was unlikely to be important.

The galvanic series for metals immersed in seawater
