**Report of the Inspection of an
unnamed dory which sank on**

Loch Awe

with the loss of three lives on 29 May 1999

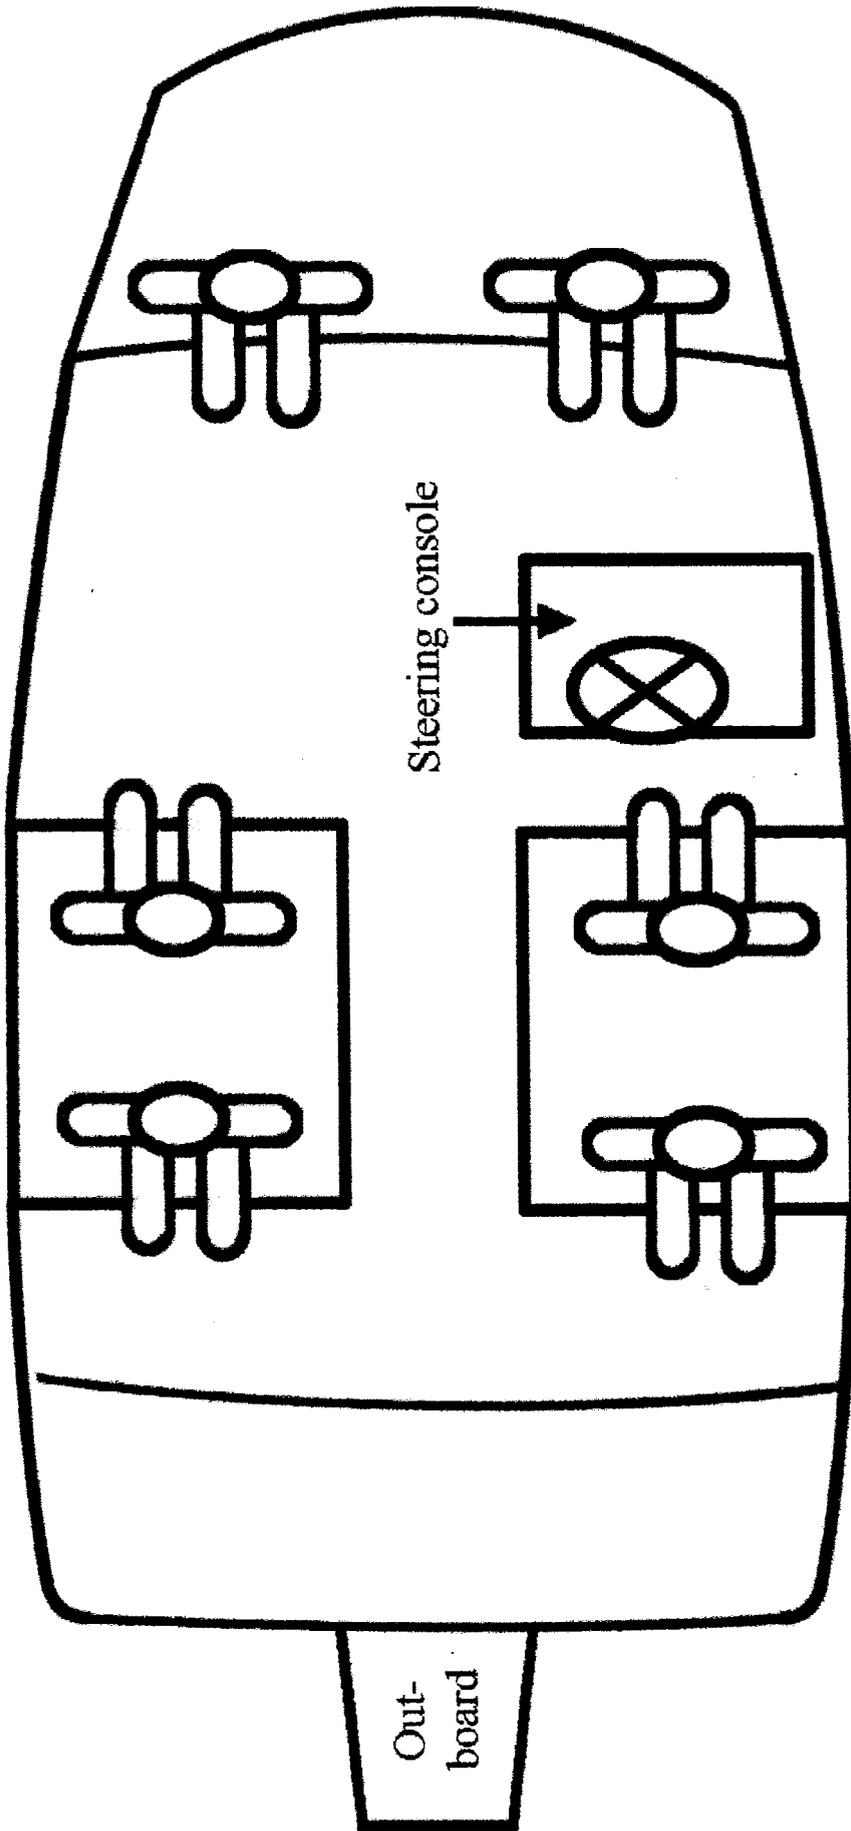
Figure 11

For the inspection afloat the dory was launched off its trailer at a beach near Oban. The dory was loaded with the engine and six adults to represent as closely as possible her condition prior to the accident **(Figure 11)**. It was recognised that the dory was inspected in sea water, whereas the accident occurred in fresh water, but this was not considered to be significant (a boat displaces about 2.5% more fresh water than salt water). It was also recognised that one of the crew in the accident was a child. These two weight discrepancies would tend to cancel each other out.

Forward port corner	0.24m
Forward starboard corner	0.24m
Aft starboard corner	0.46m
Aft port corner	0.46m

The test lasted about 20 minutes, after which the dory was put back on its trailer and pulled out of the water. When the drain plug to the void was removed a substantial amount of water flowed out.

When the dory was tested by the MAIB (**Figure 11**), the void was initially dry, however, a freeboard of only 0.24m at the forward end is not considered to be satisfactory for prevailing sea conditions. Two persons seated forward
