Report of the investigation of
two lifting wire failures
on starboard Fast Rescue Craft davit
of safety stand-by vessel
Dea Fighter
on 13 May and 16 July 1999

Marine Accident Investigation Branch
First Floor, Carlton House
Carlton Place
Southampton
SO15 2DZ

Report No 39/2000

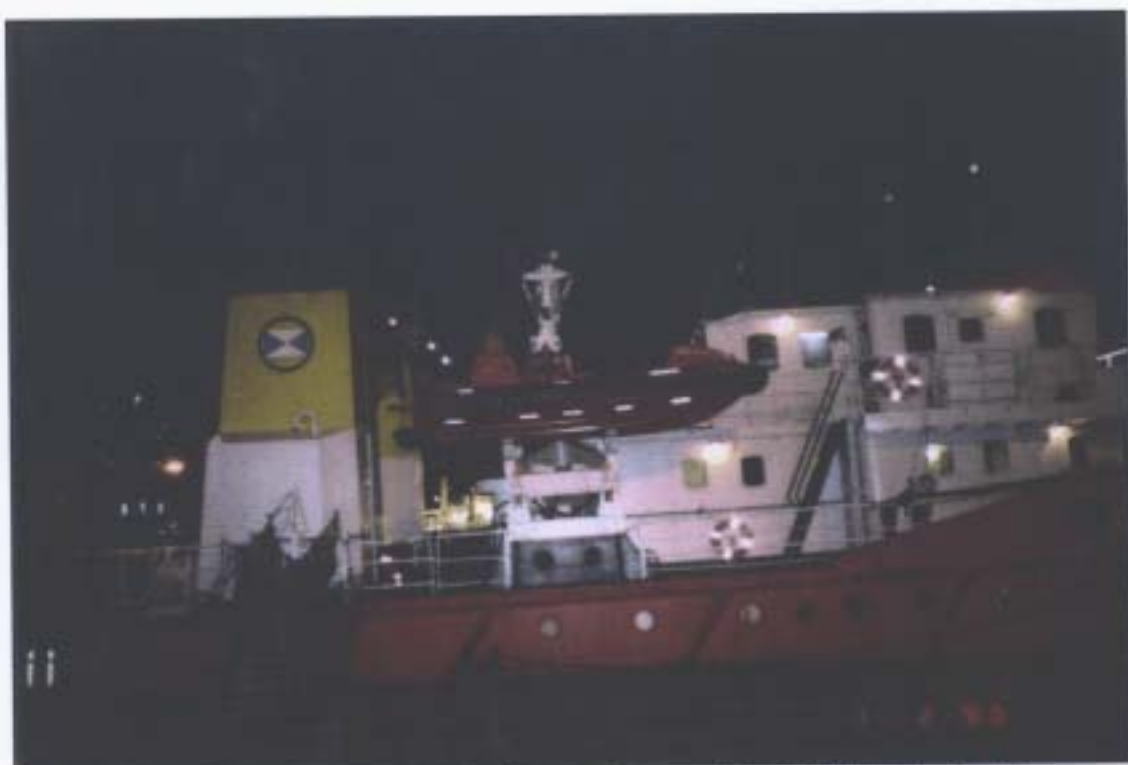
Starboard side of *Dea Fighter* showing Fast Rescue Craft, davit and wheelhouse

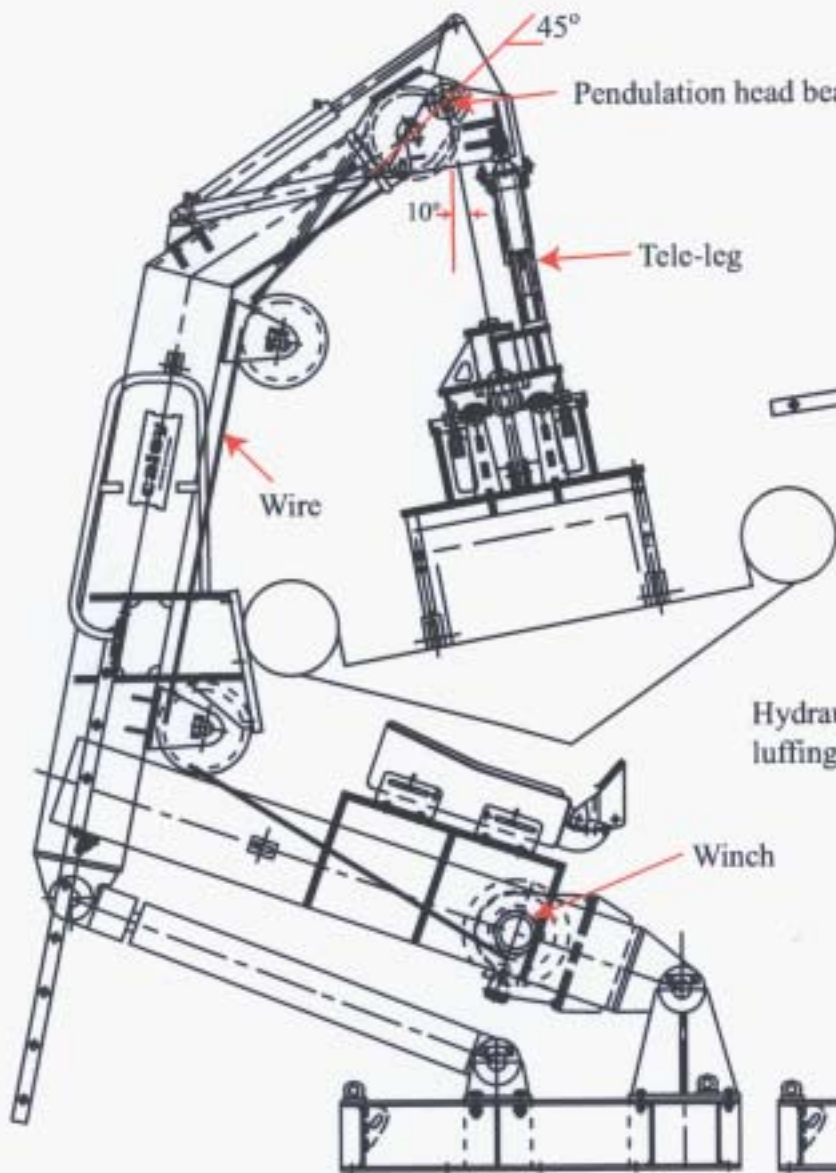
Figure 1A - Stowed

With the davit's arm in the inboard position and the weight of the FRC just taken by the wire, both the tele-leg and the length of wire between the top sheave and the FRC's hook will be about 10° from the vertical (see **Figure 1A**).

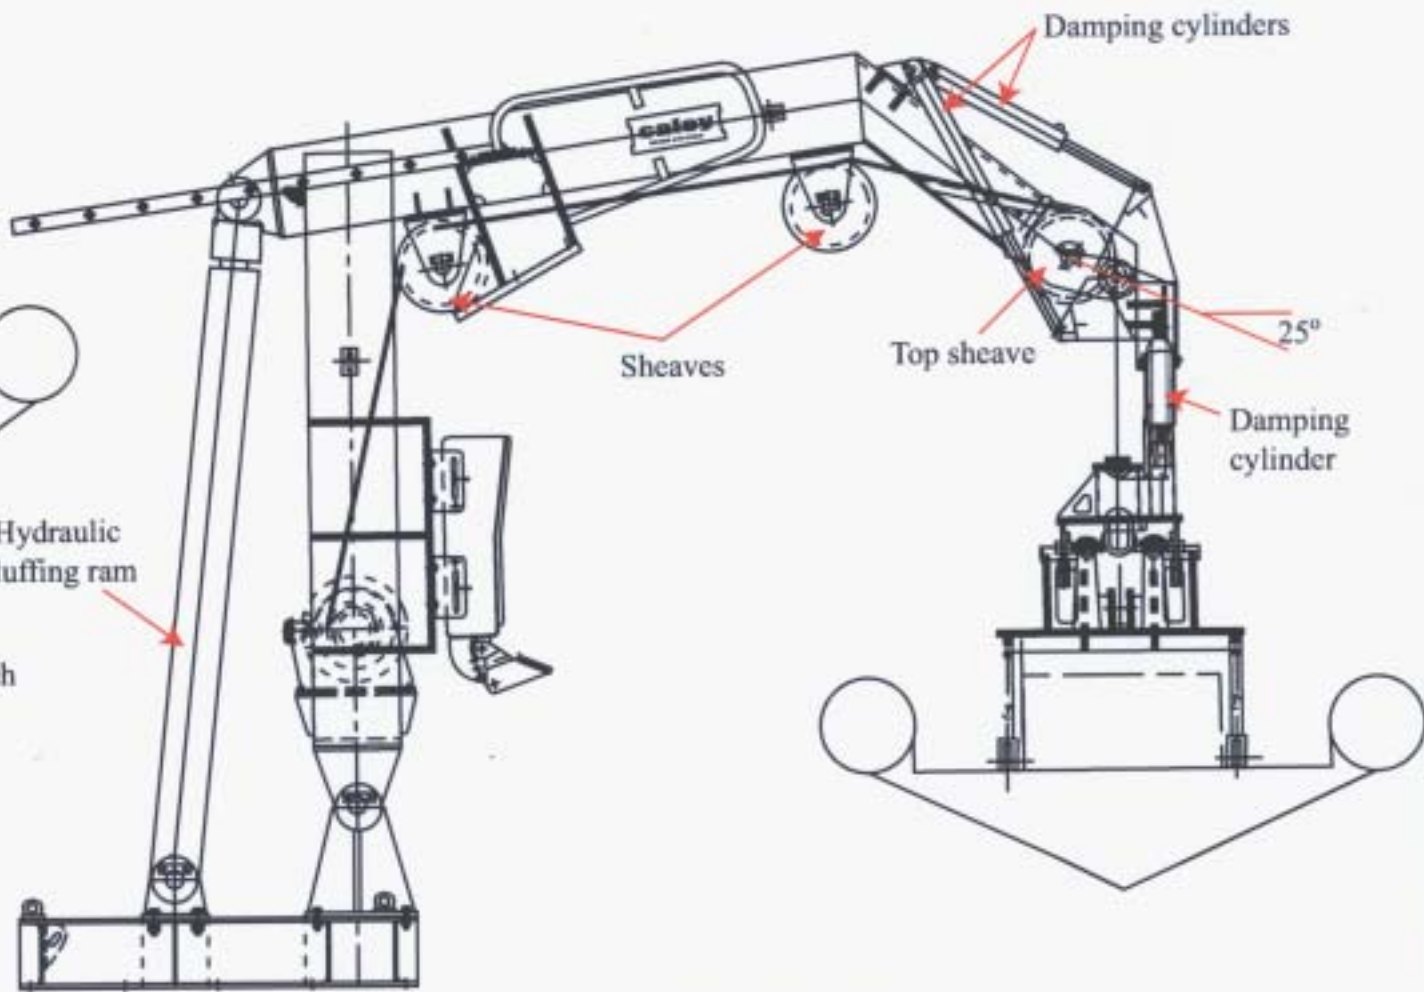
Figure 1B - Swung out

In swinging out to the extreme outboard position, the davit arm will rotate about 70° . However, because of their initial inclination of 10° , the tele-leg and the wire from the FRC's hook will rotate only 60° relative to the davit arm (see **Figure 1B**).

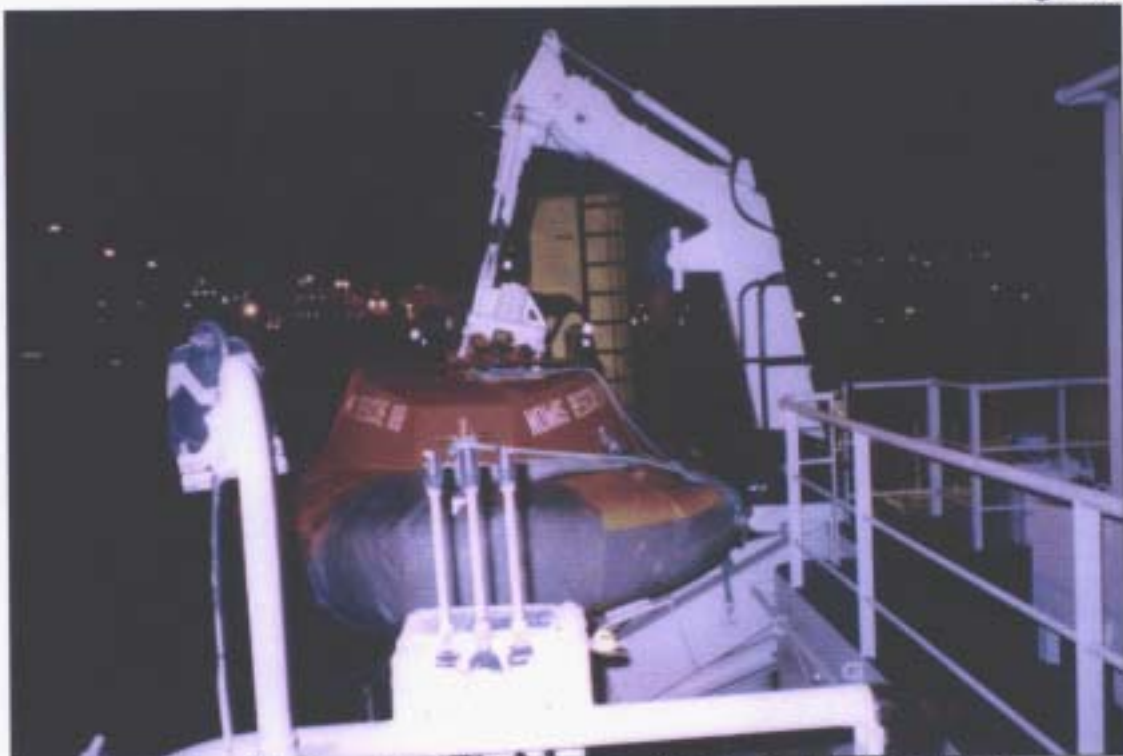
Figure 2

View of starboard davit from its control station (centre foreground)
