**Investigation into the collision between
the UK registered cargo vessel**

Hoo Robin

Arklow Marsh

on the River Trent on 2 March 1999

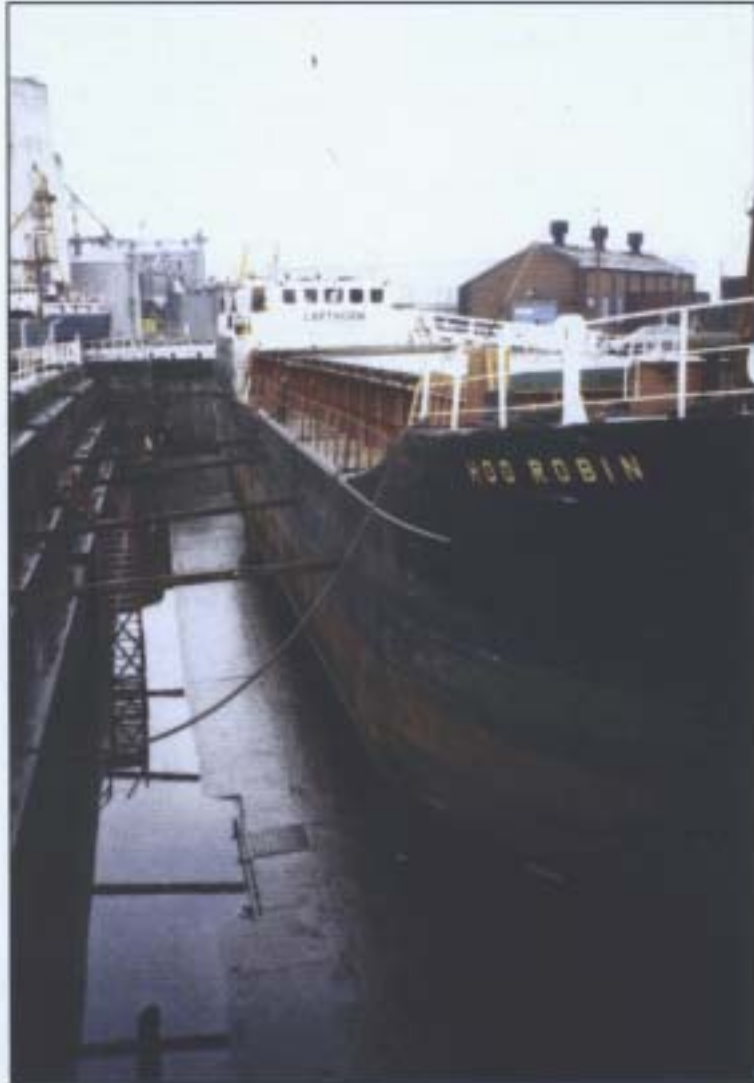
Photograph 1

Hoo Robin

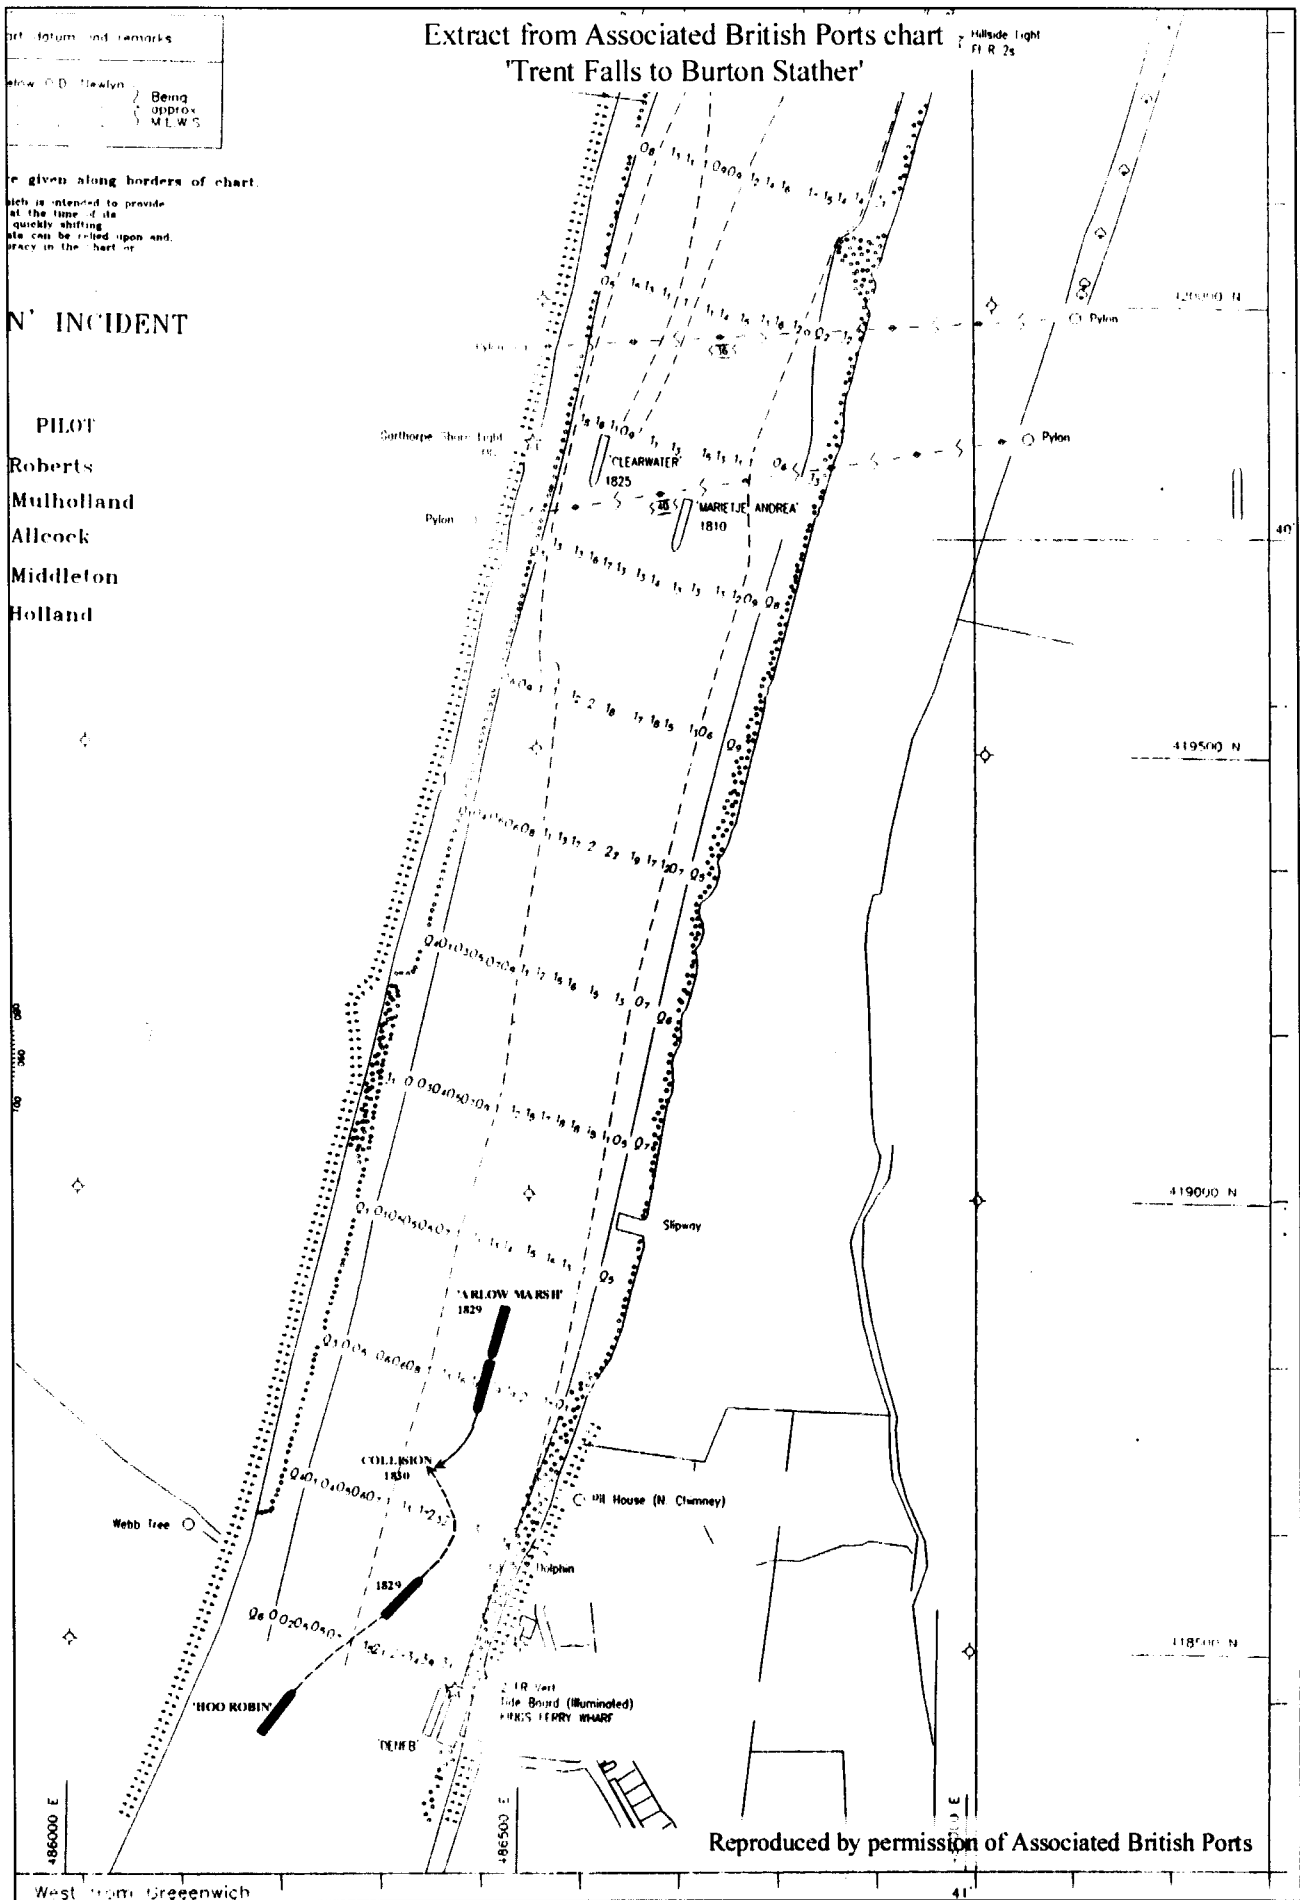
Figure 1

At 1805 *Arklow Marsh* (maximum draught 4.6m) passed Apex light and entered the River Trent inbound for Keadby with a licenced pilot on board. Three other small cargo vessels were inbound at about the same time; *Clearwater* and *Marietje Andrea* were ahead of her and *Ara* was half-a-mile astern. There were also a number of barges inbound and outbound.

Hoo Robin, and the other vessels, broadcast their positions on VHF Channel 17 when passing key points in the river (see Annex). *Hoo Robin* contacted both *Clearwater* and *Marietje Andrea* as she approached them and agreed to pass both of them red-to-red (ie on each other's port side).
