Marine Accident Report No. 4/99

Report on the Underwater Survey  
of the Stern Trawler

**GAUL H. 243**

and the supporting Model Experiments  
August 1998 – January 1999

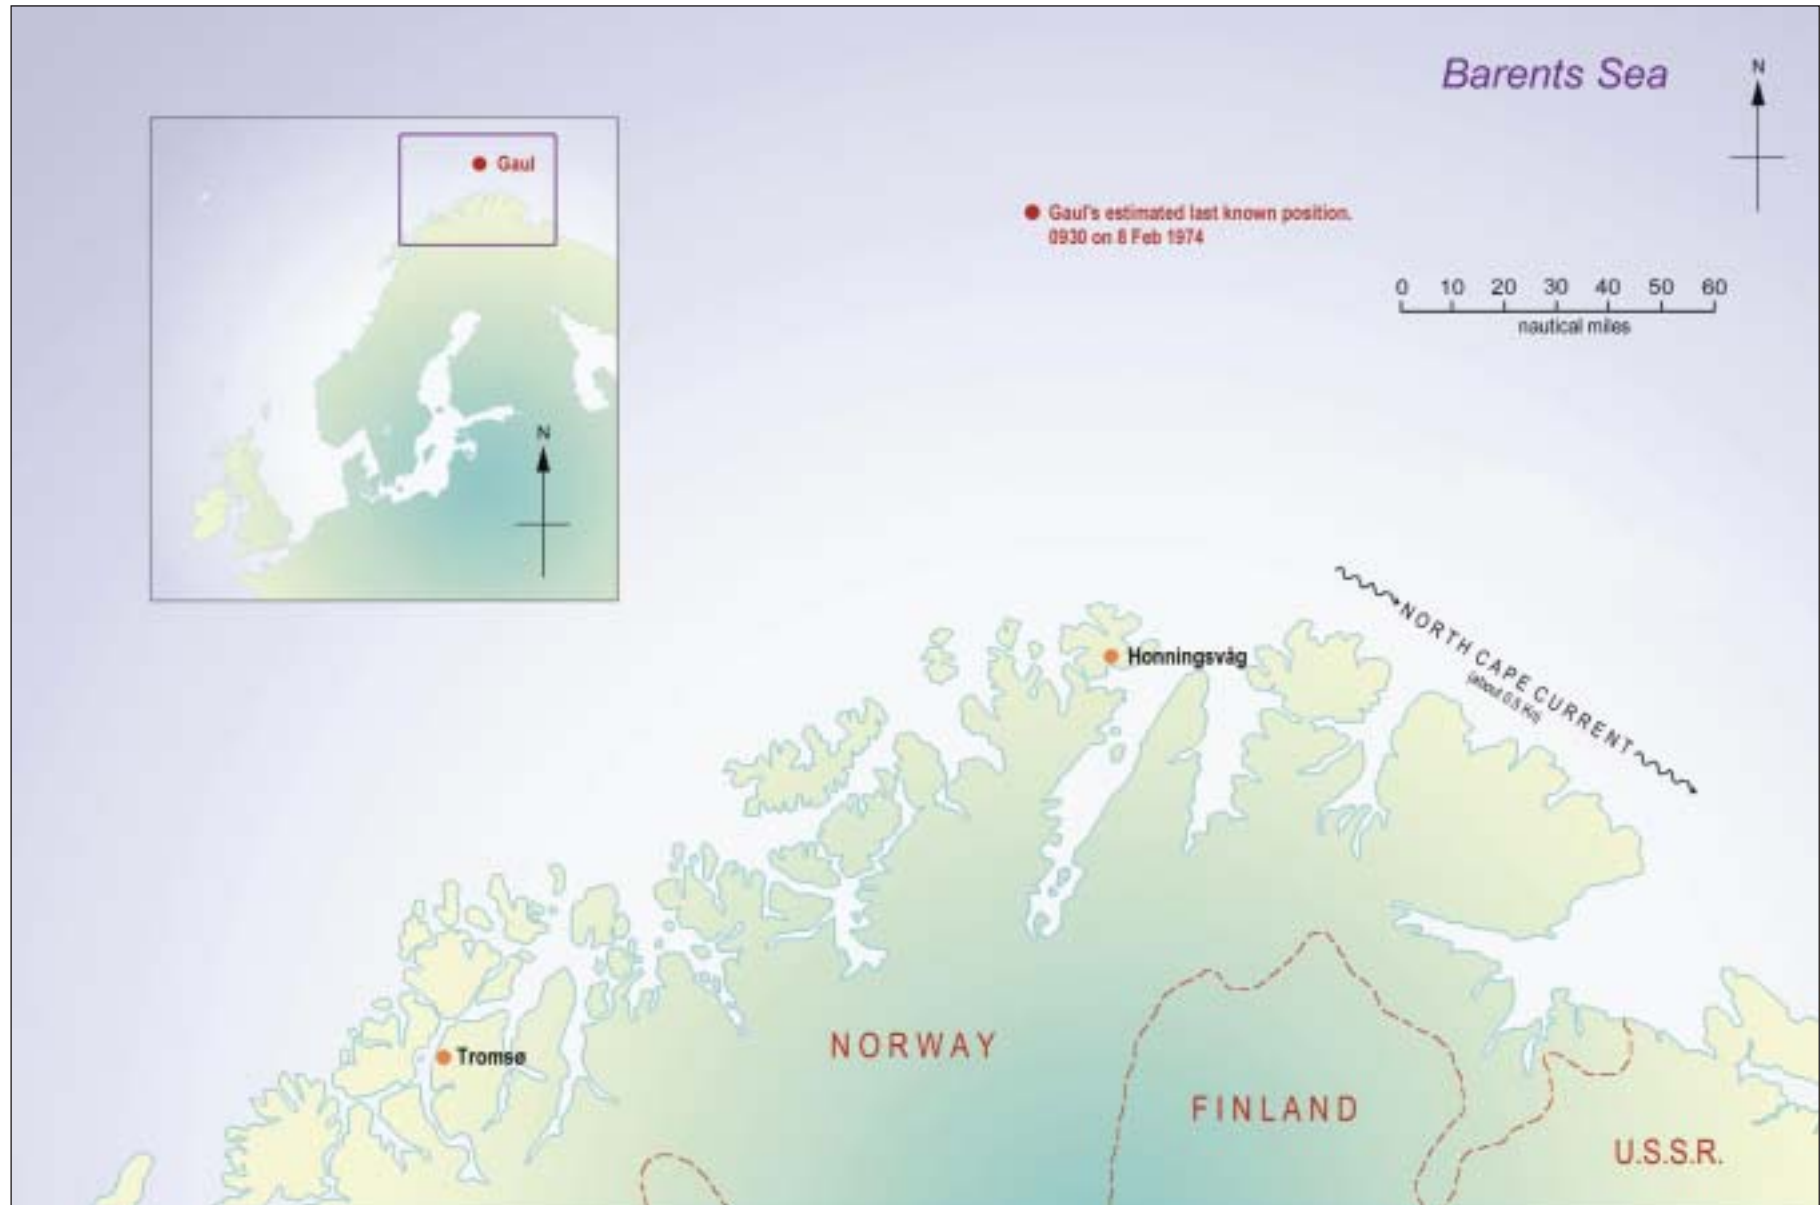
Figure A: Gaul's last known position

The position of *Swanella* and *Gaul* at the time was given, very approximately, as 72° 25’N 25°E (**Figure A**). The mate on *Swanella* was firmly under the impression that *Gaul* was lying beam on to the seas carrying out a job that would have prevented her dodging head to the weather. It also transpired during the conversation that *Gaul* was waiting for the 1030 skippers’ schedule to see what other trawlers were catching on the Malangan Bank where the weather had not stopped them fishing.

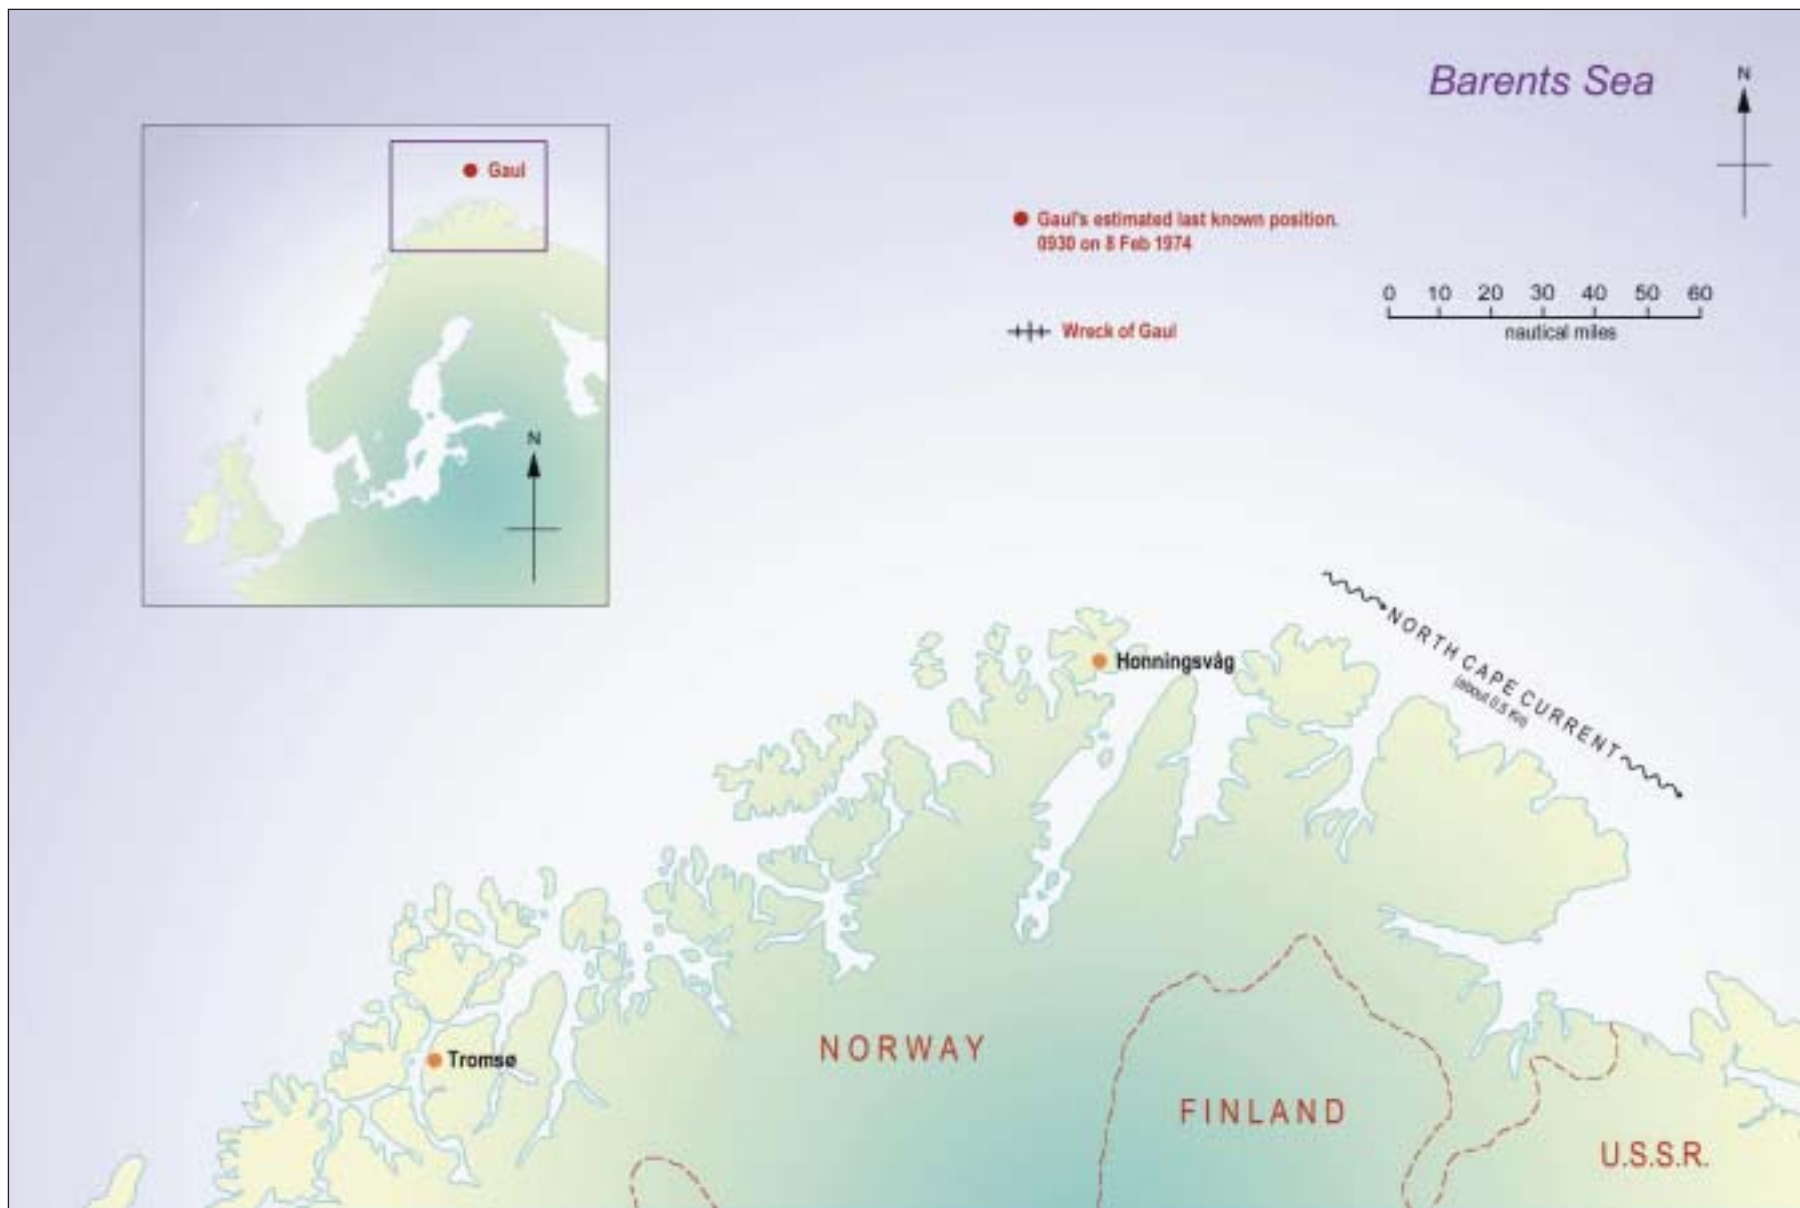
Figure B: Position of wreck of Gaul

In the years following *Gaul*’s disappearance trawlers have snagged gear on wrecks on the North Cape Bank. One such snagging involved the Norwegian trawler *Rairo* losing her gear on some form of underwater obstruction in position 72°04’N 25°05’E on 15 November 1975.

In August 1997 a team funded by Anglia Television and the Norwegian Television Company, NRK, and led by Mr Norman Fenton, sailed from Hammerfest, Norway to find the wreck of *Gaul*. They headed for an area on the North Cape Bank (Nordkapp Banken) which contained the wreck discovered by *Rairo* which Mr Fenton believed to be the missing vessel. Once at the selected position a side scan sonar was used to locate the wreck and after several hours searching, a promising target was found. A remotely operated vehicle (ROV) was lowered to the seabed, manoeuvred close to the contact and positioned to identify it. It was the wreck of a trawler and positively identified as *Gaul*.

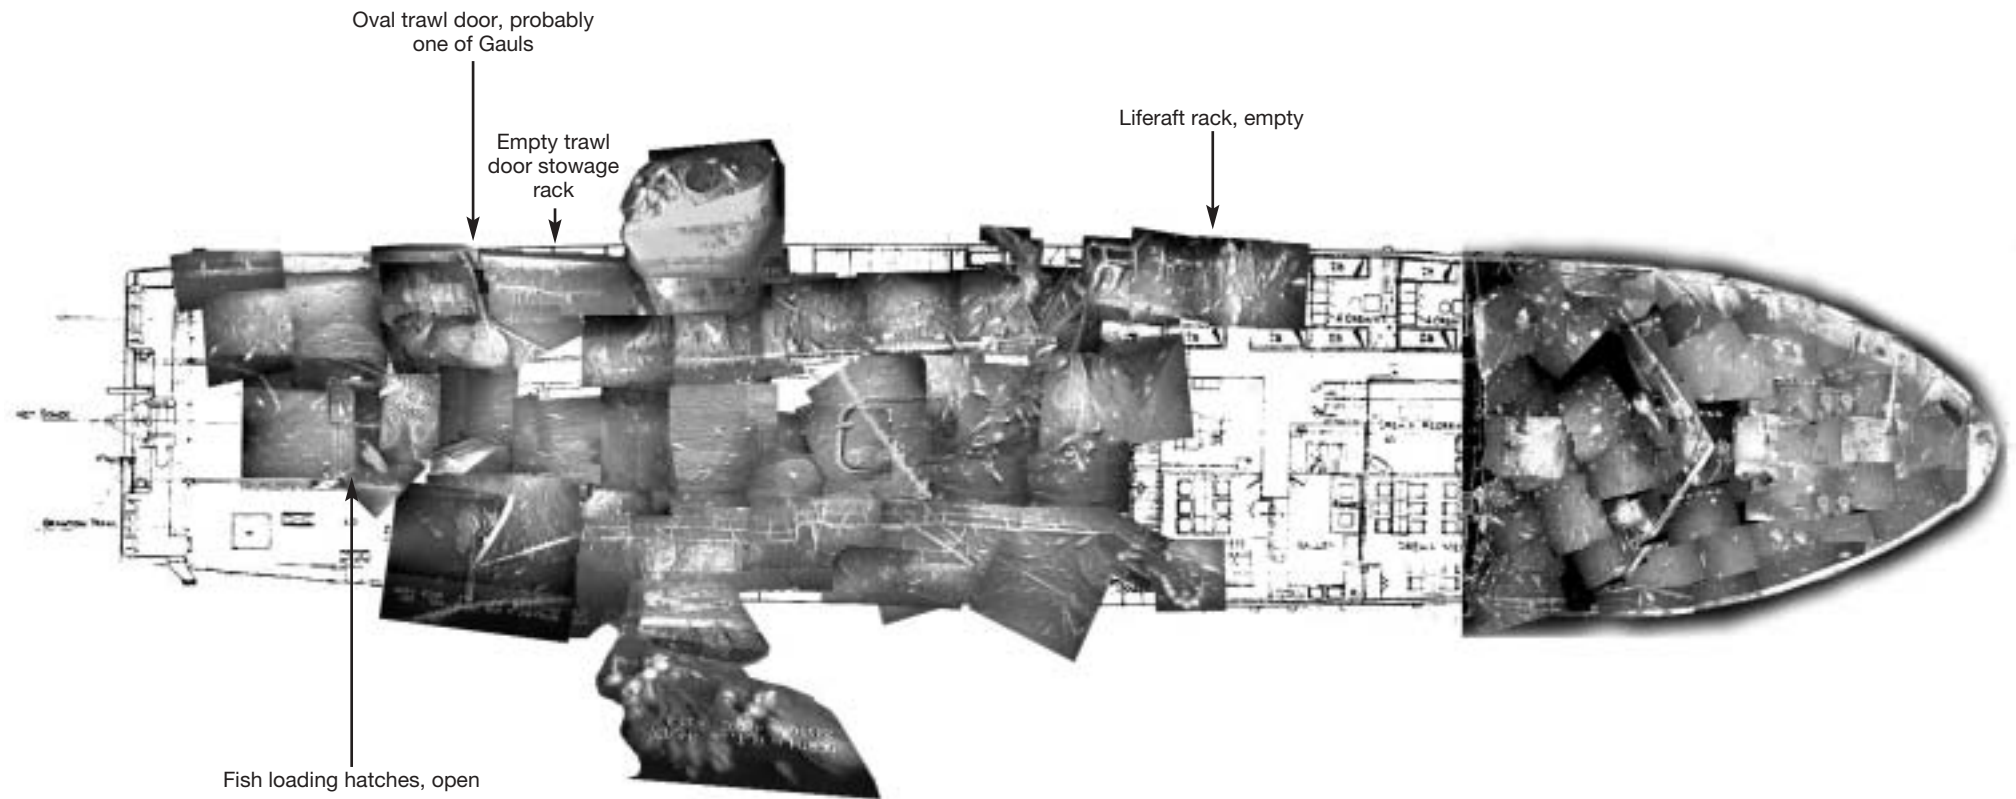
Figure G: Plan view of trawl deck and forecastle deck

The machinery removal hatch, inboard of the port funnel, was down but unsecured.

Note: 1) Nets prevented photography over the aft starboard corner of the trawl deck

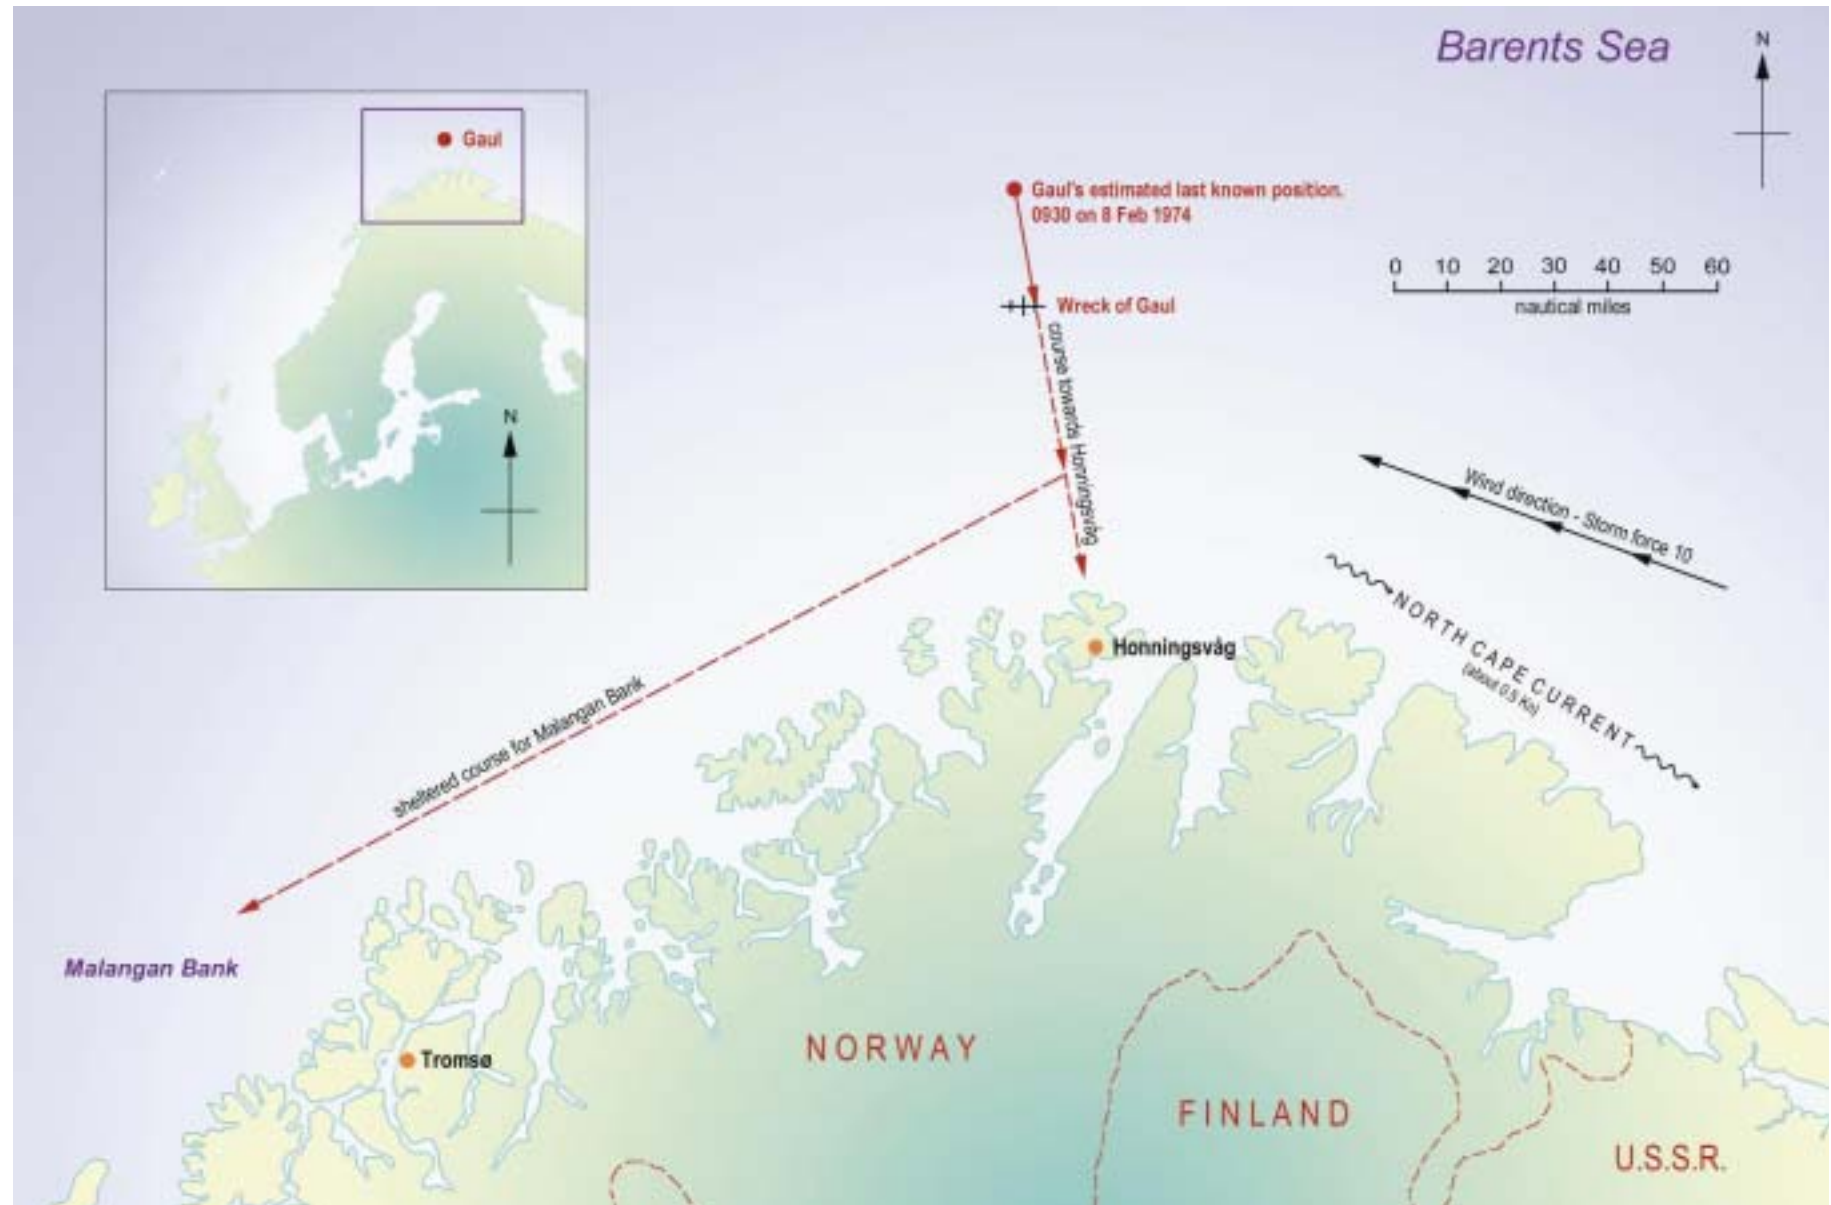
Figure J: A reconstruction of Gaul's last movements

The investigation concludes that just before she was lost *Gaul* was very likely making good a course of 170° towards the land. This probably meant her actual course was to port of this, putting the weather 4 to 5 points on the port bow.

It is not known at what time *Gaul* turned towards the land. When she was last seen she was heading approximately WNW (292°), or downwind. It is assumed that the skipper was trying to reduce both pitching and rolling while the crew completed essential tasks. Nor is it known at what speed she would have proceeded when she started making way. In the prevailing conditions it is unlikely that she would have proceeded very fast. It is thought that she might have been making about 5 knots which is consistent with the estimate of propeller pitch from the underwater survey. If she had started to make way shortly after she was last seen at about 0930, and on the assumption that she had made good a speed of about 5 knots, she would have been in the position where she was eventually found at about 1330.

This estimate of her last course and speed does not however, explain how she came to be beam on to the sea.

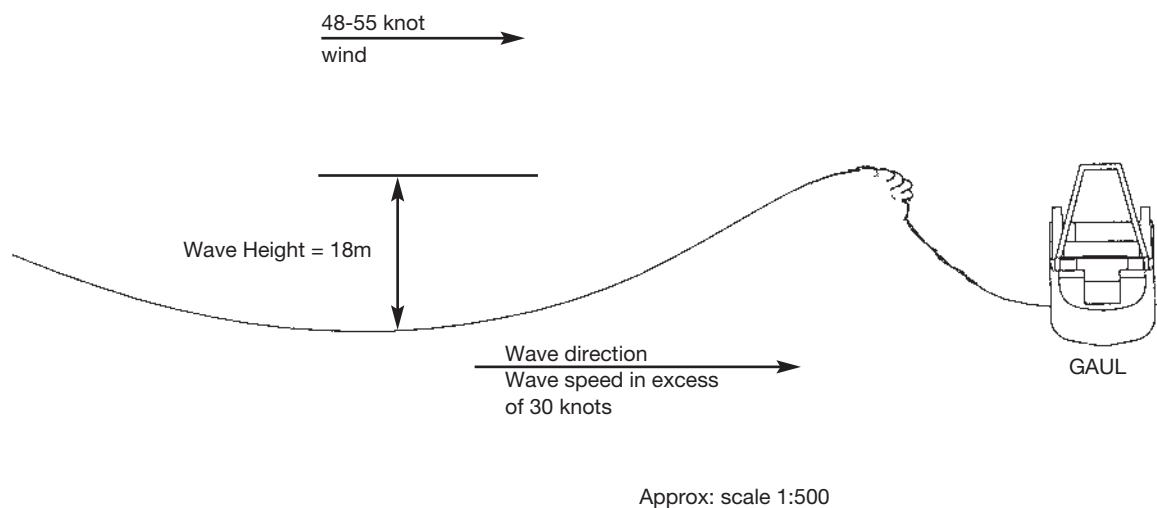
A trace of the wave heights and the roll motion of the GAUL model for Run 28, during which a *knock down* occurred. The height of the first steep wave of the wave group was 18m from crest to trough. This wave became a breaking wave and was responsible for the *knock down*. The wave trace represents the wave profile at the model's mean position at the start of the run.
