**Report of an investigation  
into the loss of  
PESCALANZA PZ744  
and six lives  
on  
2 November 1998**

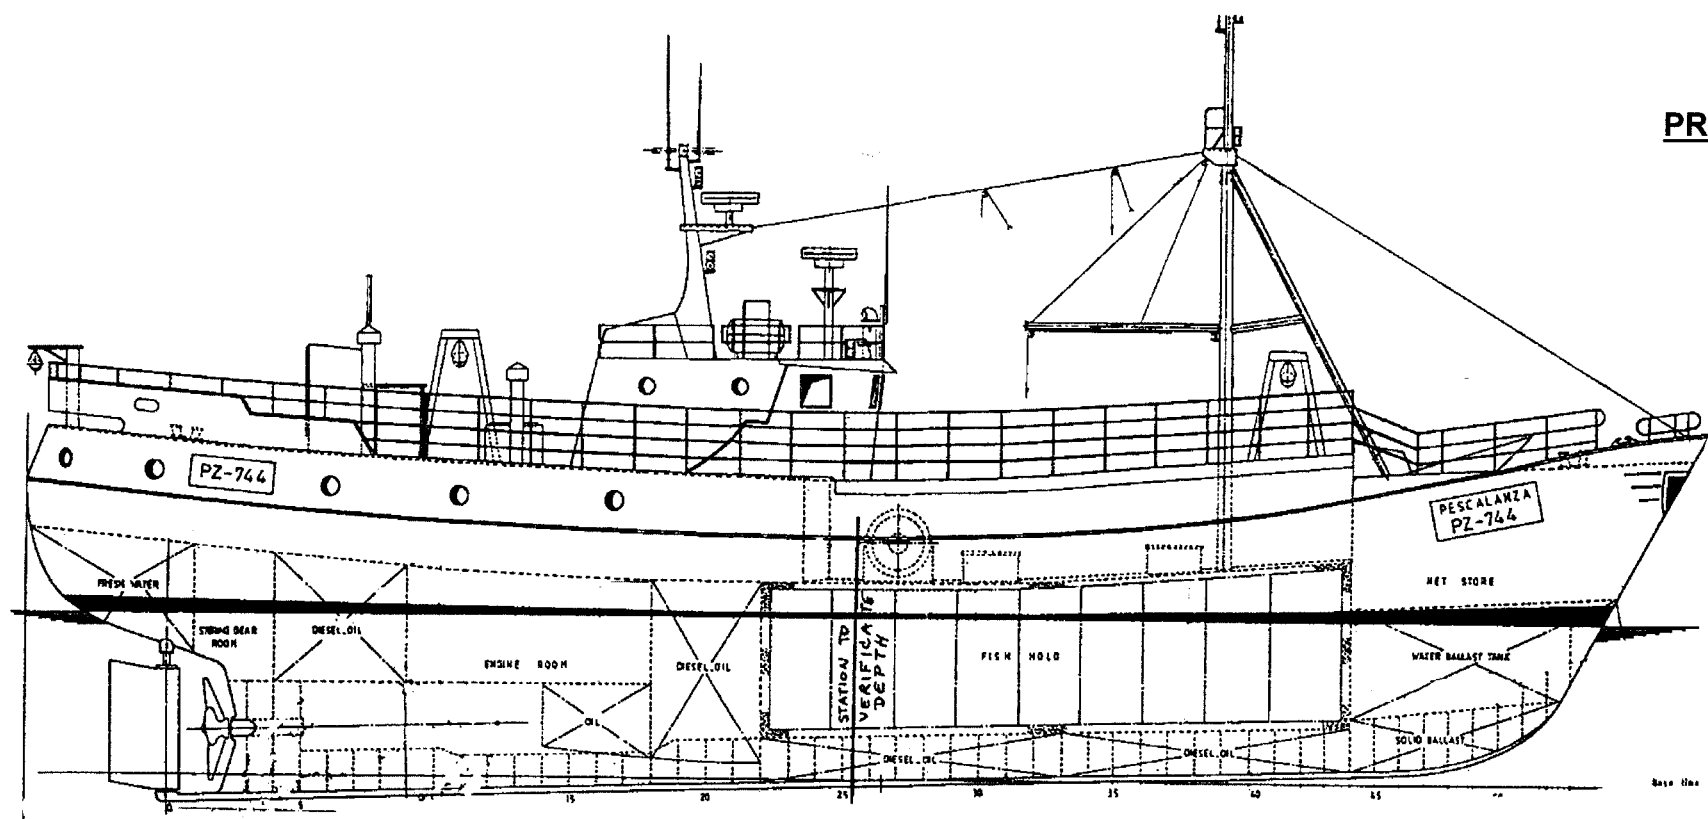
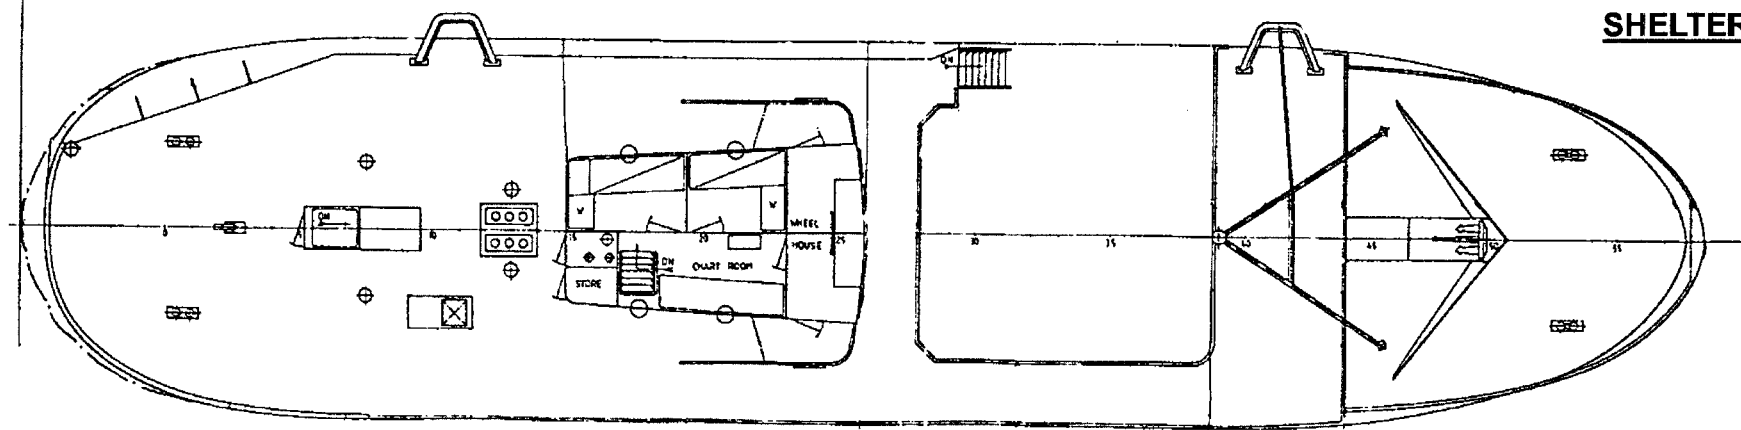
Figure 1 - FV Pescalanza PZ-744

There is insufficient evidence available to the MAIB to identify precisely how water entered *Pescalanza* but it is obvious she shipped a substantial quantity very quickly. As there is no report of structural damage from eye-witnesses, it is reasonable to suppose water entered through the weathertight door protecting the shelter from the main deck area which had been left open while recovering the trawl gear.

The volume between the main deck and the shelter deck aft of the bridge front was included in the zone used in calculating stability. Allowing water into this space would have an adverse effect on the vessel's stability, and this is clearly noted in *Pescalanza's* Stability Booklet which was approved by the Marine Safety Agency on
