Report of the investigation
of the grounding of
ARCO ARUN
off Broadness Point, River Thames
on 13 October 1998

FILE: MAIB 1/6/106

SYNOPSIS (all times are UTC)

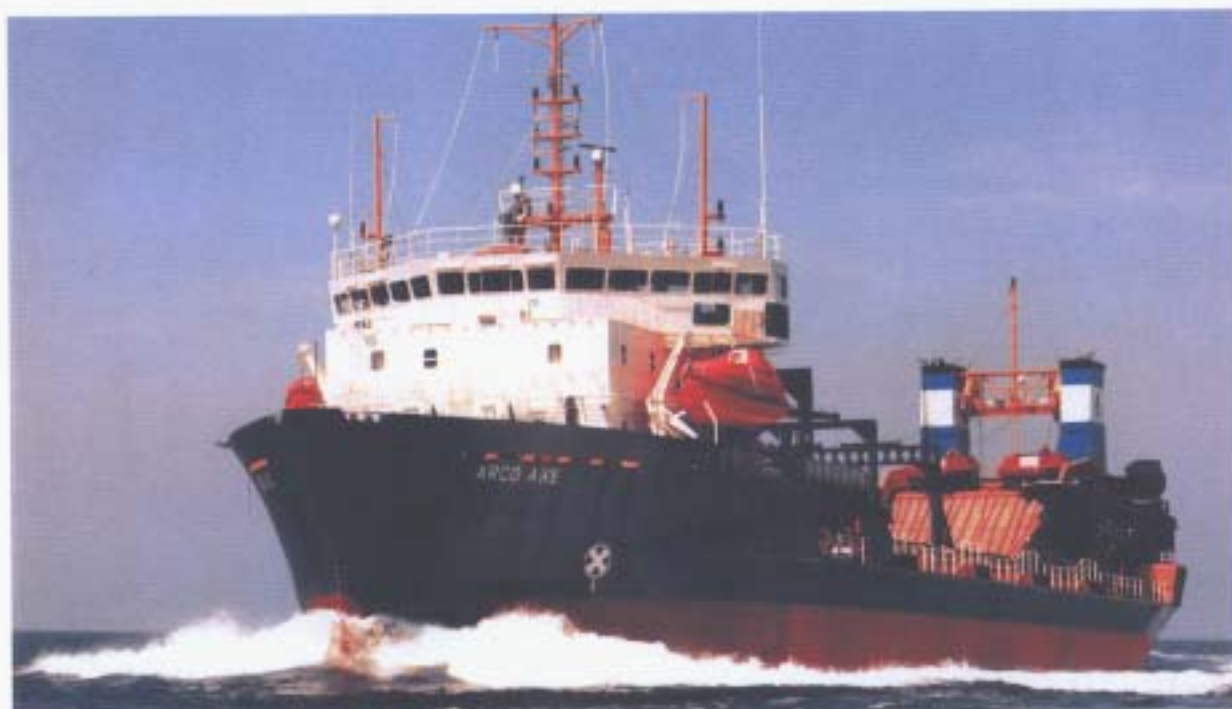
PHOTOGRAPH 1

Arco Axe - Sister ship to Arco Arun

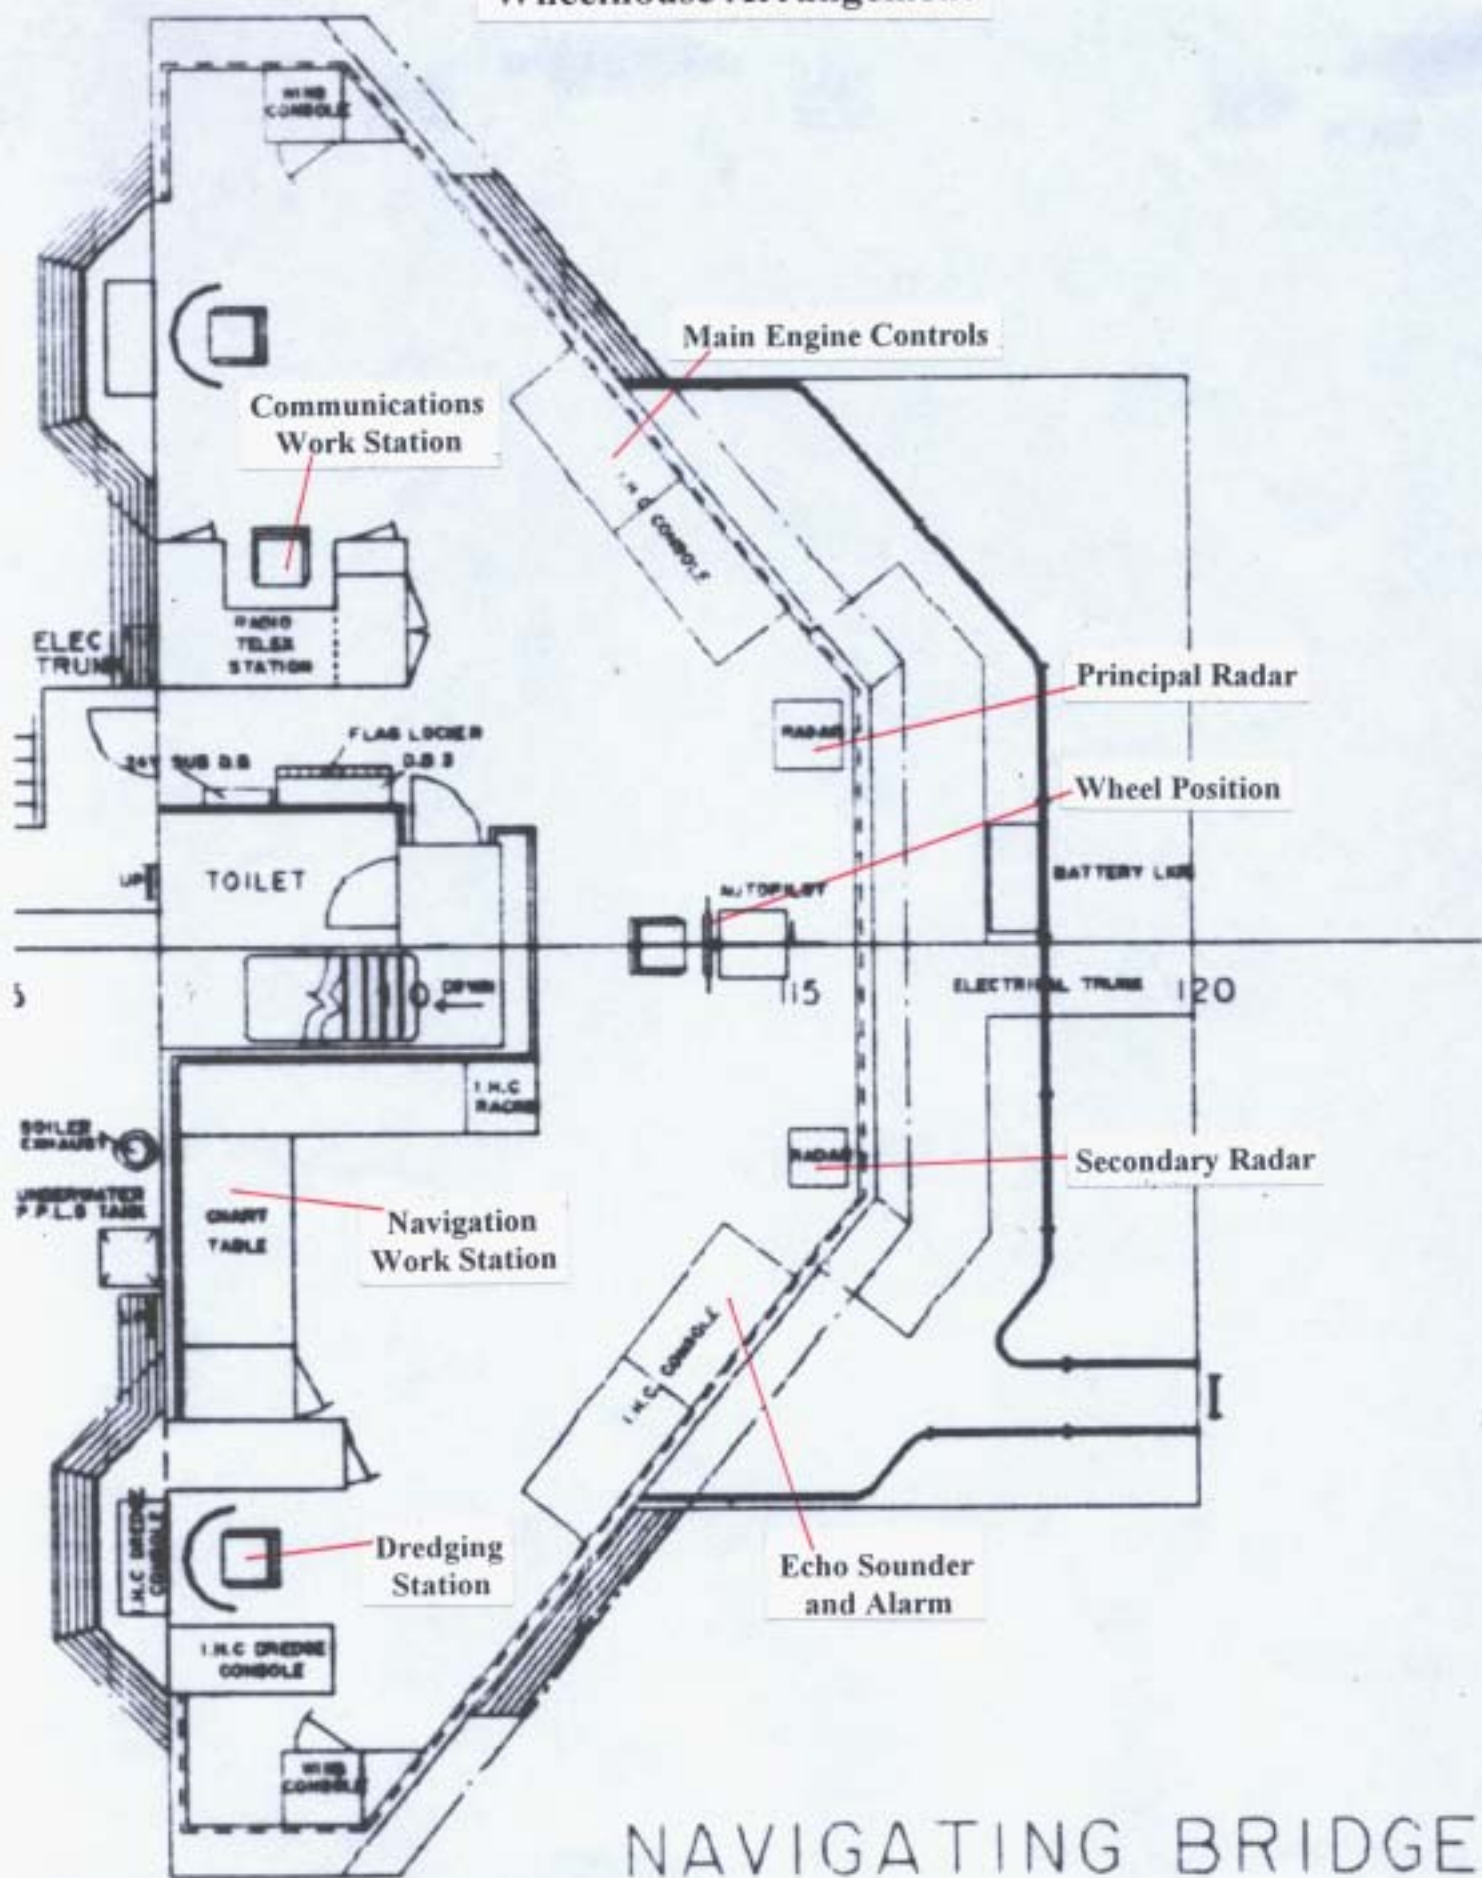
Wheelhouse Arrangement

In addition to standard navigation, safety and control equipment, the wheelhouse (**Figure 3 - wheelhouse arrangement**) contains winch, gantry, and pump controls used during loading and discharge. These controls are positioned at two stations which are located aft in the space on port and starboard sides, overlooking the cargo working area.
