**A report on the investigation of the capsize and
foundering of the workboat/tug
Trijnie
with the loss of one life
in the approach channel to Milford Docks,
Milford Haven, on 8 September 1998**

Marine Accident Investigation Branch
First Floor Carlton House
Carlton Place
Southampton
SO15 2DZ

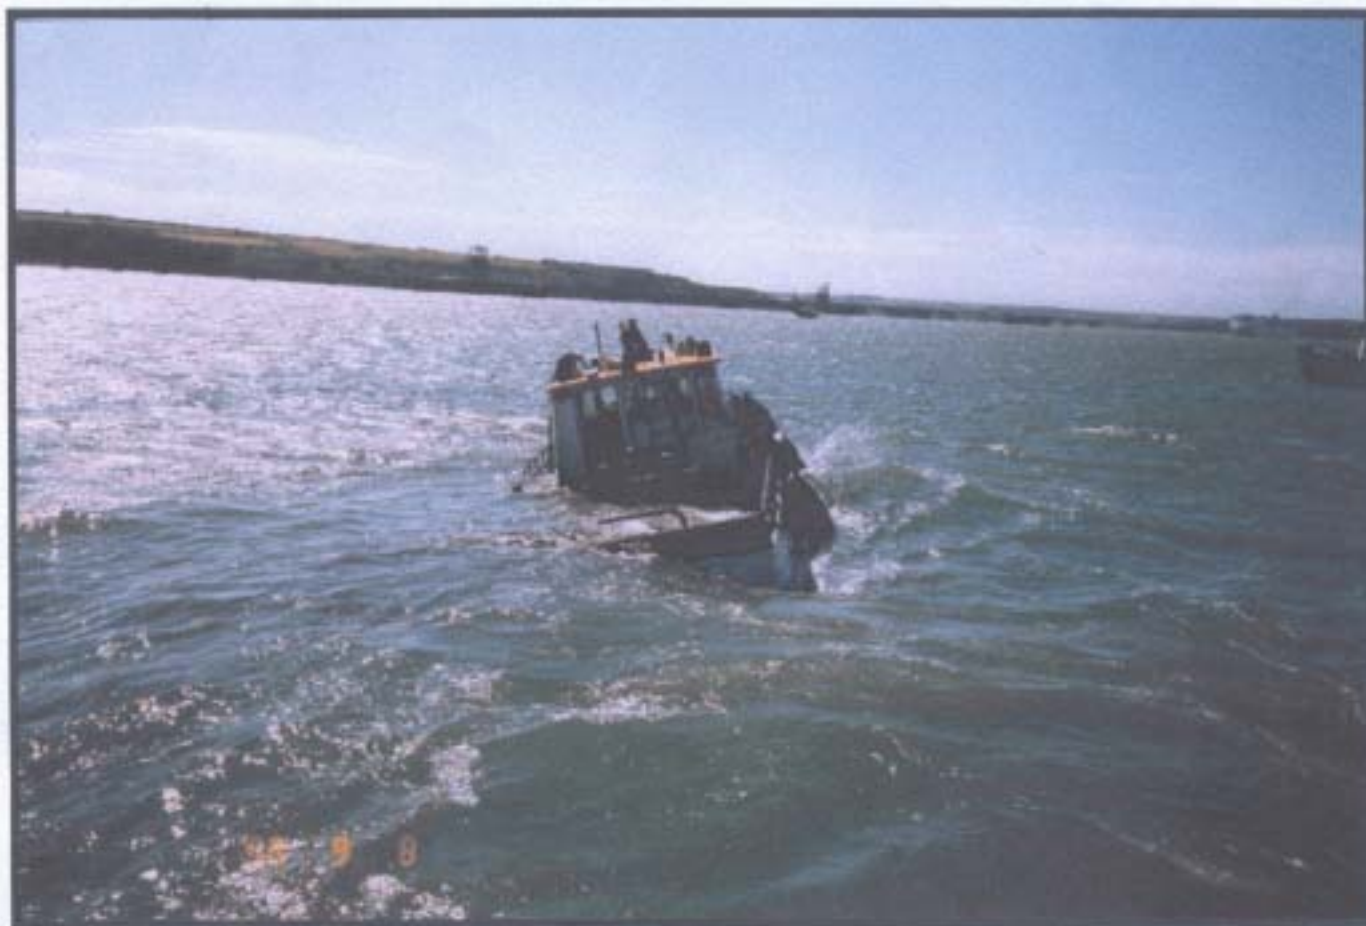
Trijnie partially submerged at low water, prior to her salvage

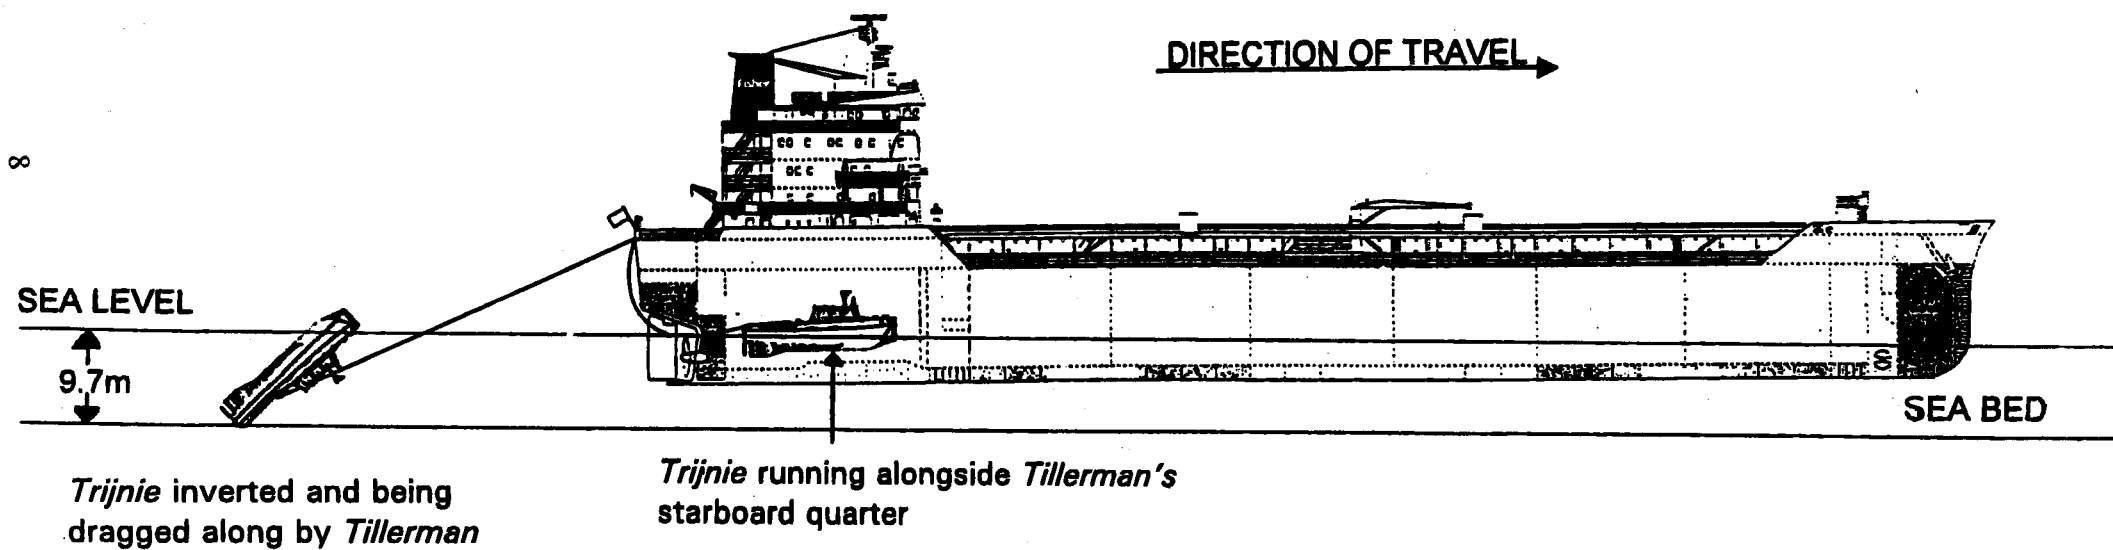
Following her capsize, *Trijnle* had taken up an inverted bows-up attitude. The mooring line, on which there was a lot of weight, was still attached to the ship (**Figure 3 and Photographs 1 and 2**). The pilot and Port Control discussed the implication of letting go the mooring line and whether the tug would sink. By this time fire brigade divers had been called to the scene to search the tug for the missing crewman. It was then suggested that *Anglegarth* could take over from *Tillerman* to keep *Trijnle*'s bow above water pending the arrival of the divers.

Profiles of *Trijnie* and *Tillerman*
(Tug and ship to scale)

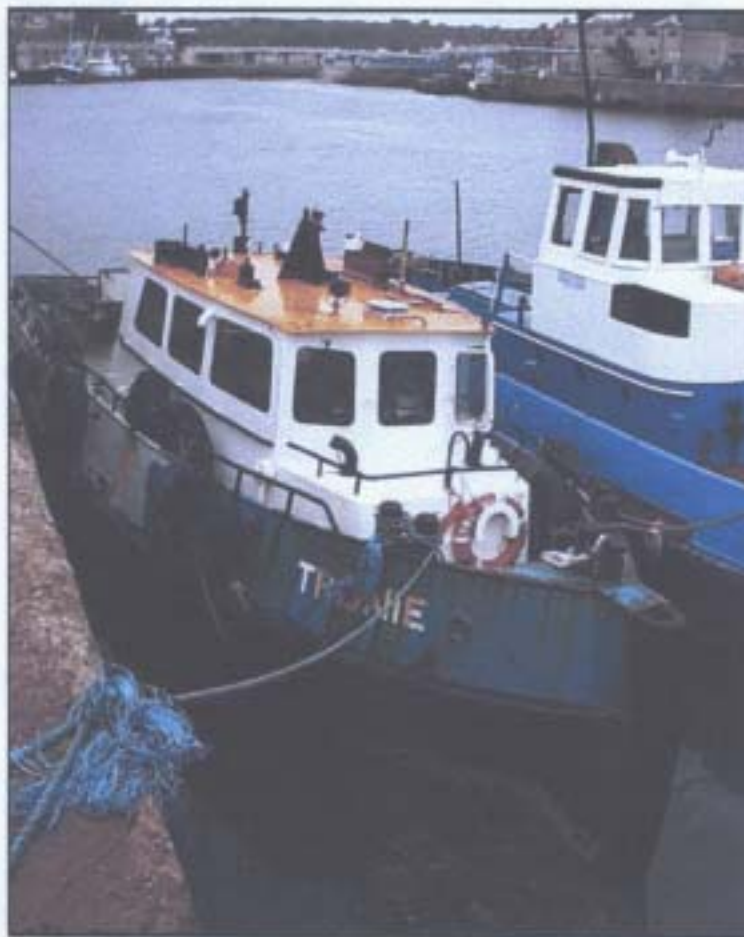
4. A general view of the fore part of *Trijnie*

Delta Catalytic modified *Trijnie* to make her more suitable for her new role at Milford Haven. Most of the equipment on top of the wheelhouse was removed or shortened to reduce her air draught and prevent damage when operating close under ships and terminal structures. The EPIRB was placed in a seat locker for safe keeping. A guard rail was erected around the after deck bulwarks. An inverted "U" shaped rail was erected to protect ships' mooring lines from snagging on the after deck hatches. A new tow hook release wire was rigged and led from the release mechanism to the top of a vertical stanchion, which was above and just forward of the hook, to an aperture just under the wheelhouse top, and then forward under the wheelhouse deckhead lining to a handle above the coxswain's helm position.

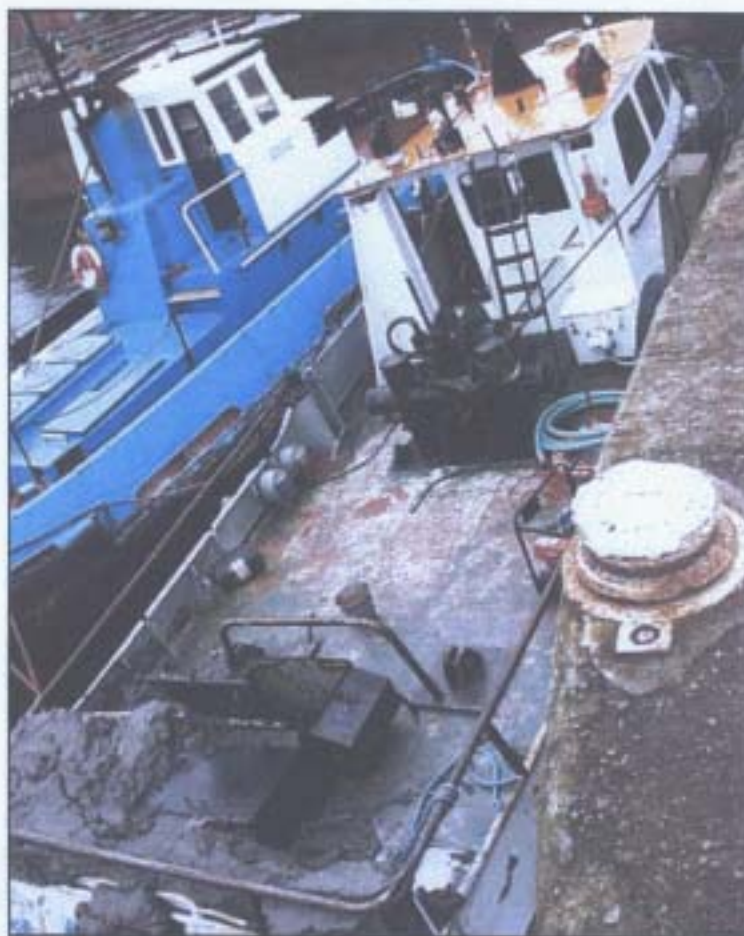
5. A general view of the after deck of *Trijnie*

Steering gear flat
access hatch

New guard rail

Engine room
access hatch

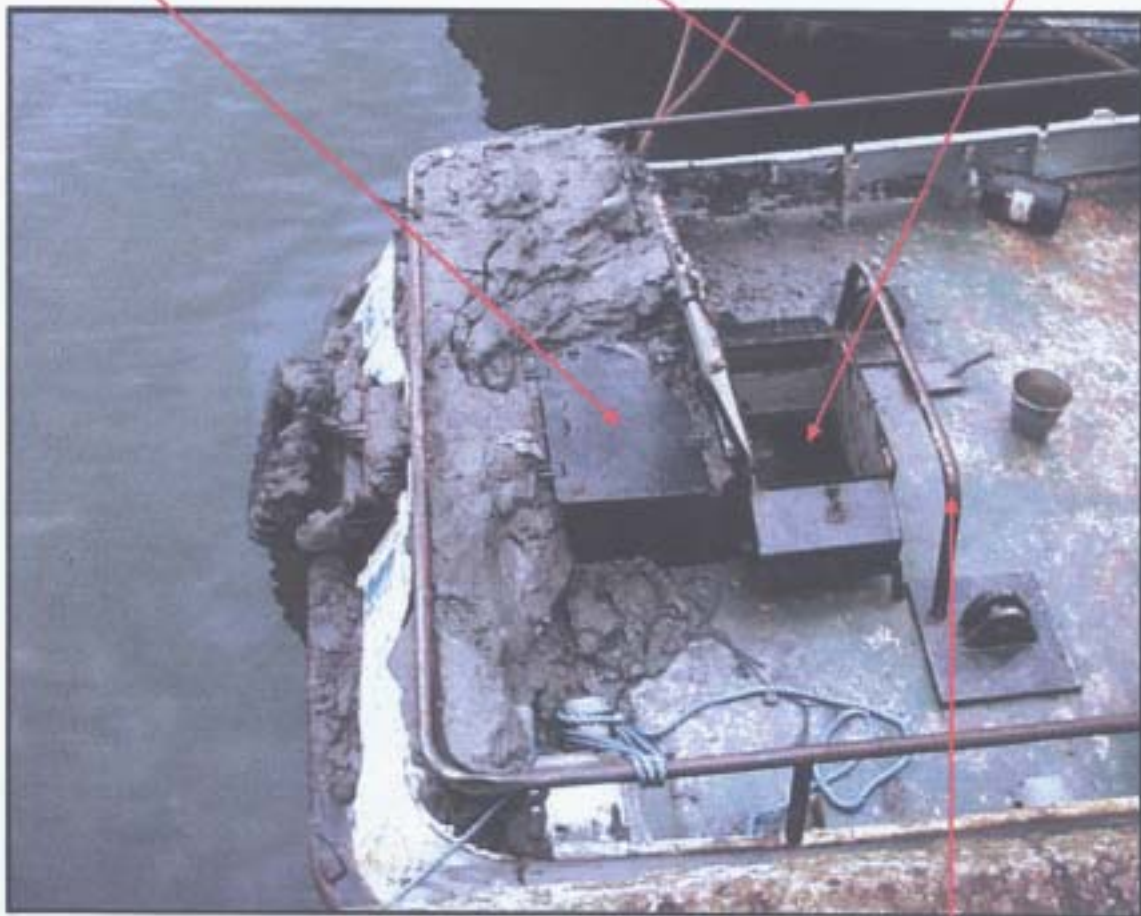
6. A closer view of the stern

New 'U' shaped rail

When *Trijnie* was raised following the accident, it was found that the tow hook release wire **was** not secured to the hook but tied **off** on the vertical stanchion (**Photograph 7**). It was confirmed that none of the divers had touched the wire at any time. The investigation revealed that the wire had been tied **off** when working at the Texaco berths. The crews found heaving lines fell on the release wire when being thrown from ships and tripped the hook, which was inconvenient when running mooring lines.
