**Report of an Investigation**  
**into a switchboard explosion on**  
***m.v. Pride of Le Havre***  
**on 27 July 1998**  
**off the Port of Le Havre, France.**

The explosion is considered to have been caused by a direct connection being made between two phases of the 660volt incoming supply. Contributory causes include the use of non-company issue test equipment and entangled test leads.

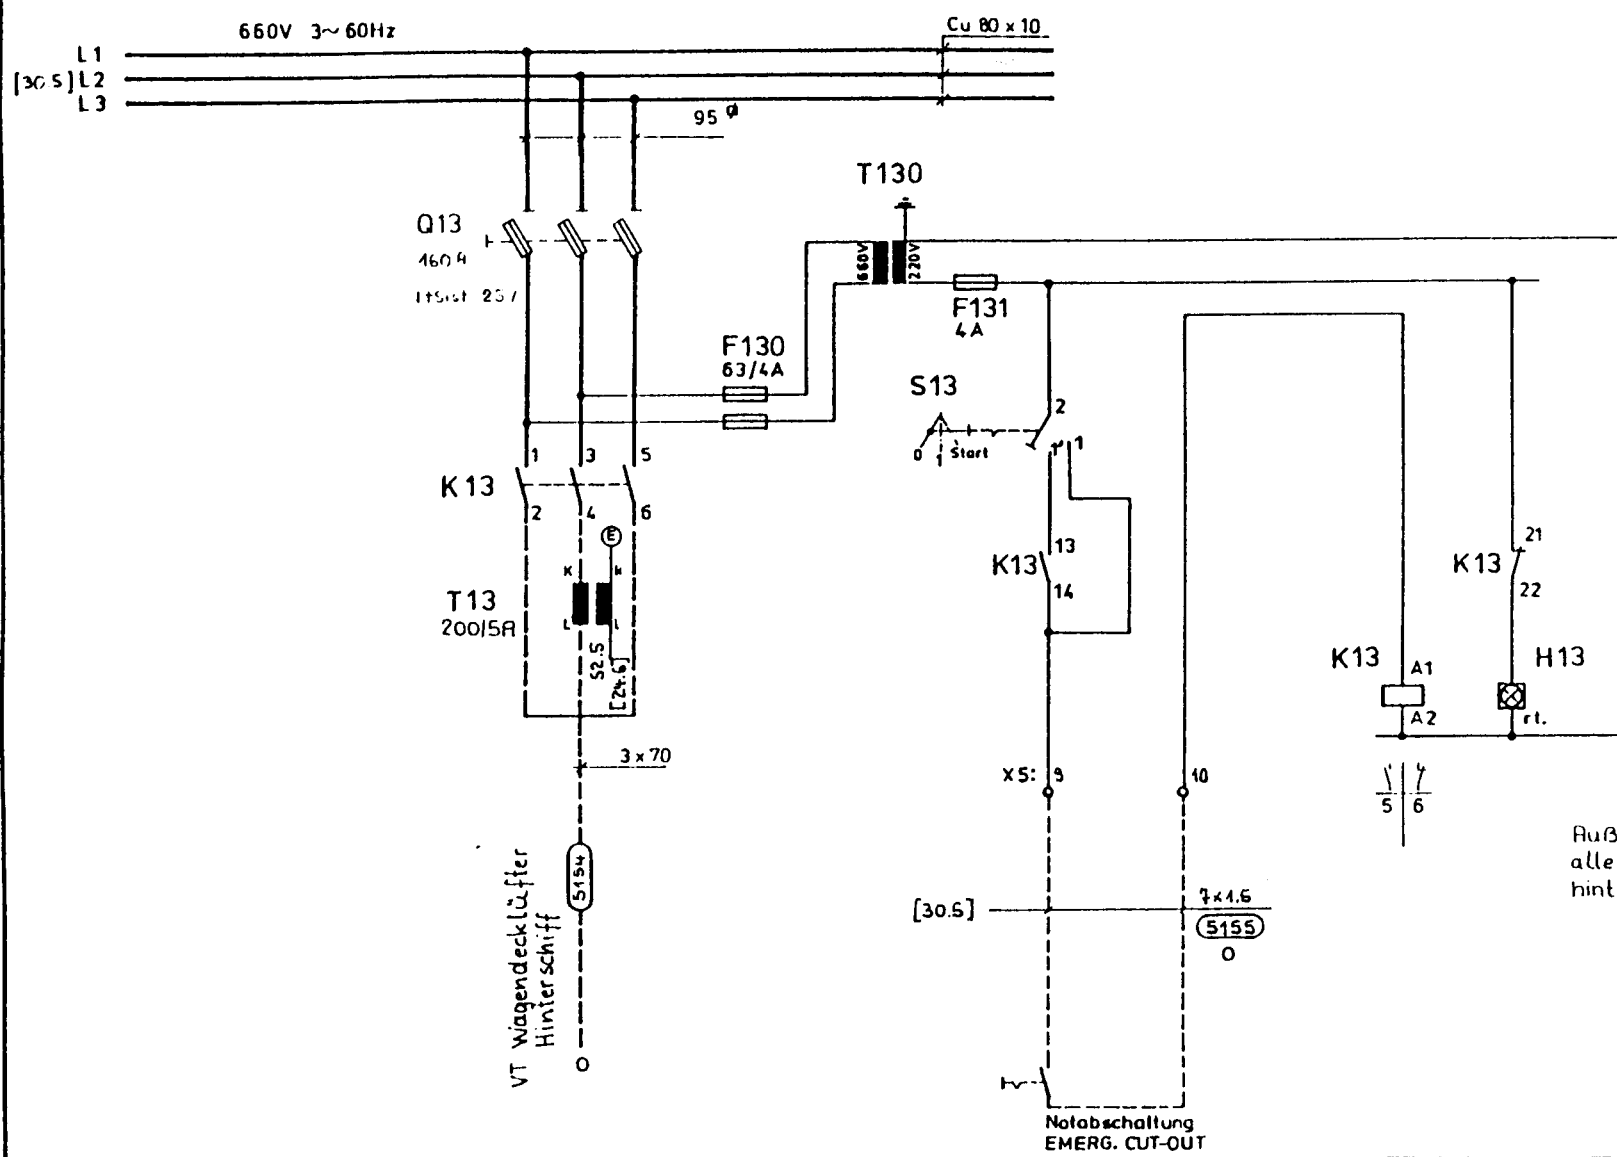
Datum: 8.3.89		AEG		HAUPTSCHALTТАFEL		VT Wagendecklüfter Hinterschiff		32	
		Gepr.: Hofner				Feld PANEL 3		271.121.906 STR-3		Blatt 13/31	
Änderung	Datum	Name	Norm	Urspr.	Ers.f.	Ers.d.					Blatt 13/31

*All three fan supply contactors found heat damaged and contaminated by falling debris from above, contactors replaced with new ships spares. Fuse base carriers and control wiring cleaned and checked, wiring replaced as necessary. Six fuse carriers re-newed with ships spares, insulating plate renewed. Three control transformers re-newed with ships spares.*

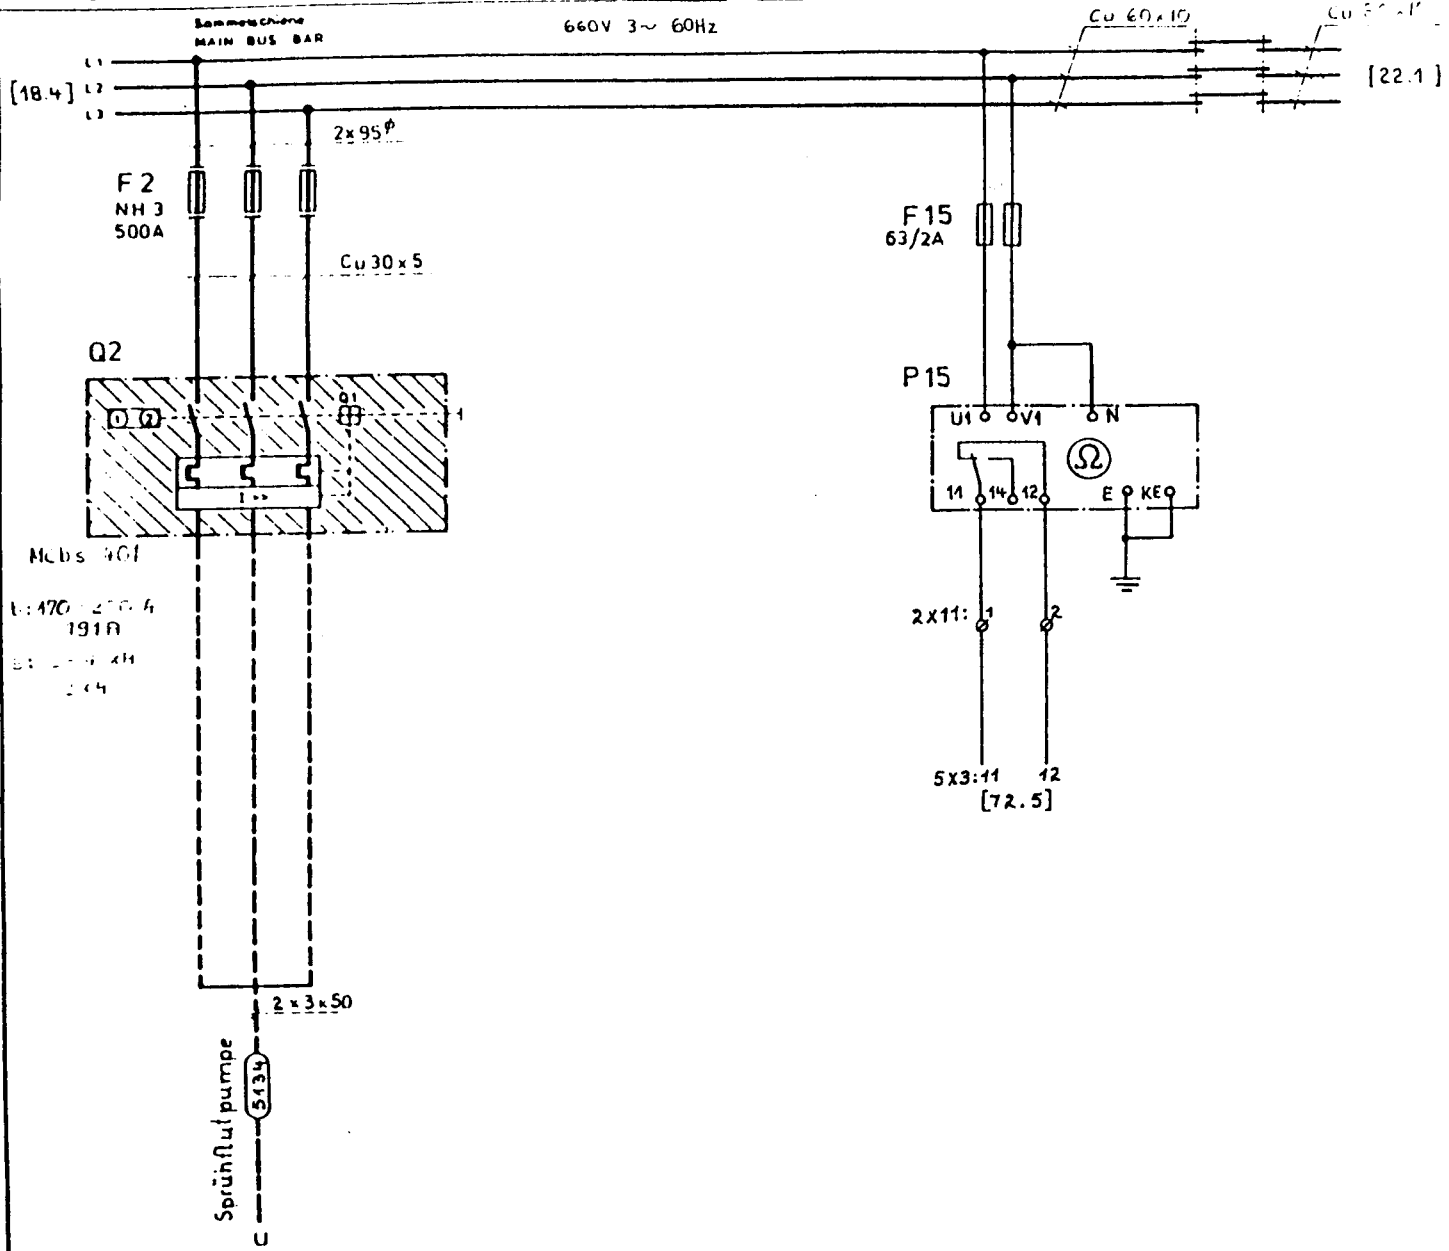
AEG		HAUPTSCHALTSTAFEL		Sprühflutpumpe		= 20	
Feld		2		271.121.906		STR-3	
PANEL		2		271.121.906		STR-3

*DRENCHER PUMP - 630 ampere fuse bases destroyed by heat, direct replacements not available either from ships spares or local suppliers. After consultation with "Class", it was agreed to carry out temporary repairs using available 400 ampere fuse switch pending supply of correct equipment. Original cables cut back and re-terminated. (Subsequent testing following completion of repairs proved satisfactory)*

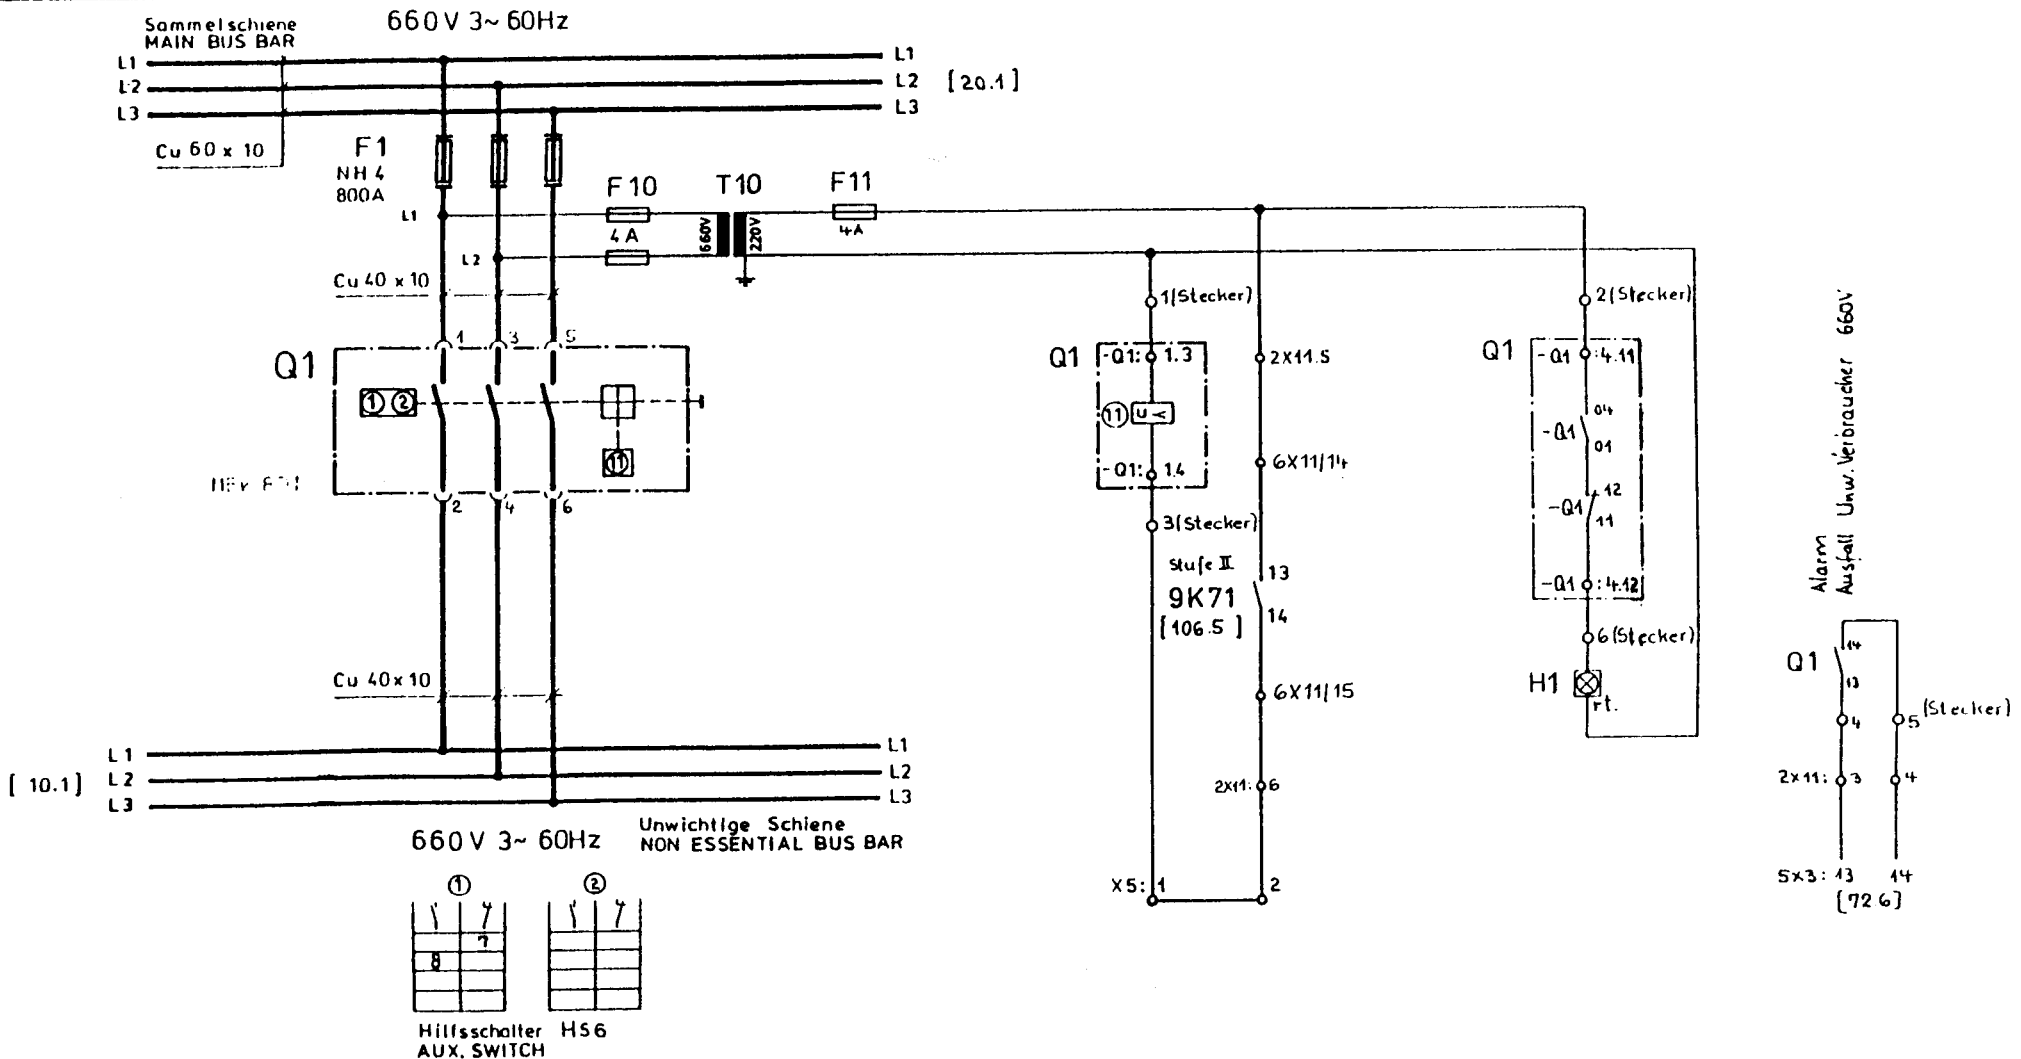
Datum: 2.3.77		<b>AEG</b>	HAUPTSCHALTAFEL		Unwichtige Verbraucher 660V		18	
Bearb: Halber					Feld	271 121 906 STR-3		Blatt 6
Gepr:					PANEL	2		81
Änderung	Datum	Name	Norm	Urspr	Ers 1	Ers 2

*NO 2 NON ESSENTIALS - Fuse carriers contaminated and showed signs of damage. These were removed for inspection. 800 ampere fuses checked and found blown, ships spare fuse bases and carriers fitted and fuses re-newed.*

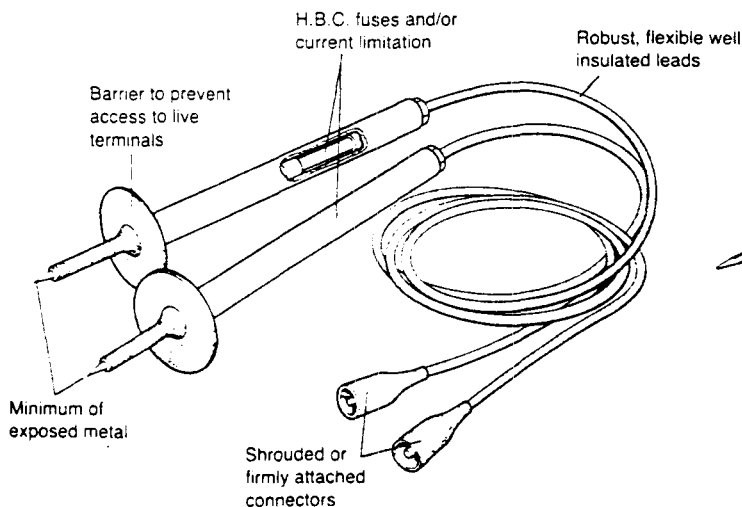
Figure 1: Test probes and leads (recommended type)

- (iv) are sheathed to protect against mechanical damage;
  - (v) are long enough for the purpose, while not too long so that they are clumsy or unwieldy;

- (vi) do not have accessible exposed conductors other

than the probe tips, or have live conductors accessible to a person's finger if a lead becomes detached from a probe, indicator or instrument when in use. The test lead or leads are held captive and sealed into the body of the voltage detector.

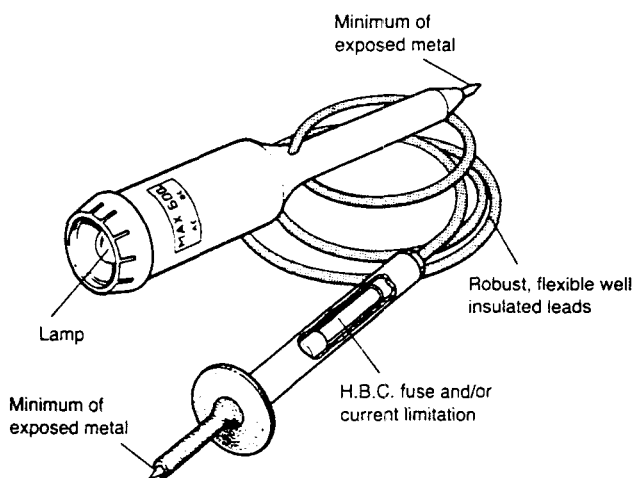
Figure 3: Typical test lamp

These detectors require protection against excess current. This may be provided by a suitable high breaking capacity (hbc or hrc) fuse or fuses, with a low current rating (usually not exceeding 500 mA), or by means of a current-limiting resistor and a fuse. These protective devices are housed in the probes themselves. The test lead or leads are held captive and sealed into the body of the voltage detector.

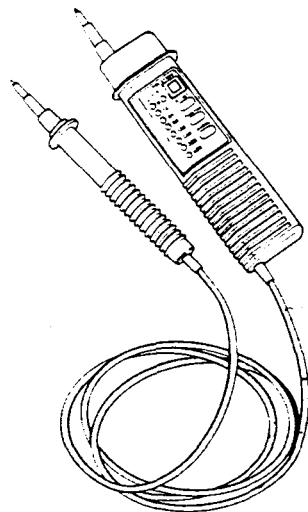
Figure 4: A typical 2-pole voltage detector

These detectors are designed and constructed to limit the current and energy which can flow into the detector. The limitation is usually provided by a combination of circuit design, using the concept of protective impedance, and current limiting resistors

built into the test probes. These detectors are provided with in-built test features to check the functioning of the detector before and after use. The interconnecting lead and second test probe are not detachable components. These types of detector **do not** require additional current limiting resistors or hbc fuses to be fitted provided that they are made to an acceptable standard and the contact electrodes are shrouded as in 9(a)(ii).
