Report on the investigation of  
the collision between the German container ship

***Merkur***

and the United Kingdom fishing vessel

***Silvery Sea***

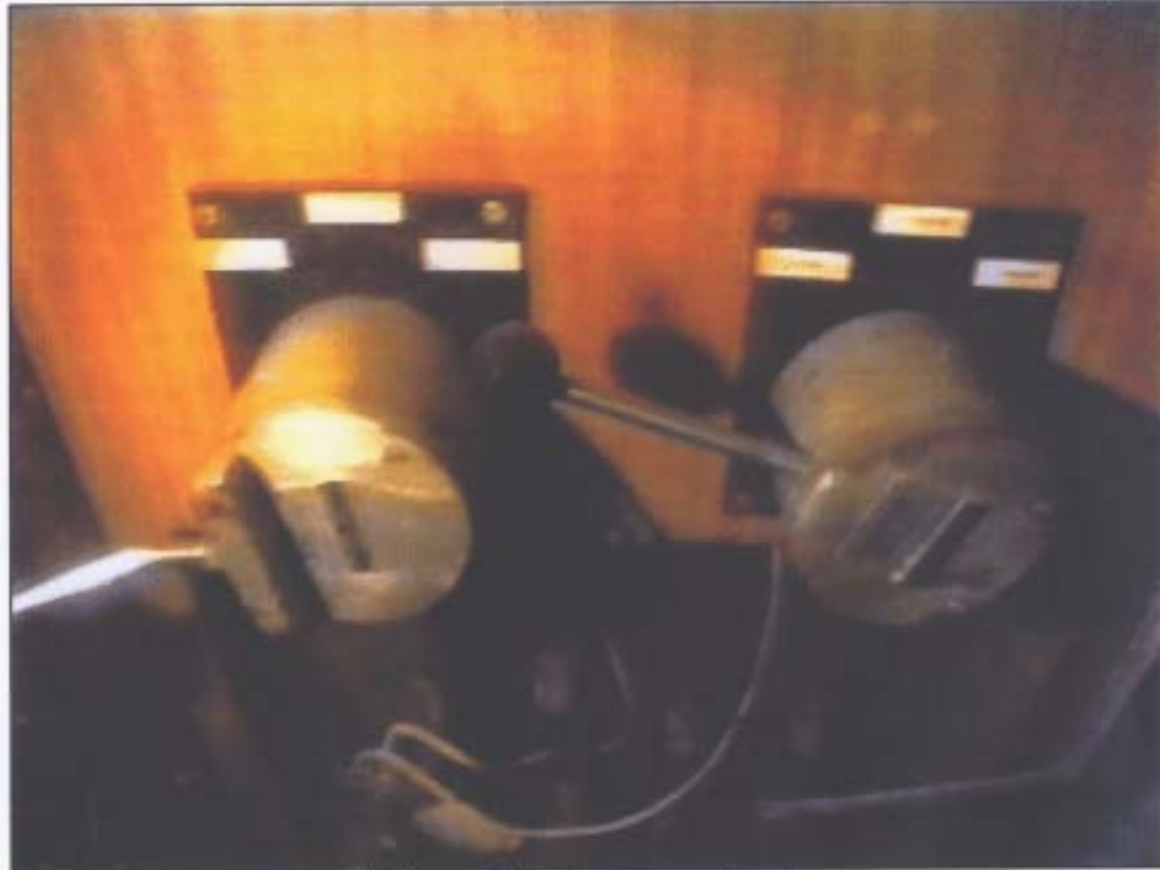
Photograph 6

The bow and stern transverse thrusters  
(starboard wheelhouse door to the right of the photograph)

On the starboard bulkhead, the control levers for the forward and aft athwartship thrusters were horizontal and pointing forward. The controls were electrical actuators for hydraulic proportional valves, and the neutral position for the levers was upright. Therefore, both levers were apparently on the full-to-port thrust position. However, they were probably pushed forward by the ingress of water through the starboard door close by (**see Photograph 5**).

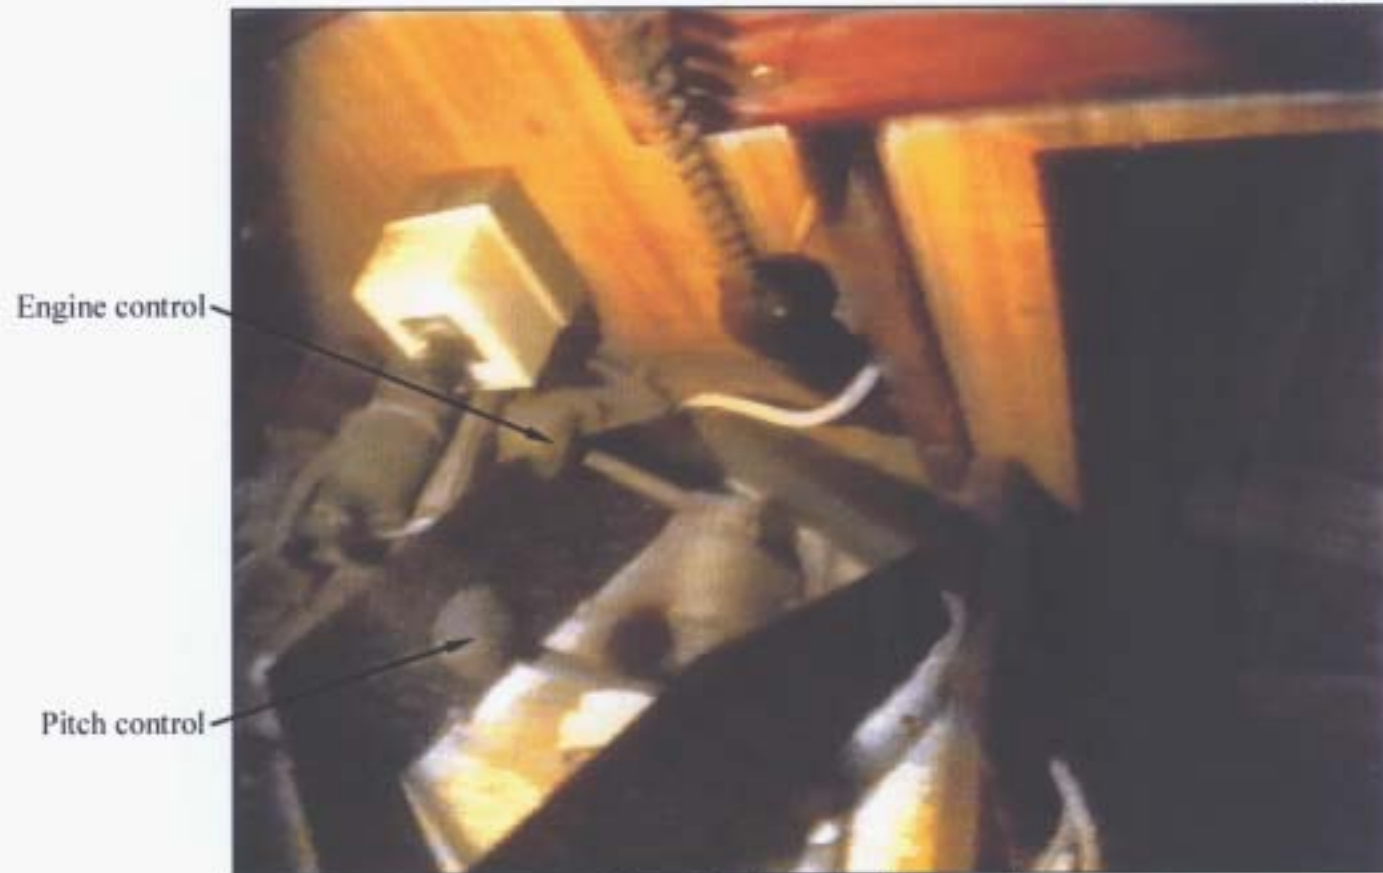
Photograph 7

View of engine and pitch controls

The engine speed and the propeller pitch control levers were set forward by similar amounts, indicating the engine was engaged and that the propeller pitch was on number 6 (out of 10) in the ahead position (**see Photograph 6**). The setting on the

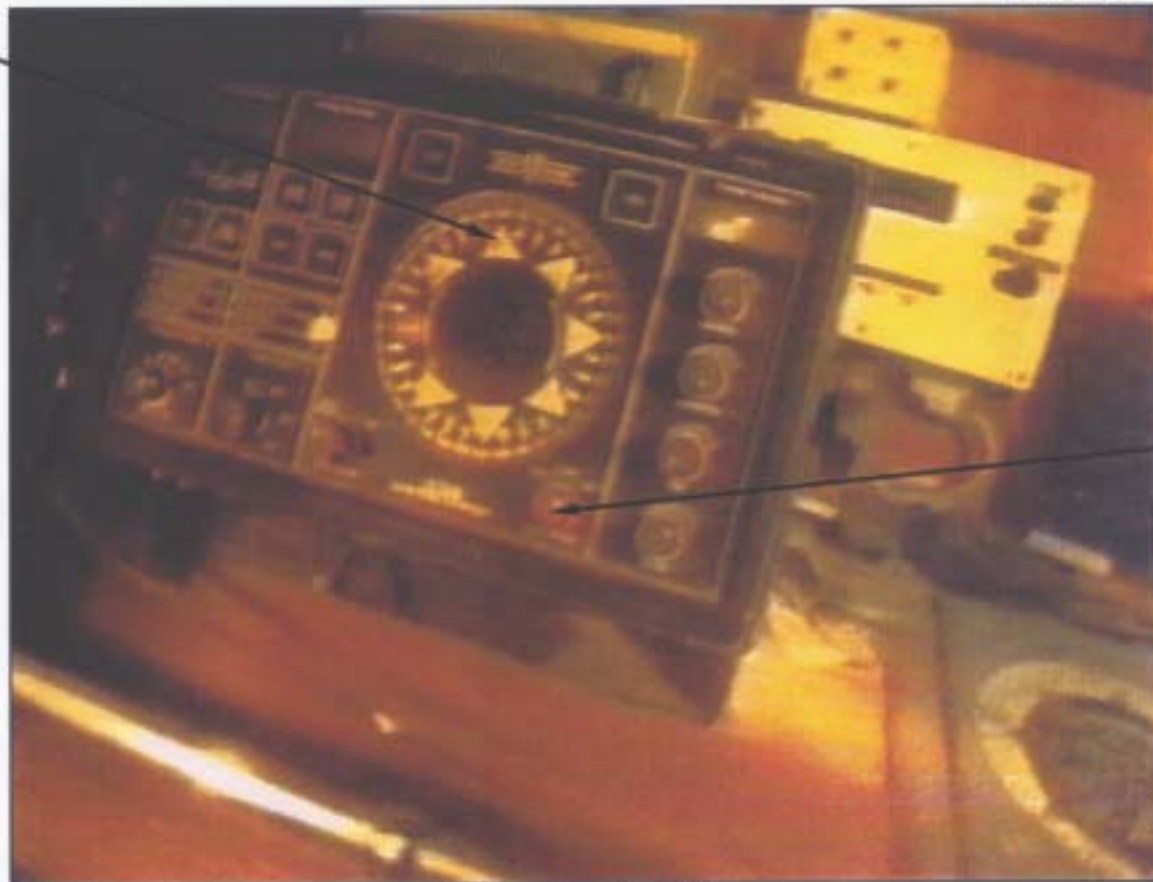
The rotary switch for  
"off/stand-by/on"

The automatic pilot

The gyrocompass heading was 126° on the autopilot, the heading selector dial was between 100° and 103° and the “off/standby/on” rotary switch indicator was pointing to “on” (see **Photograph 7**).
