**Report on the investigation
of a rupture of the port economiser on board**

Island Princess

resulting in two deaths

Report No 37/2000

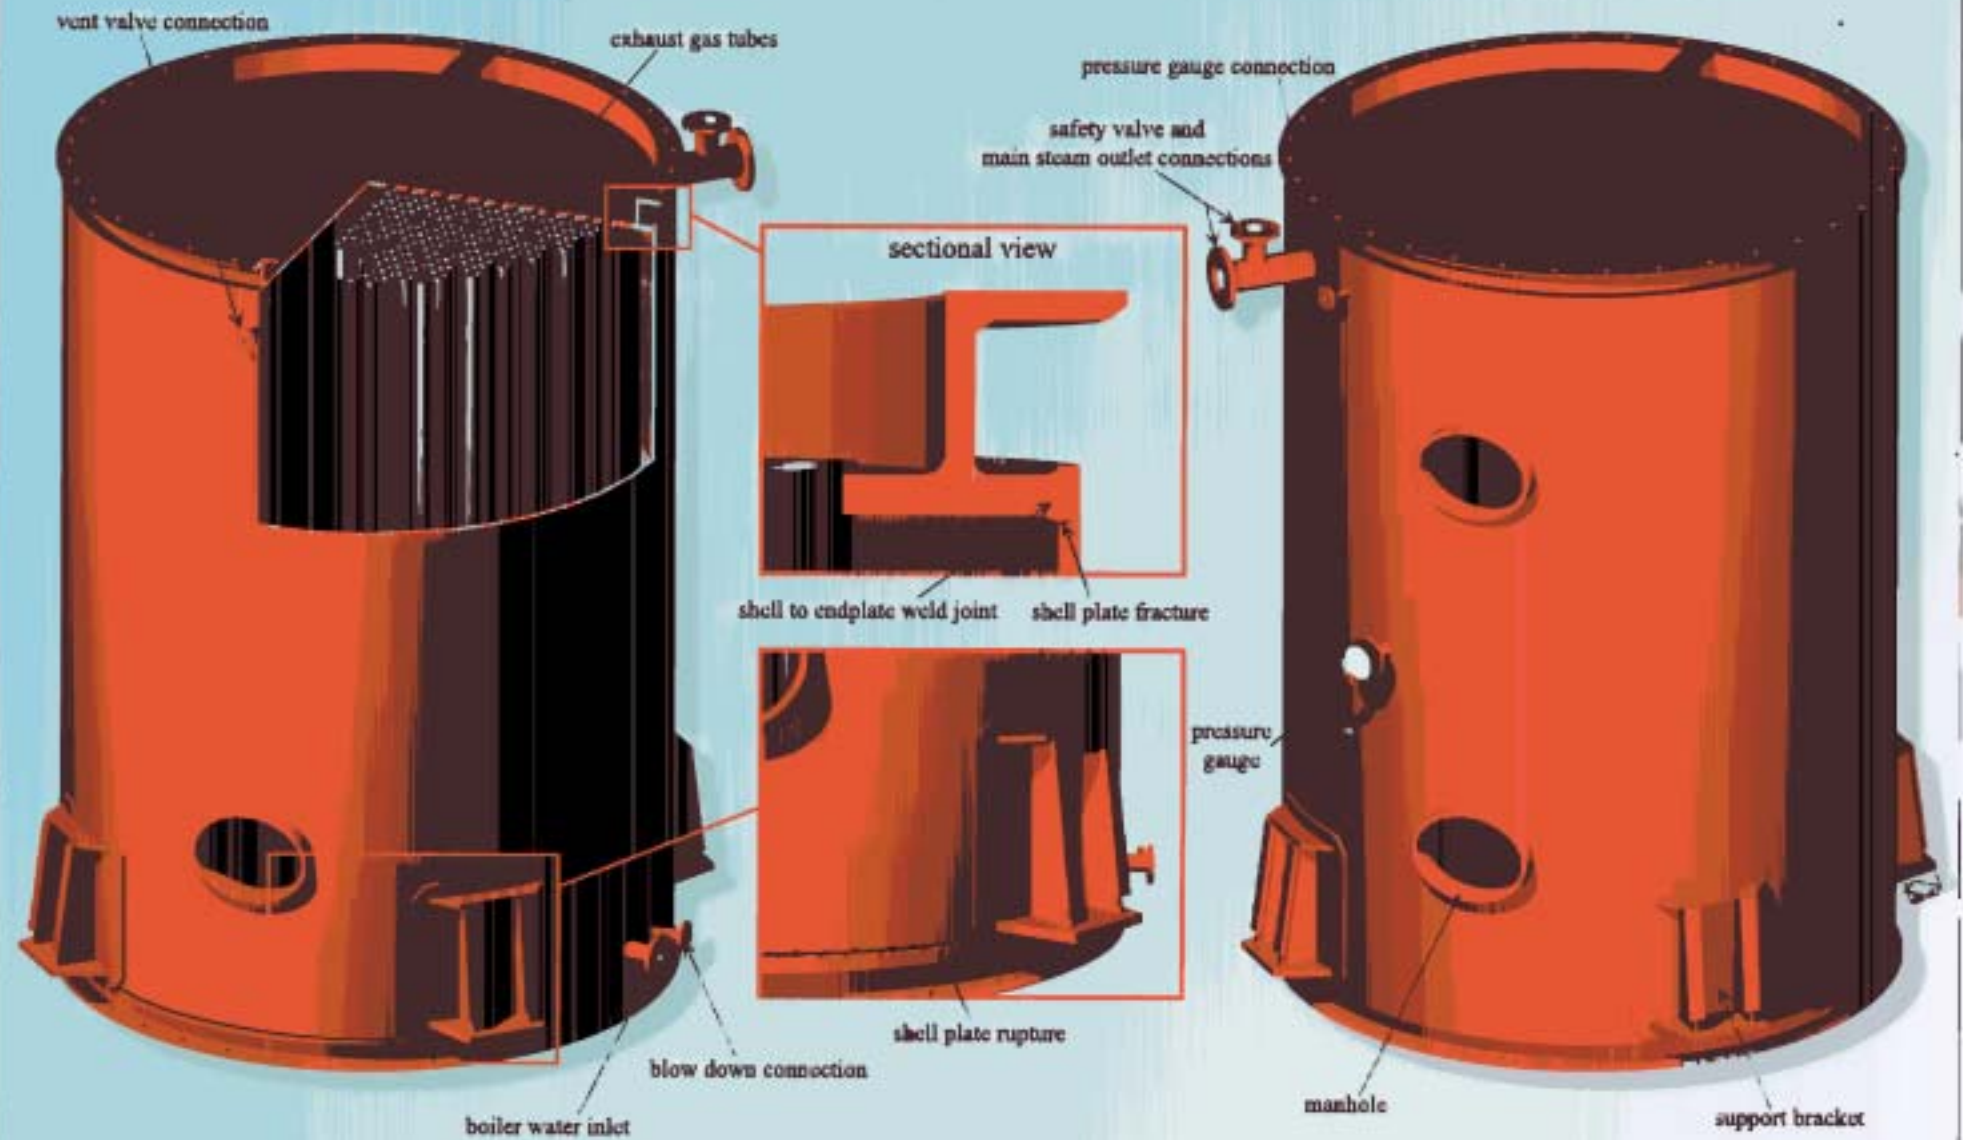
Figure 5

Port economiser

The shell-plate was ruptured circumferentially about 35mm from its lower edge. It occurred along the shell-to-endplate weld toe, and through an arc subscribing the forward support bracket and the port support bracket (**Figure 5**). The shell had sprung outwards at the rupture, leaving an air gap of up to 20mm. Magnetic particle inspection showed a crack extending 16mm into the support bracket doubling plate welds.

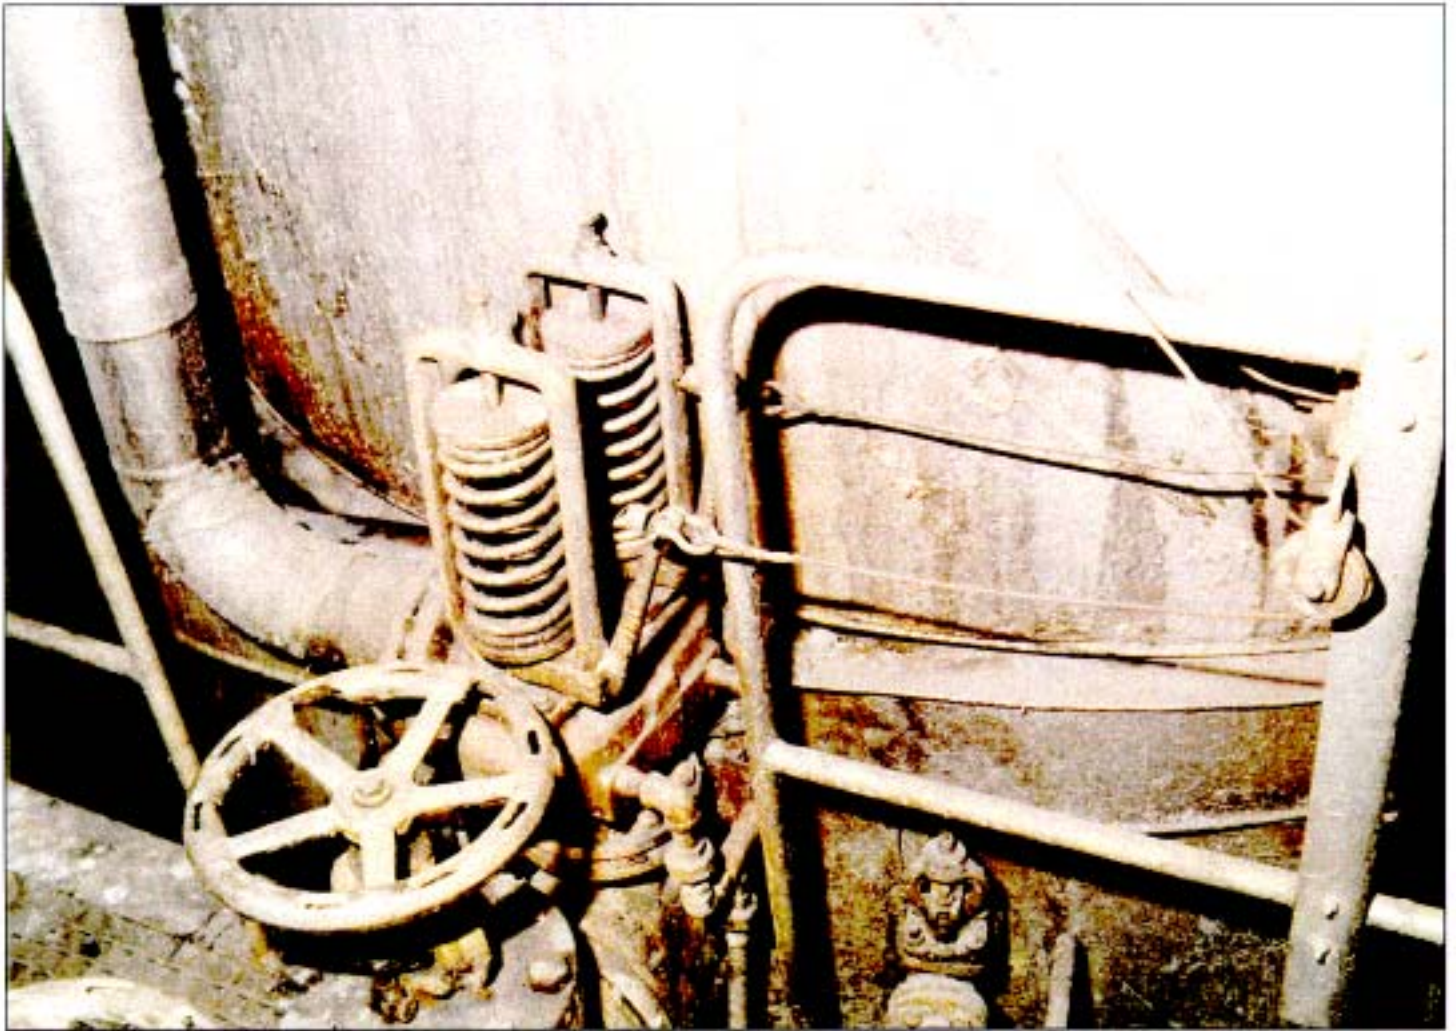
Figure 6b - Starboard economiser safety valve

The safety valves were NAF 546348 duplex (double) simple, spring-loaded safety valves, set in a single carbon steel valve body having a common inlet. The valve body was mounted on the economiser in the fore and aft direction. For the purpose of the report, individual safety valves are referred to as the aft or forward valves as appropriate. Each valve is designed with a capacity to be sufficient to prevent overpressure. Two valves are fitted as a safety precaution, should one fail to operate as designed.

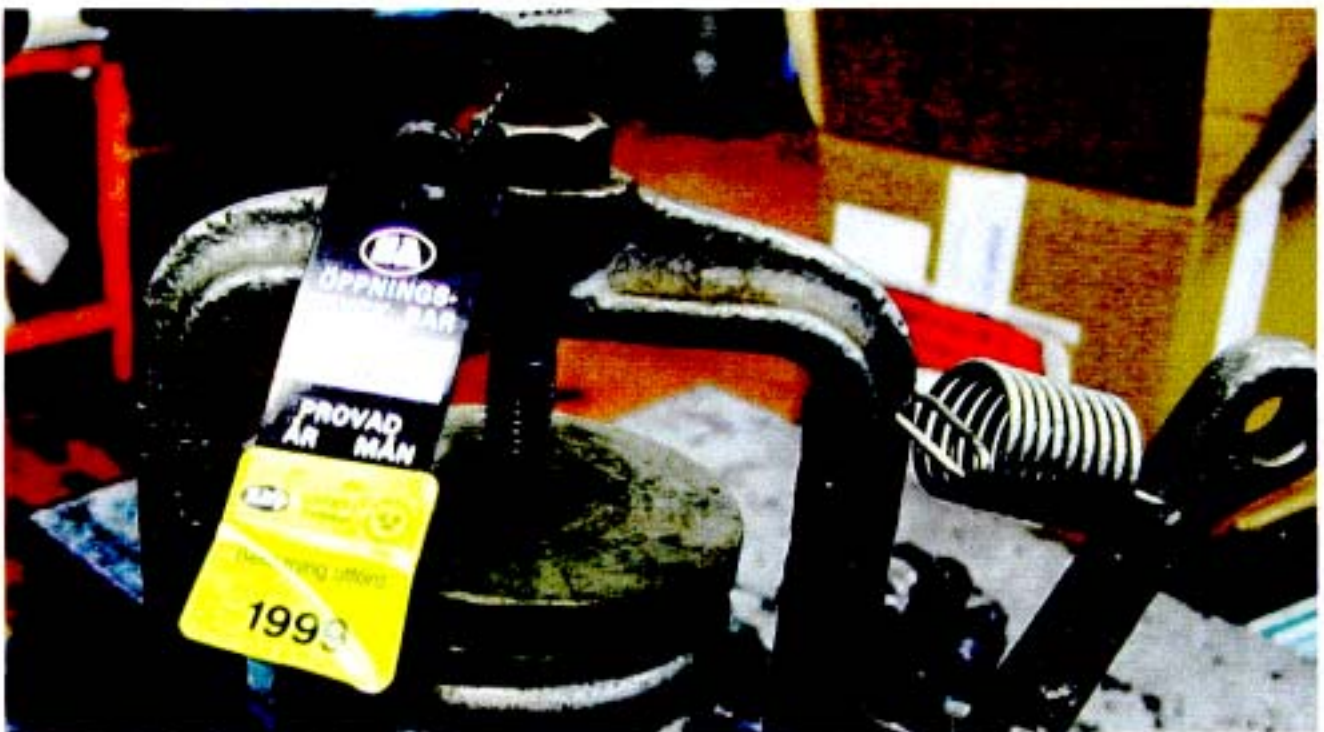
Figure 6c - Sealing arrangement for the NordAmatur safety valve
(photo taken at the factory)

The spring adjusting screw had a facility to enable the valve to be sealed to provide evidence of unauthorised adjustment of the valve setting with the adjusting screw (**Figure 6c**). The springs were encased in a metal shield.

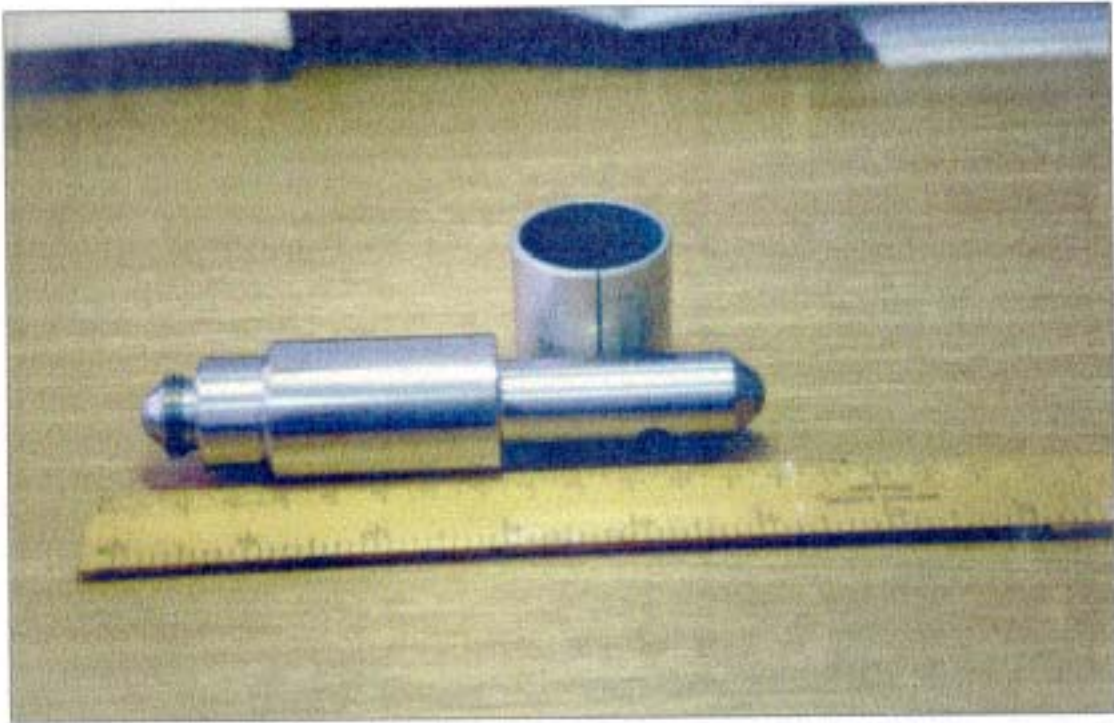
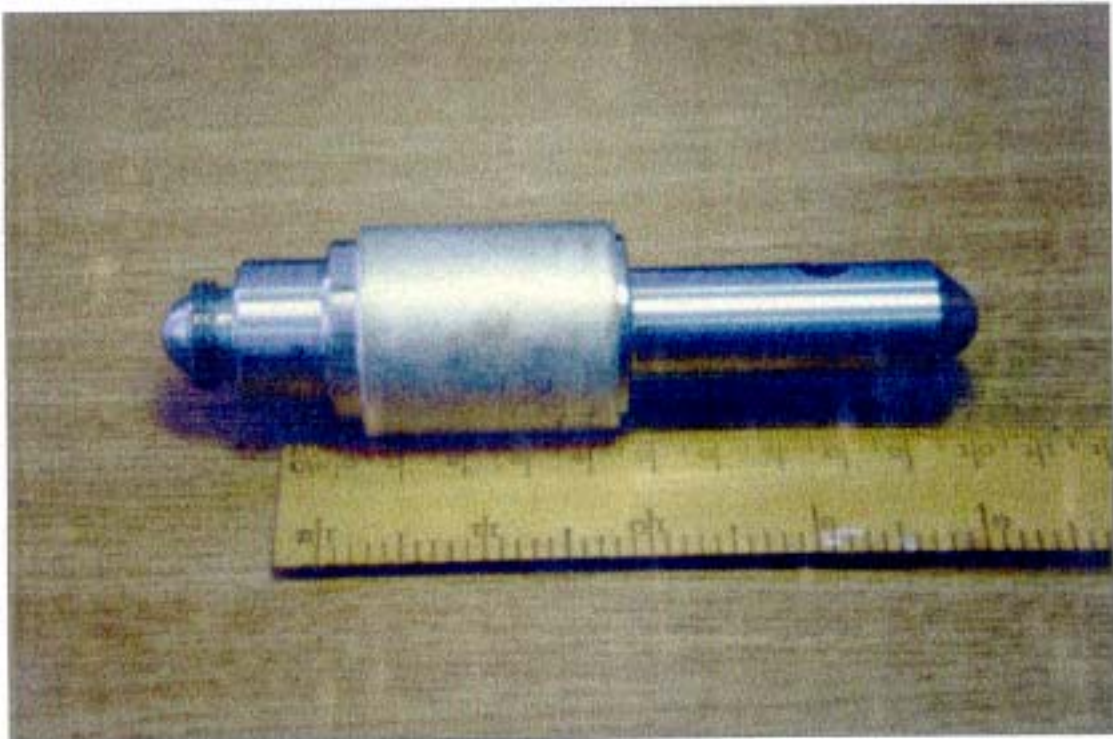
Figure 7 - Spindle guide and spindle

The stainless steel valve spindle is guided by a 2.0mm thick, composite lined guide bush press fitted to the housing of the valve cover (**Figures 6a and Figure 7**). The guide bush is a Glacier DU bearing. DU is a trademark for The Glacier Bearing Company.

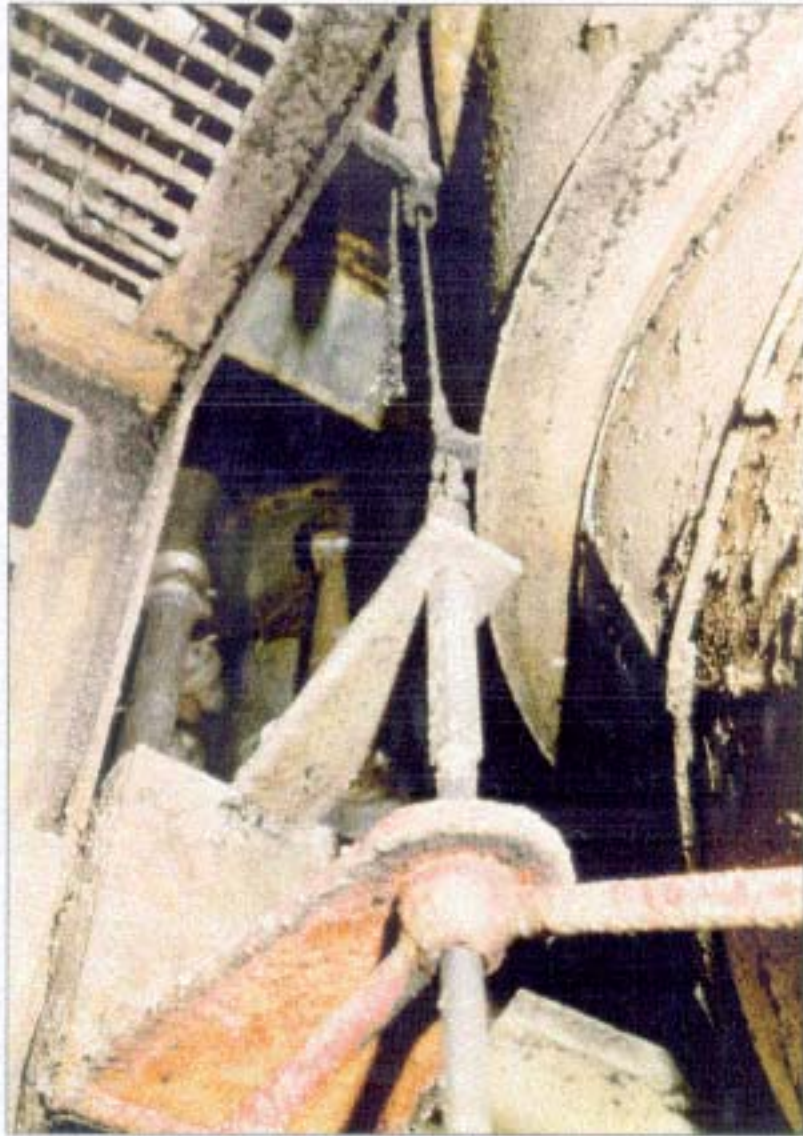
Figure 8 - Starboard economiser casing gear and handwheel in the open position

The safety valves on the oil-fired boilers and economisers were fitted with easing gear designed to open the safety valves with or without pressure on the boiler, and maintain them in the open position. They could be used to release pressure in an emergency, and to test the safety valve for freedom of movement. Each of the four handwheels, situated on the boiler flat level of Fiesta deck, remotely operated the safety valve easing gear bell-crank on each oil-fired boiler and economiser. The bell-cranks were connected to the handwheels operating cables running on pulley wheel guides. Each handwheel had an indicator to show that the safety valves were selected "open" or "closed" (**Figure 8**), but were not marked to identify the corresponding safety valve.
