Marine Accident Report 3/99

Report of the Inspector's Inquiry
into the Sinking of the Fishing Vessel

Margaretha Maria **BM148**

with the loss of four crew
between 11 and 17 November 1997

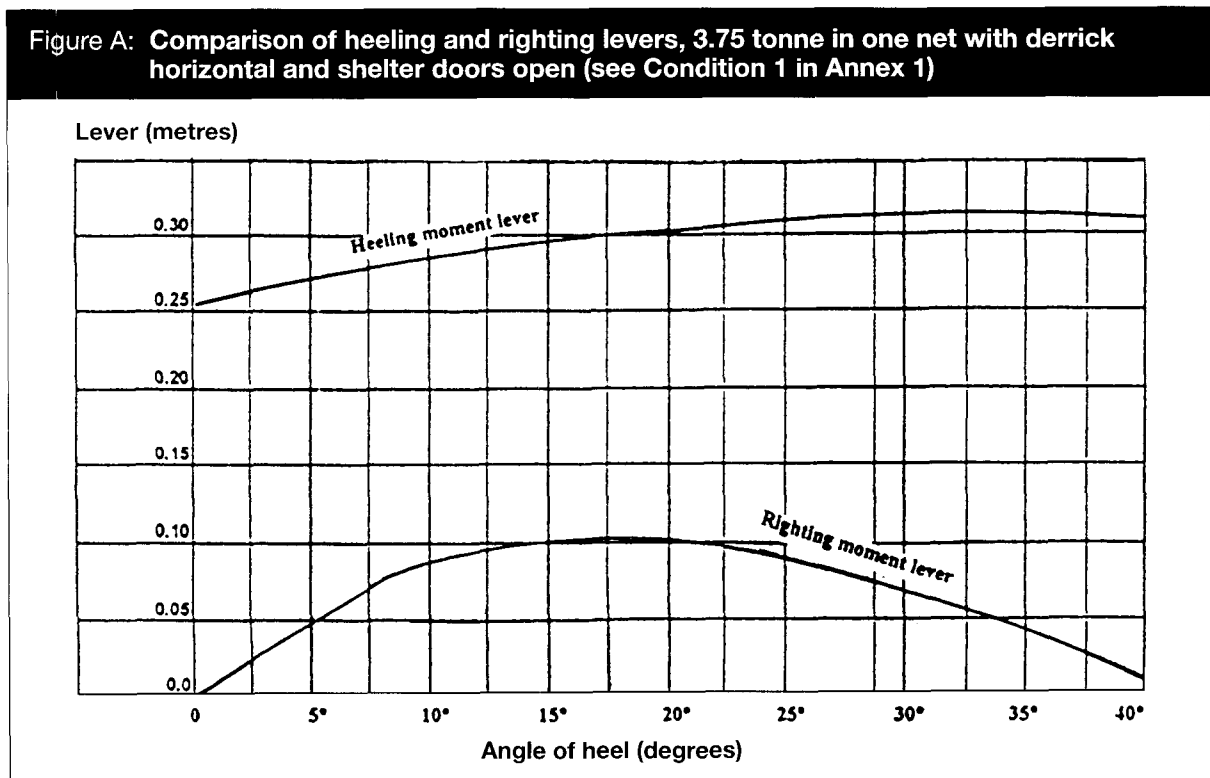
The starboard net was found empty.

It may have been damaged earlier in the incident. With both sets of gear at the surface containing substantial weights, the starboard net damage may have been caused by it being overloaded. Release of its contents would have generated a large heeling moment and equivalent heeling lever, significantly larger than the vessel's righting lever as shown in **Figure A**. Capsize to port would have been certain.

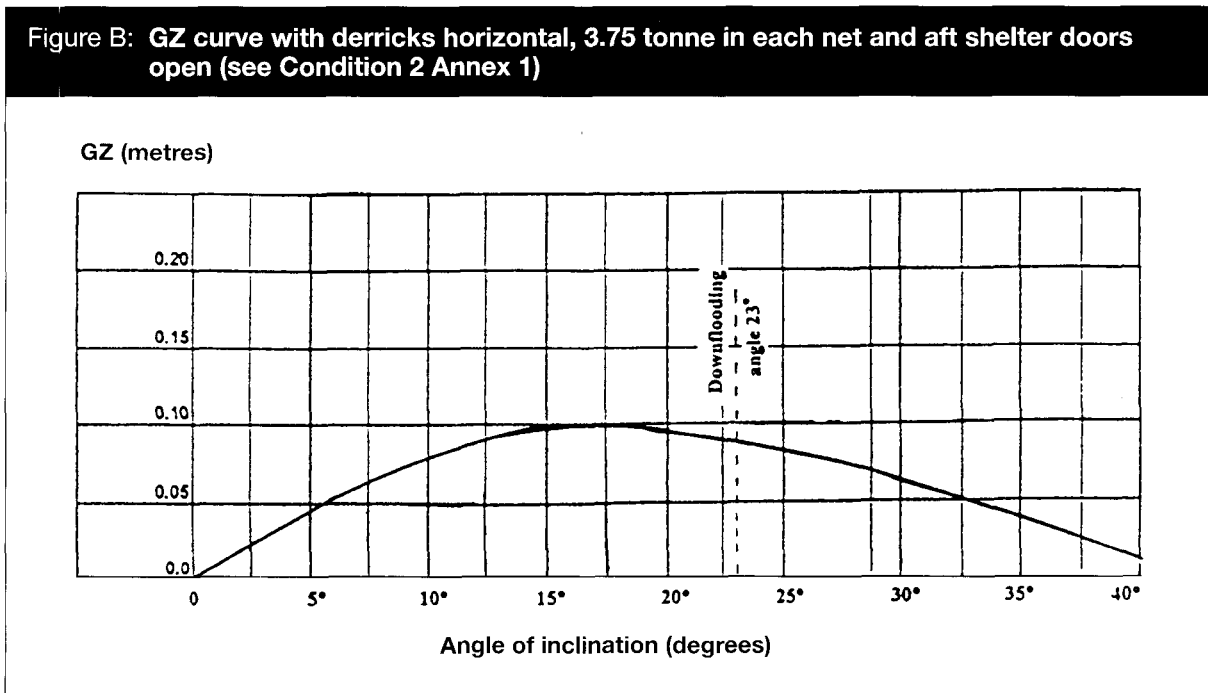
The two sets of gear would have been brought to the surface with the derricks horizontal. Although the effects of the additional weight would have reduced the vessel's stability, it was insufficient to cause a capsizing unless the weather was particularly poor (**Figure B and Condition 6, Annex 1**). The weather over the few days following the vessel's departure from Newlyn was reported to be good.

Having lifted the two sets of gear to the surface, the crew topped the derricks to allow access to the lazy deckies on the beams' inboard shoes. The lazy deckie could then have been connected to the gilson to bring the cod ends into the side of the vessel. As the port lazy decky was found still attached to the shoe of its beam it is apparent that the crew had not reached this stage.

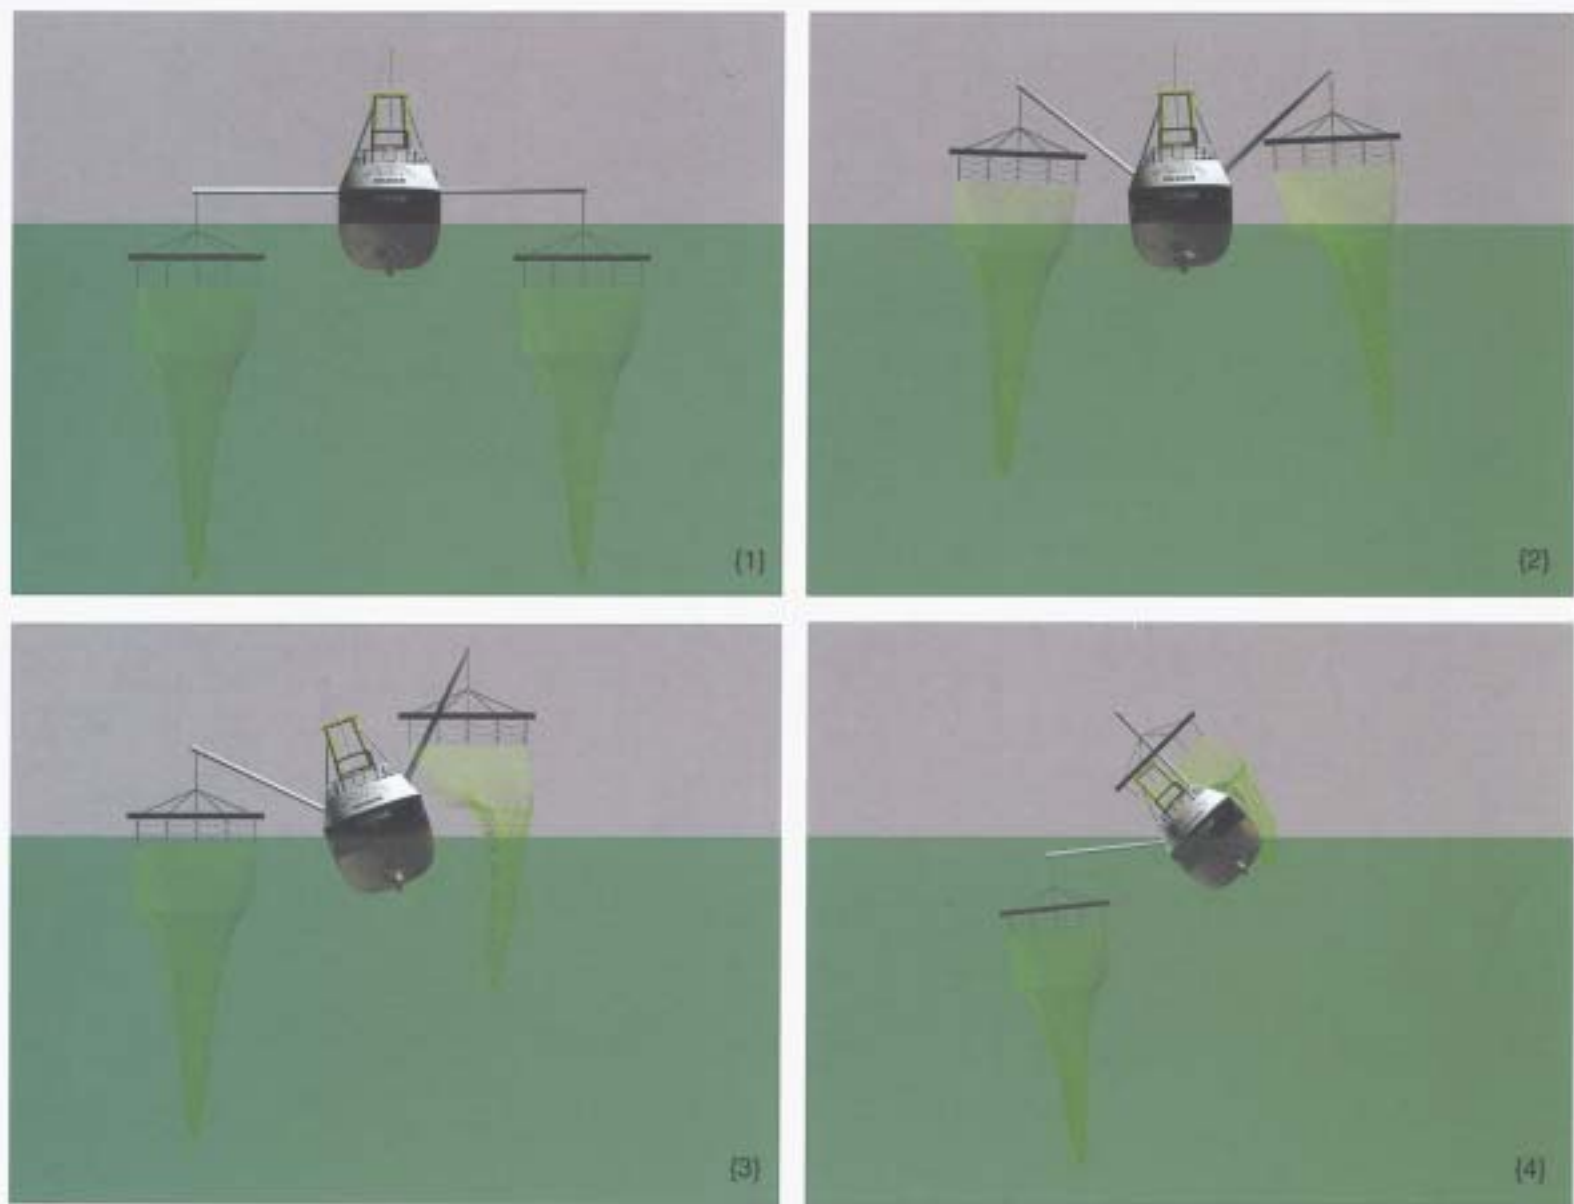
Figure 15 (1-4)

In order to set out clearly the Inspector's view as to the most likely cause and sequence of the vessel's loss, the conclusions of earlier sections are now collated in the form of a reconstruction of the likely events leading to the sinking. Significant stages of the capsize and sinking are set out in the images of **Figure 15**. Reference is made to the relevant image of **Figure 15** by a number in brackets, thus { }.

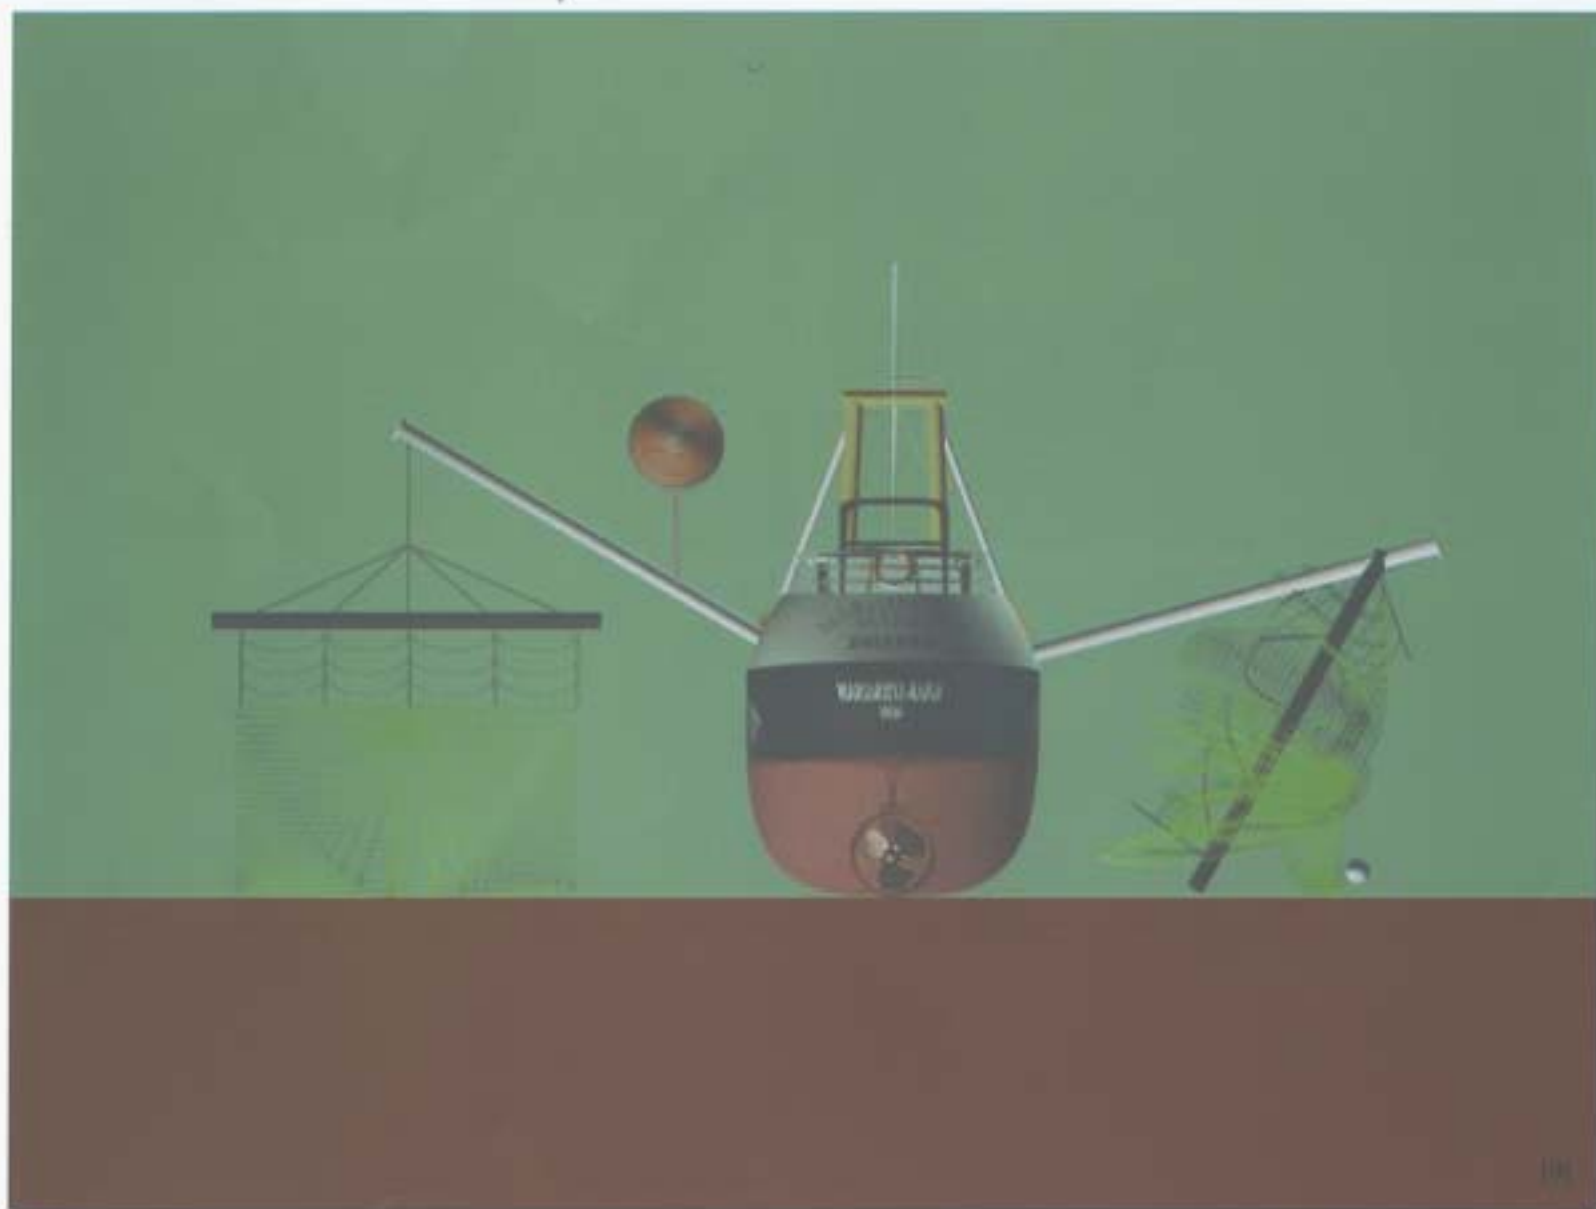
Figure 15 (9)

The vessel continued towards the sea bed, finally making contact and coming to rest almost upright {9}.

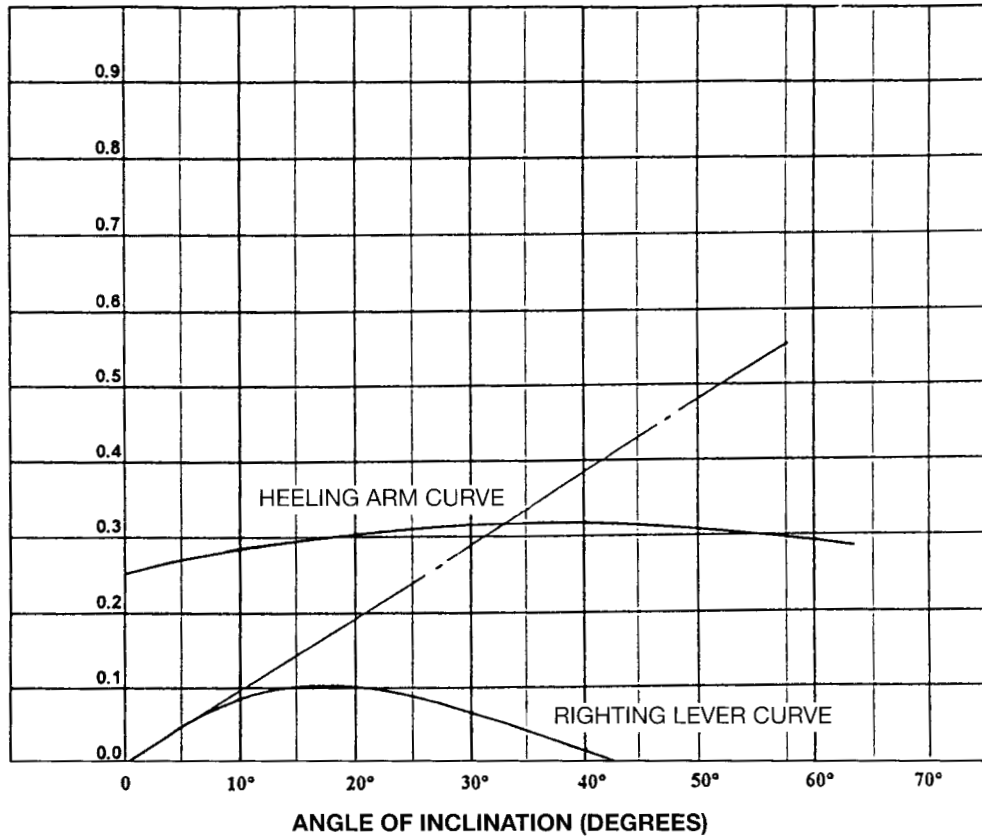
Condition 1: Beams at derrick ends, additional 3.75 tonne in one net and with derrick horizontal (access doors to shelter open)

Actual Value	Rule Minimum
Area Under Curve up to 30° (0.0654 × (1))	0.041*	0.066 M.Rads
Area Under Curve up to 40° (0.0581 × (2))	0.048*	0.108 M.Rads
Area Difference from 30° to 40°	0.007*	0.036 M.Rads
Angle at which Maximum GZ Occurs	17°*	25 Degrees
GZ at 30°	0.067*	0.240 Metres
Initial GM (Fluid)	0.533	0.420 Metres

*Failure to satisfy minimum criteria

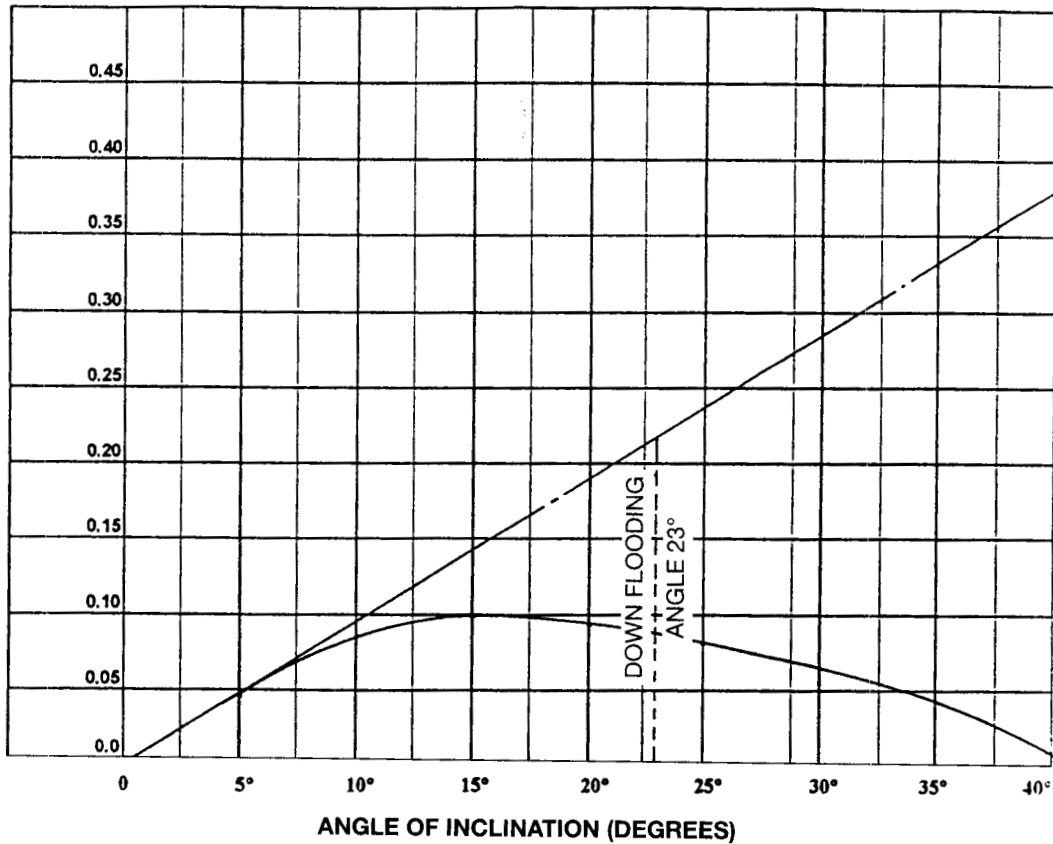
Condition 2: Both derricks horizontal, beams at derrick heads with additional 3.75 tonne in each net. Shelter doors open.

Actual Value	Rule Minimum
Area Under Curve up to 30° (0.0654 × (1))	0.039*	0.066 M.Rads
Area Under Curve up to 40° (0.0581 × (2))	0.046*	0.108 M.Rads
Area Difference from 30° to 40°	0.007*	0.036 M.Rads
Angle at which Maximum GZ Occurs	15°	25 Degrees
GZ at 30°	0.065*	0.240 Metres
Initial GM (Fluid)	0.541	0.420 Metres

*Failure to satisfy minimum criteria

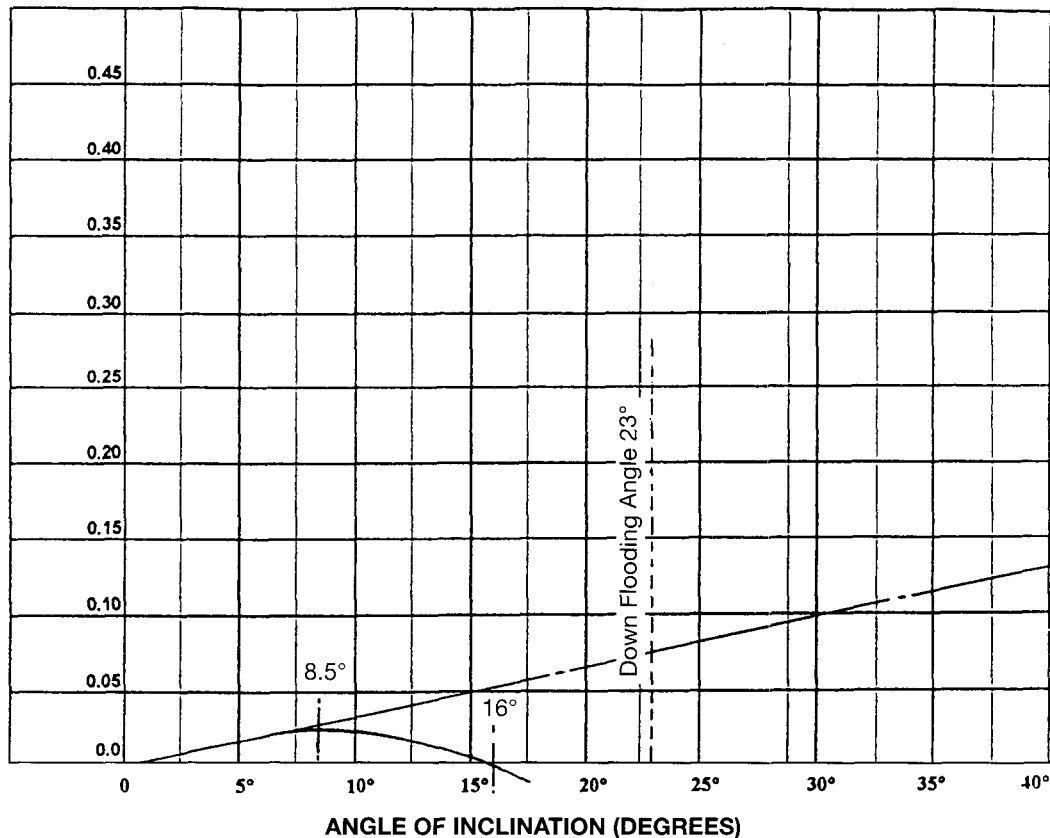
Condition 3: Both derricks 30° above horizontal, beams at derrick heads with additional 3.75 tonne in each net. Shelter doors open.

Actual Value	Rule Minimum
Area Under Curve up to 30° (0.0233 × (1))	0.004*	0.066 M.Rads
Area Under Curve up to 40°	0.000*	0.108 M.Rads
Area Difference from 30° to 40°	0.000*	0.036 M.Rads
Angle at which Maximum GZ Occurs	8.5°*	25 Degrees
GZ at 30°	-0.112*	0.240 Metres
Initial GM (Fluid)	0.187*	0.420 Metres

*Failure to satisfy minimum criteria

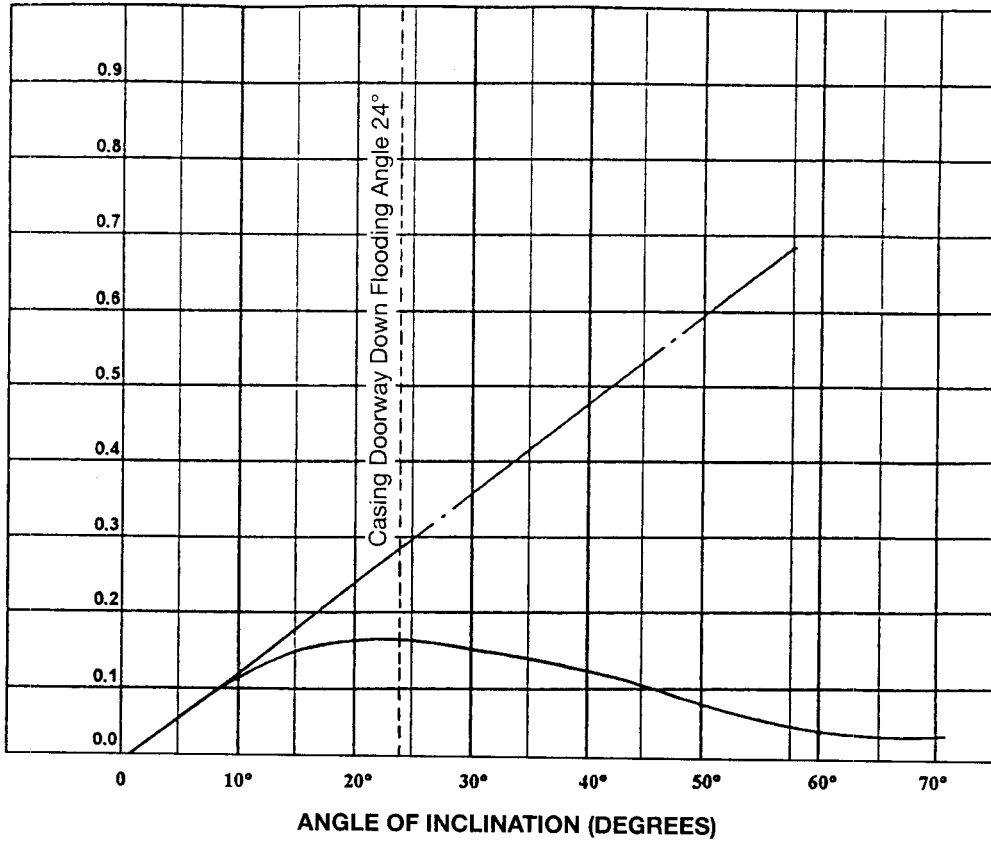
Condition 4: Both beams on deck, derricks topped to 45° above horizontal. Shelter doors open.

Actual Value	Rule Minimum
Area Under Curve up to 30° (0.0654 × (1))	0.064*	0.066 M.Rads
Area Under Curve up to 40° (0.0581 × (2))	0.088*	0.108 M.Rads
Area Difference from 30° to 40°	0.022*	0.036 M.Rads
Angle at which Maximum GZ Occurs	22°*	25 Degrees
GZ at 30°	0.151*	0.240 Metres
Initial GM (Fluid)	0.684	0.420 Metres

*Failure to satisfy minimum criteria

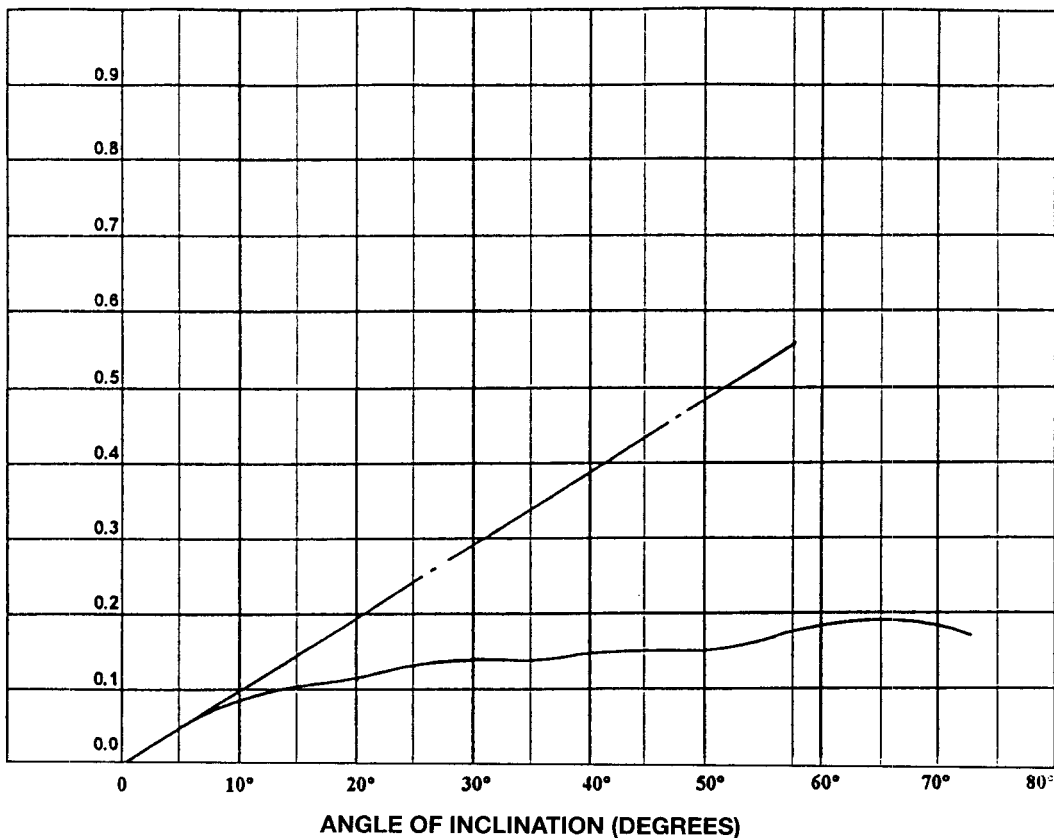
Condition 6: Both derricks horizontal, beams at derrick heads with additional 3.75 tonne in each net. Shelter doors closed.

Actual Value	Rule Minimum
Area Under Curve up to 30° (0.0654 × (1))	0.049*	0.066 M.Rads
Area Under Curve up to 40° (0.0581 × (2))	0.075*	0.108 M.Rads
Area Difference from 30° to 40°	0.026*	0.036 M.Rads
Angle at which Maximum GZ Occurs	65°	25 Degrees
GZ at 65°	0.190*	0.240 Metres
Initial GM (Fluid)	0.541	0.420 Metres

*Failure to satisfy minimum criteria

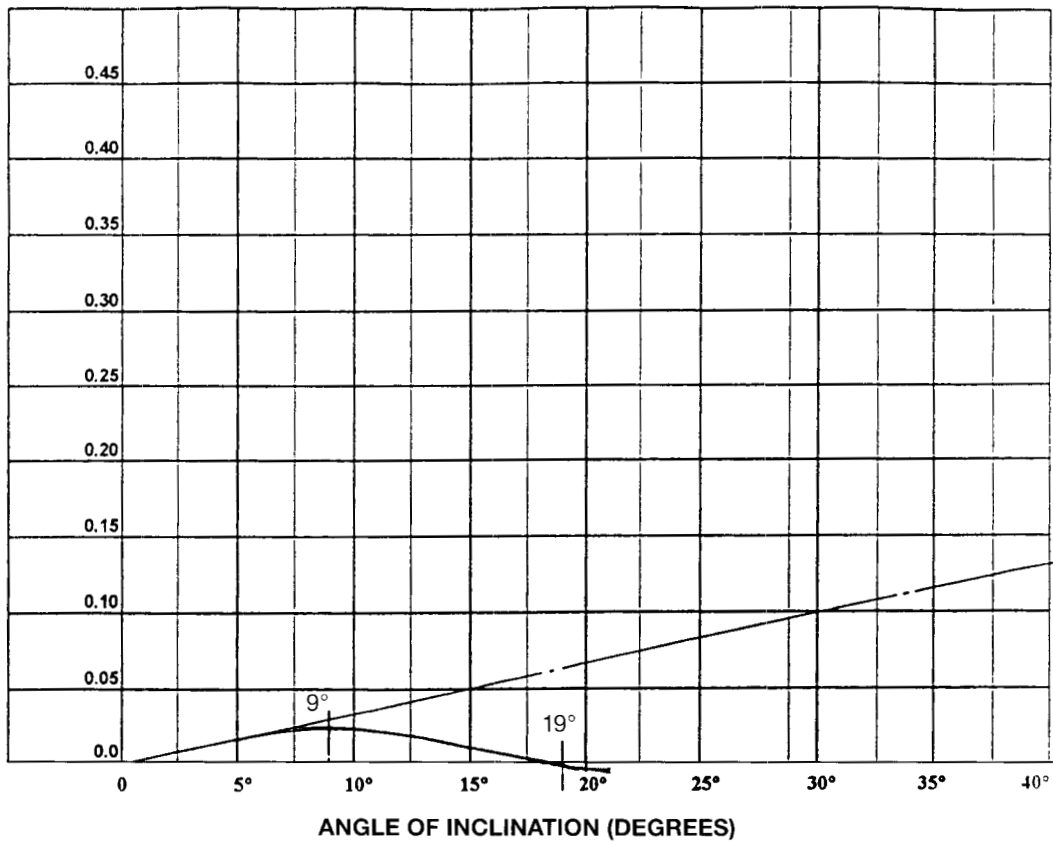
Condition 7: Both derricks 30° above horizontal, beams at derrick heads with additional 3.75 tonne in each net. Shelter doors closed.

Actual Value	Rule Minimum
Area Under Curve up to 30° (0.0276 × (1))	0.005*	0.066 M.Rads
Area Under Curve up to 40°	0.000*	0.108 M.Rads
Area Difference from 30° to 40°	0.000*	0.036 M.Rads
Angle at which Maximum GZ Occurs	9°*	25 Degrees
GZ at 30°	-0.035*	0.240 Metres
Initial GM (Fluid)	0.187*	0.420 Metres

*Failure to satisfy minimum criteria

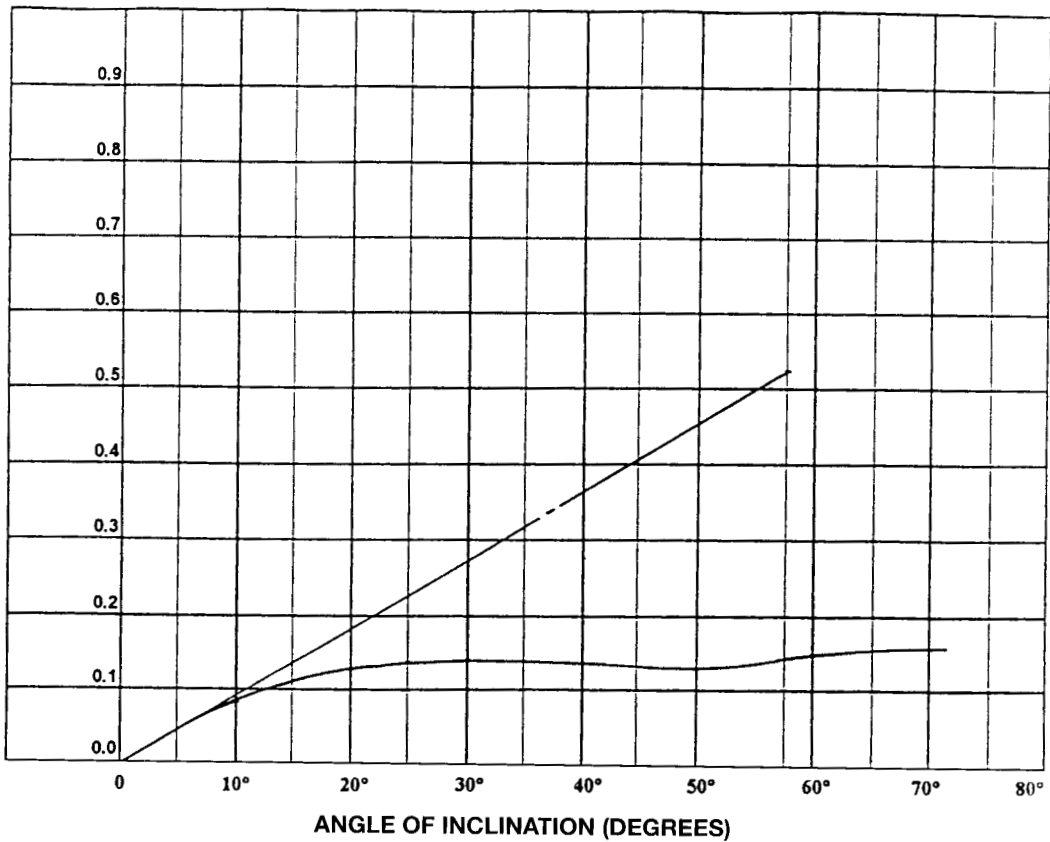
Condition 9: Both derricks topped 30° above horizontal, beams at derrick ends, nets empty. Shelter doors closed.

Actual Value	Rule Minimum
Area Under Curve up to 30° (0.0654 × (1))	0.051*	0.066 M.Rads
Area Under Curve up to 40° (0.0581 × (2))	0.075*	0.108 M.Rads
Area Difference from 30° to 40°	0.024*	0.036 M.Rads
Angle at which Maximum GZ Occurs	OVER 70°	25 Degrees
GZ at 70°	0.158*	0.240 Metres
Initial GM (Fluid)	0.523	0.420 Metres

*Failure to satisfy minimum criteria

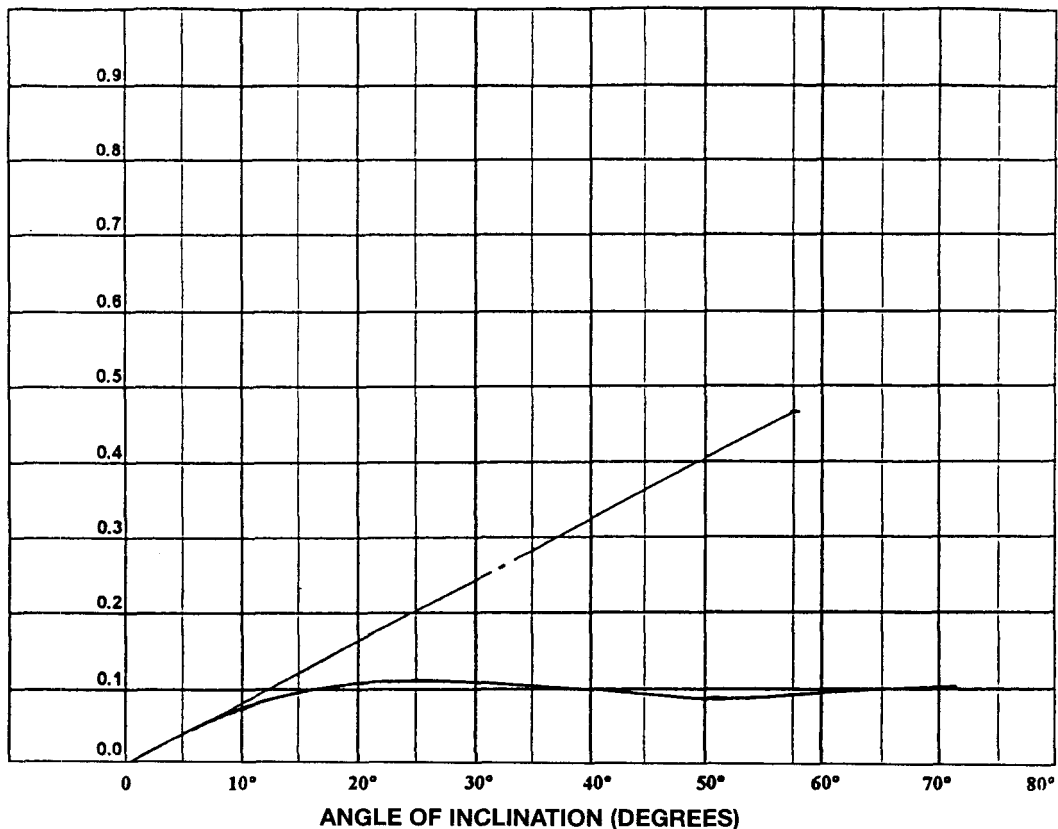
Condition 10: Both derricks topped 45° above horizontal, beams at derrick ends, nets empty. Shelter doors closed.

Actual Value	Rule Minimum
Area Under Curve up to 30° (0.0654 × (1))	0.043*	0.066 M.Rads
Area Under Curve up to 40° (0.0581 × (2))	0.062*	0.108 M.Rads
Area Difference from 30° to 40°	0.019*	0.036 M.Rads
Angle at which Maximum GZ Occurs	25°	25 Degrees
GZ at 70°	0.113*	0.240 Metres
Initial GM (Fluid)	0.465	0.420 Metres

*Failure to satisfy minimum criteria

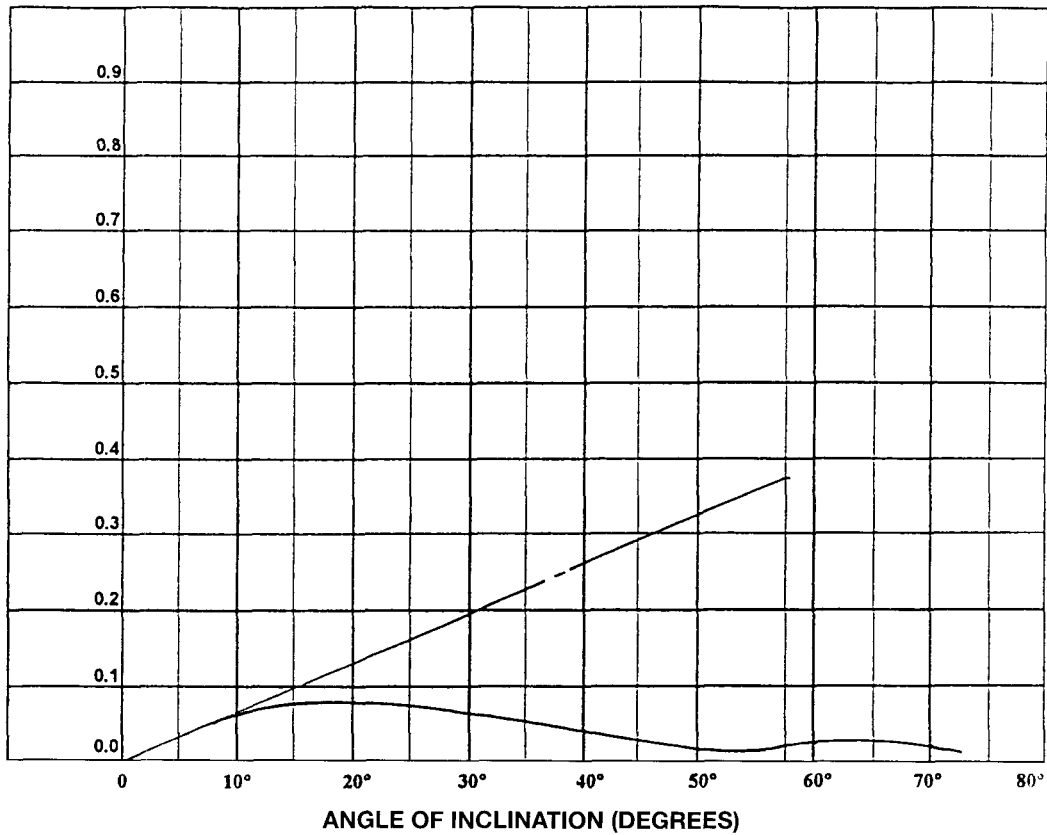
Condition 11: Both derricks fully topped, beams at derrick ends, nets empty. Shelter doors closed.

Actual Value	Rule Minimum
Area Under Curve up to 30° (0.0654 × (1))	0.032*	0.066 M.Rads
Area Under Curve up to 40° (0.0581 × (2))	0.041*	0.108 M.Rads
Area Difference from 30° to 40°	0.009*	0.036 M.Rads
Angle at which Maximum GZ Occurs	18°*	25 Degrees
GZ at 70°	0.066*	0.240 Metres
Initial GM (Fluid)	0.375*	0.420 Metres

*Failure to satisfy minimum criteria
