Marine Accident Report 1/99

Report of the Inspector's Inquiry into the sinking of the Fishing Vessel

SAPPHIRE PD 285

with the loss of four lives on 1 October 1997

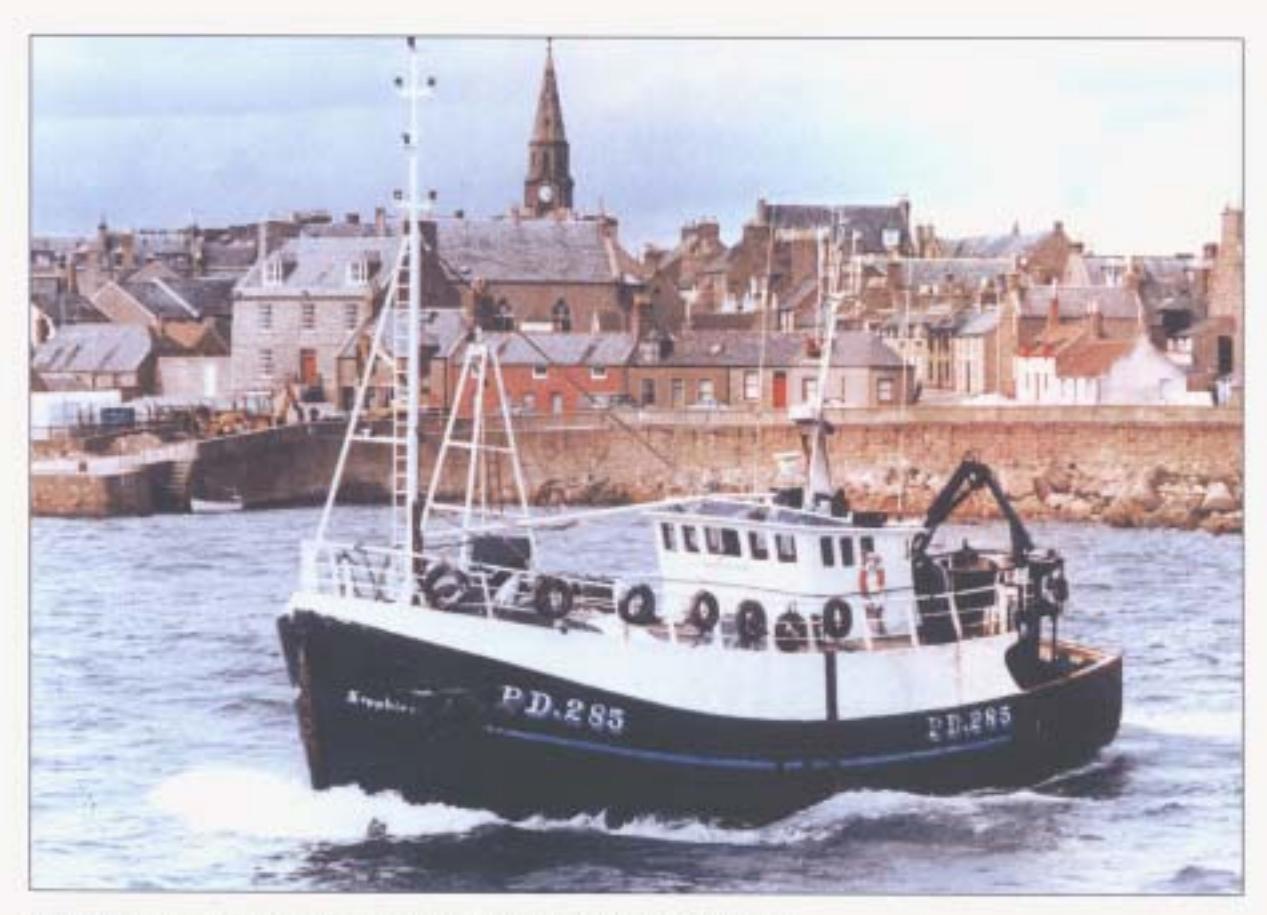
SAPPHIRE leaving Peterhead Harbour [photograph courtesy of vessel's owners]
