Report of an investigation of lifting arrangement failure

ENAK / LOVELETTER

in Sunderland Docks on 9 May 1997 with loss of one life

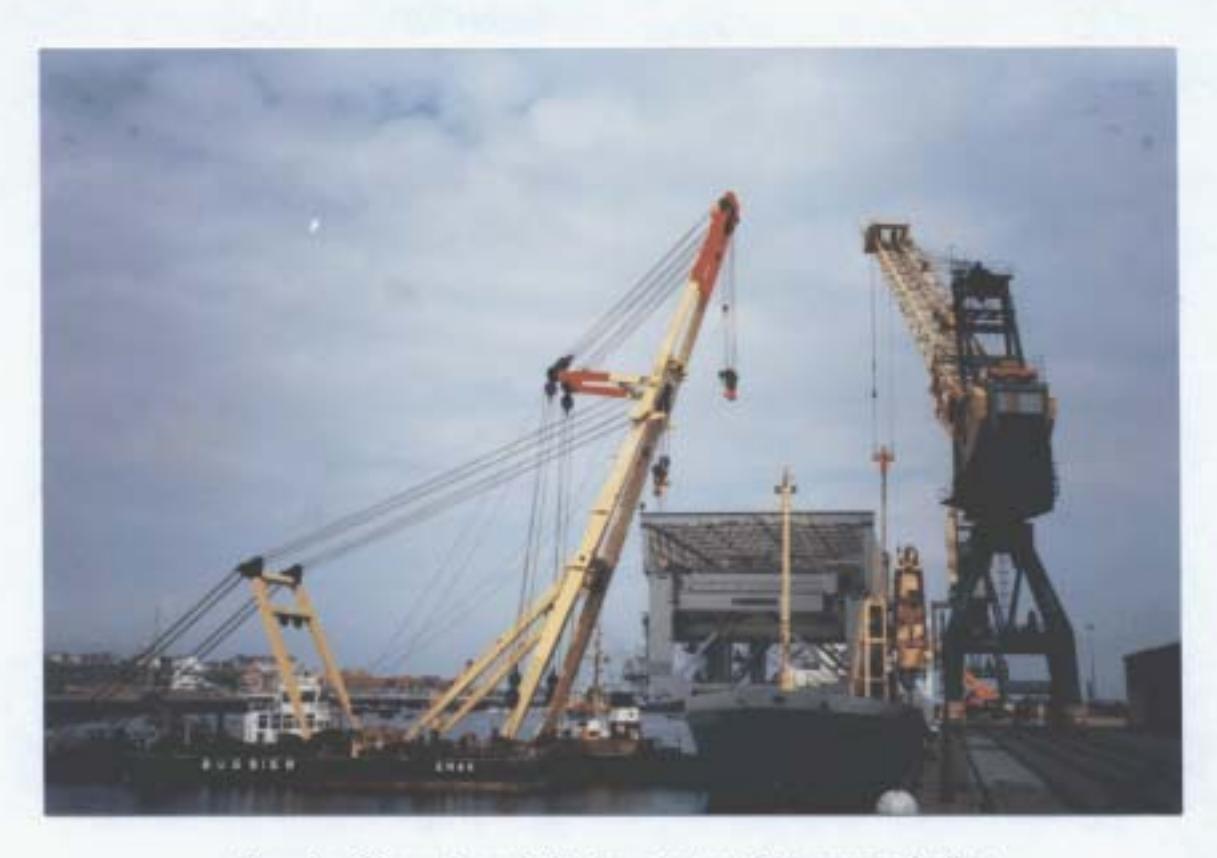
Showing Operation of 10 May, that on 9 May was similar

The free lower end of each sling was then shackled to a bracket on the lifting frame. These brackets were not the designated 125t lifting brackets. The crane driver was signalled to hoist sufficiently to remove the slack from the slings.

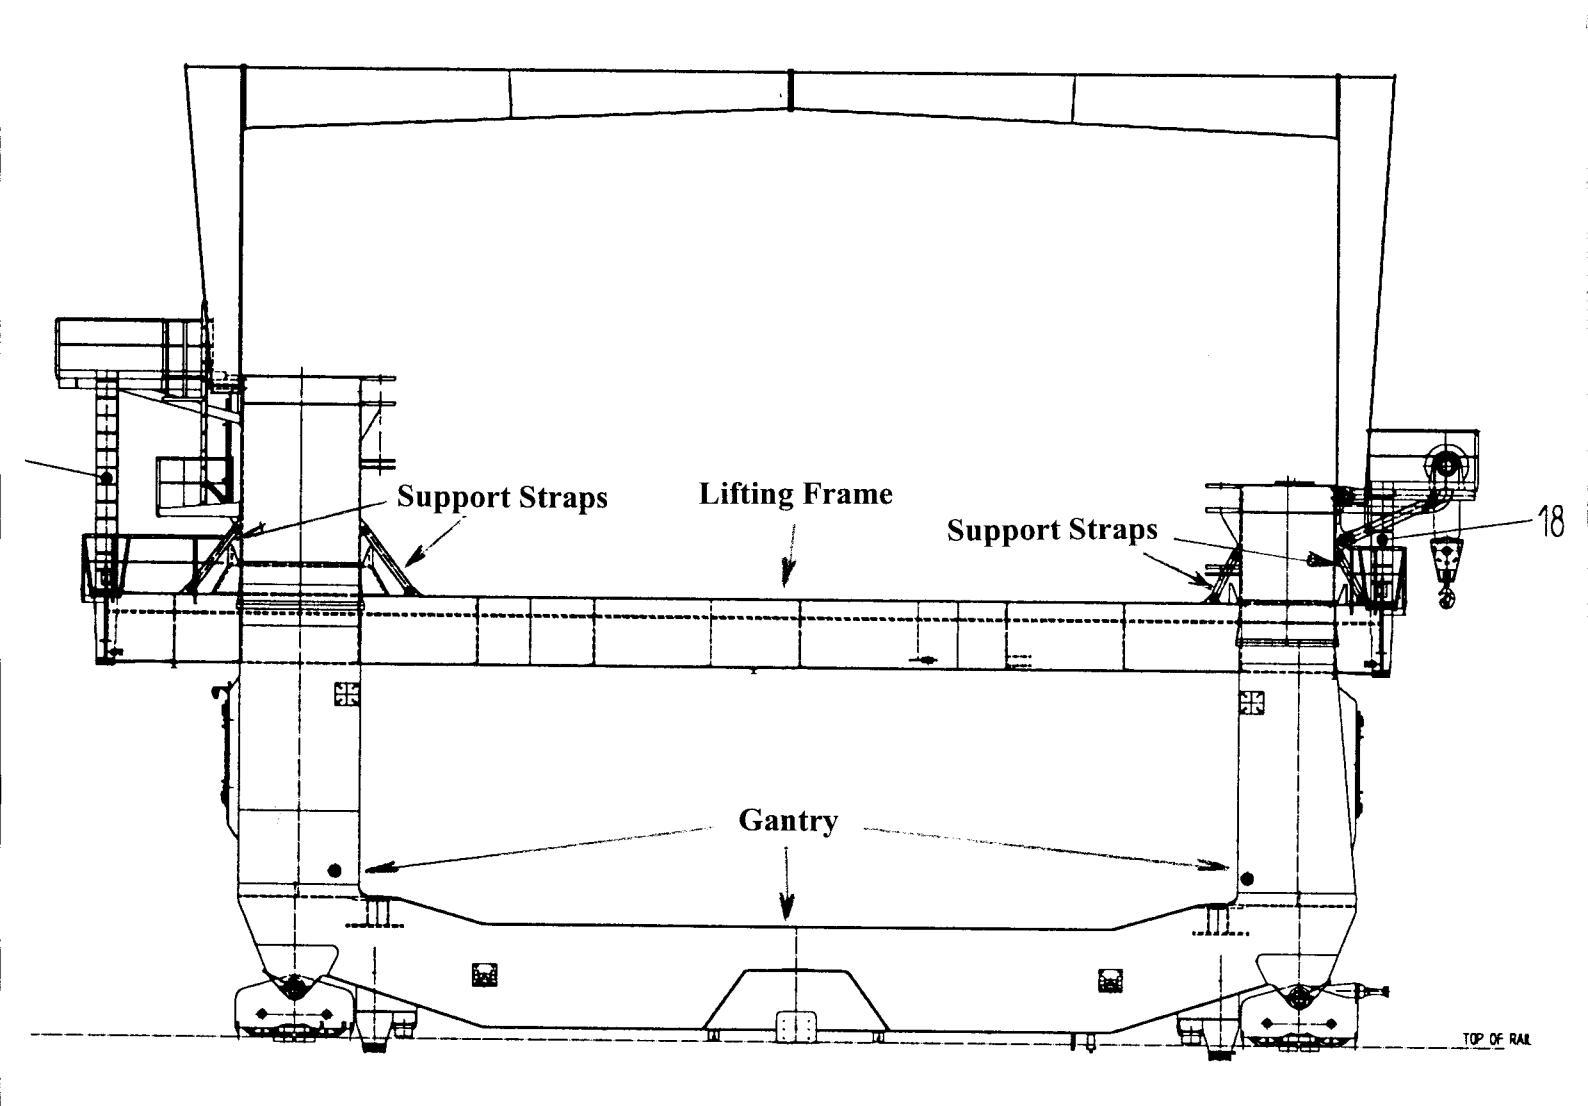
Figure 6

END ELEVATION OF GANTRY SHOWING LIFTING FRAME SUPPORT STRAPS

Another modification, which resulted from the selected floating crane ENAK having limited headroom, was the fitting of securing eyes to each lifting frame and gantry. Between these eyes steel straps were fitted which allowed each frame to remain in place, on the gantry, during transport of the gantry from Leibherr Works, Sunderland to Sunderland Docks by pontoon. The clearances in these eyes, straps and pins are such as to ensure that the lifting frame properly takes the weight of a gantry, without placing load on the straps, and give a vertical clearance of 25mm between gantry and lifting frame when the frame hung from the straps during transport by pontoon (Figure 6).

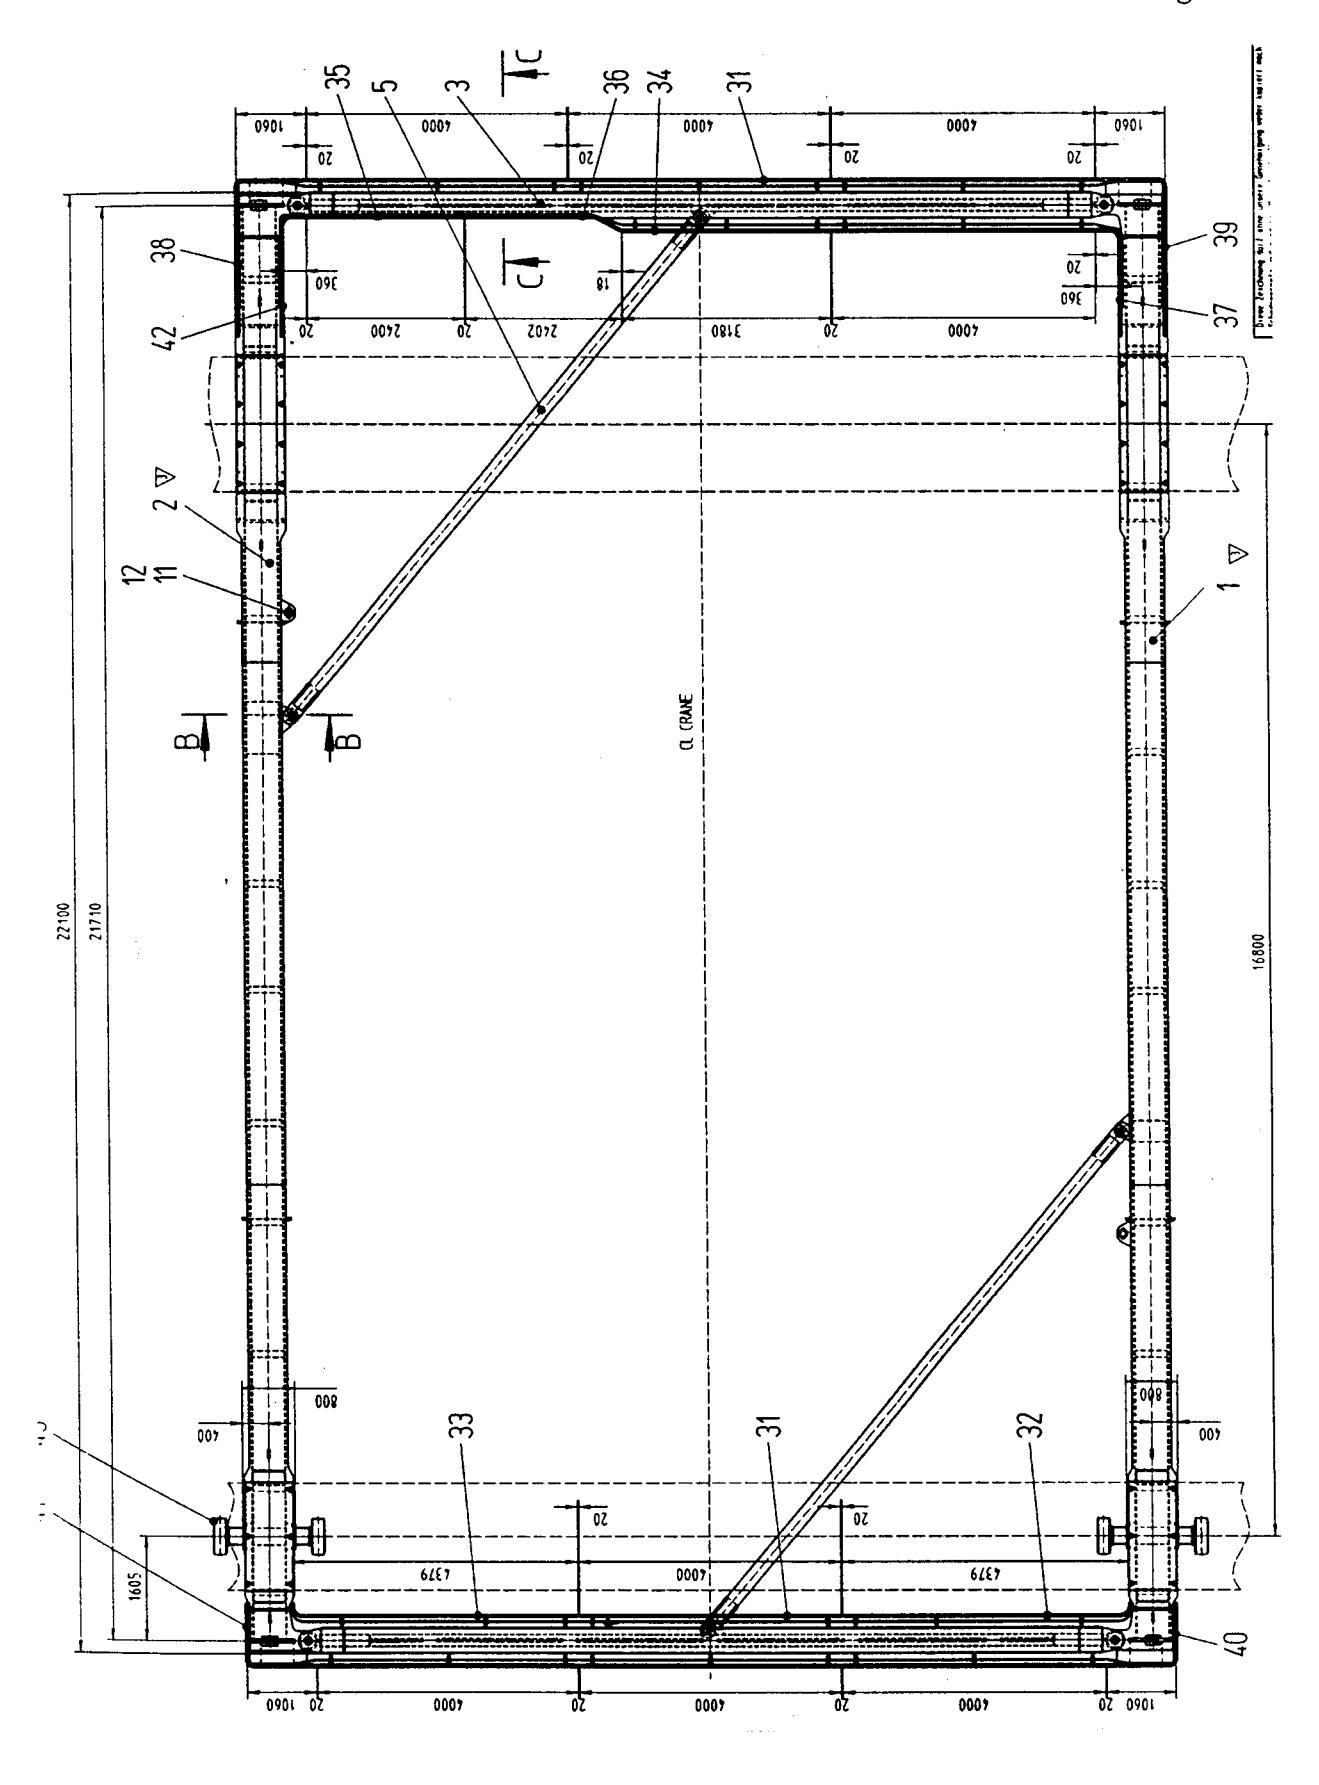
Figure 8

When assembled, the box section beams and the space frames form a structure which, in plan, is rectangular. (Figure 8). As the connections between the sides of the rectangle are pin joints, two pin jointed diagonal struts are used to maintain the beams at 90° to the space frames. The total weight of each assembled lifting frame is 40.5t.

Two pairs of wheels were added to the box sections to aid the movement of the frame across the hatch cover of the transporting ship, once lowered from the gantry (Figure 8). A walkway was also formed on the upper section by fitting guard-rails to the spacer elements.

PLAN OF LIFTING FRAME SHOWING DIAGONAL STRUTS

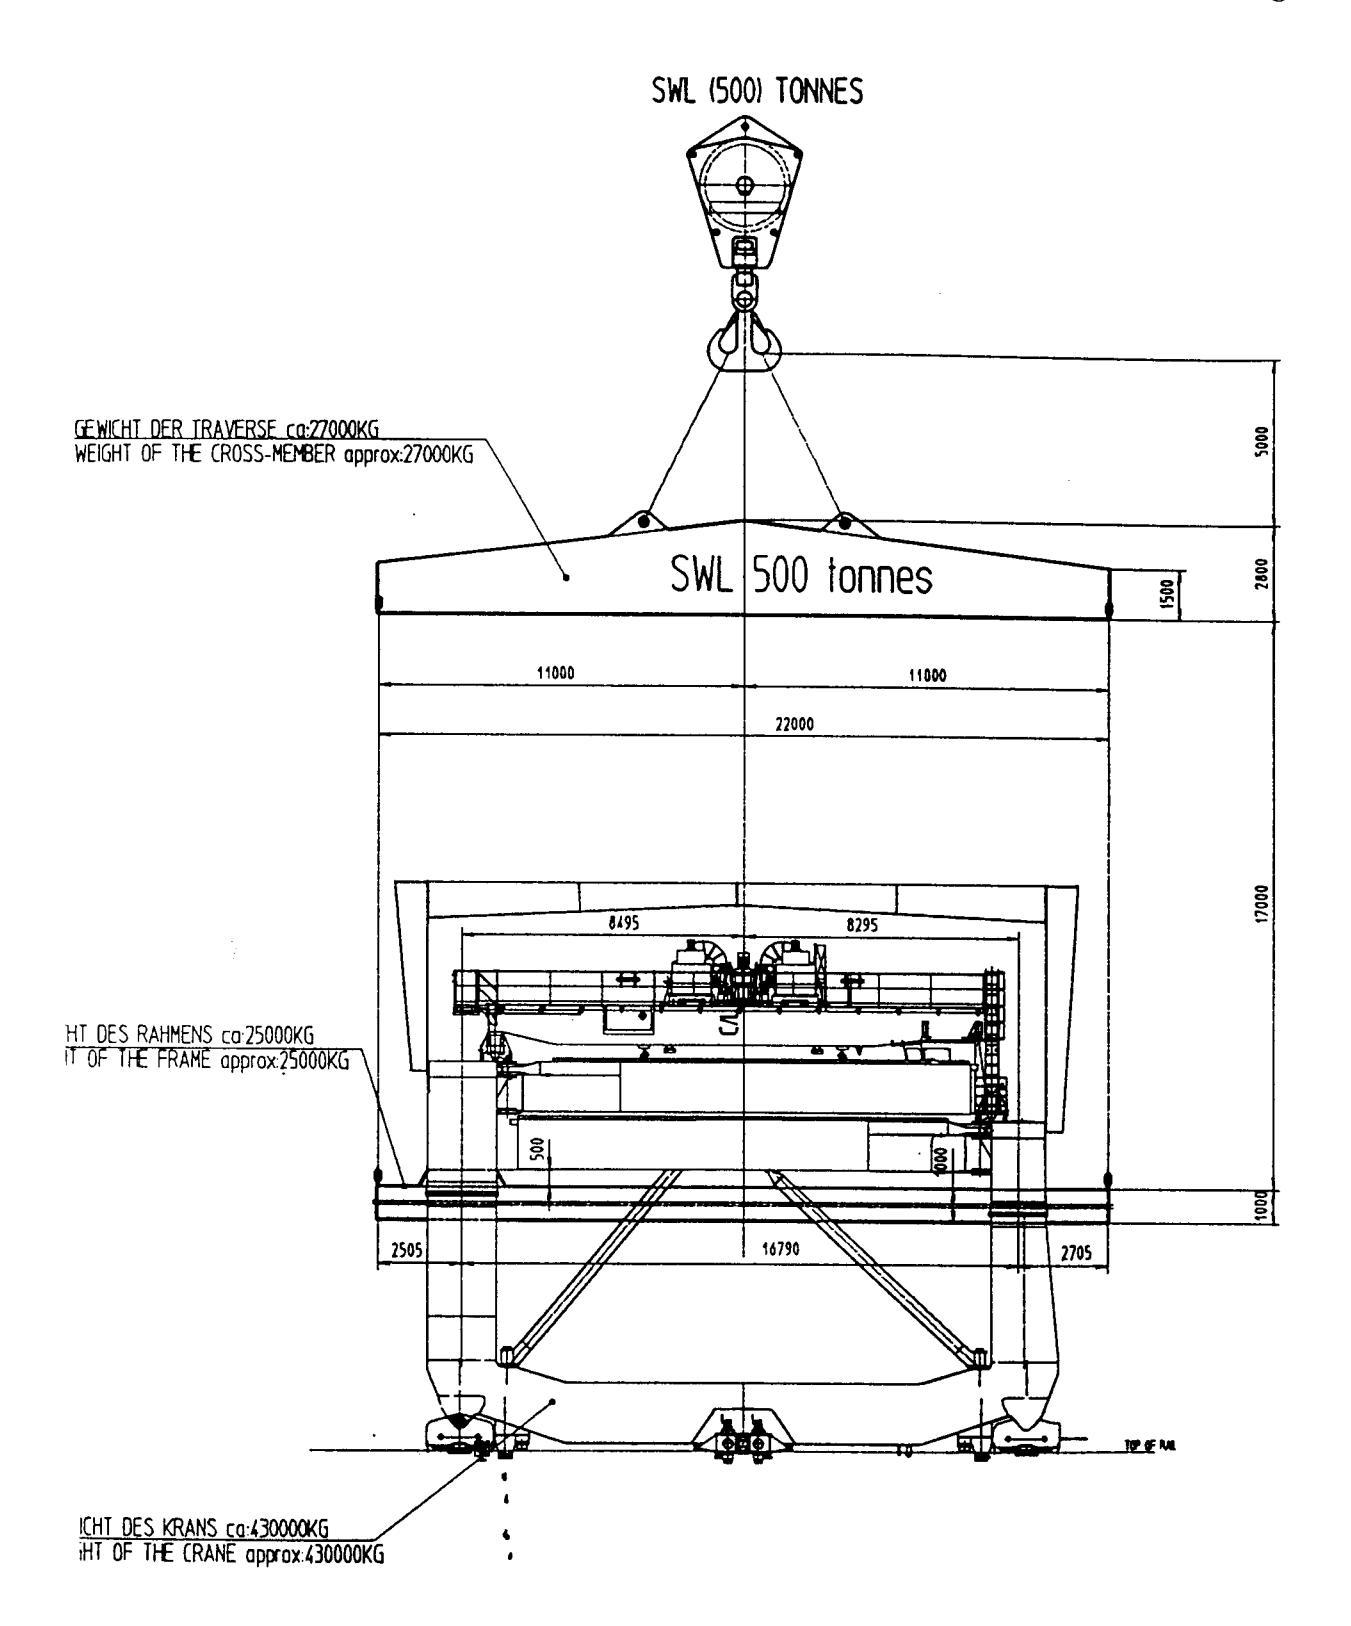
END ELEVATION OF GANTRY SHOWING LIFTING ARRANGEMENTS AND 500t SPREADER BEAM

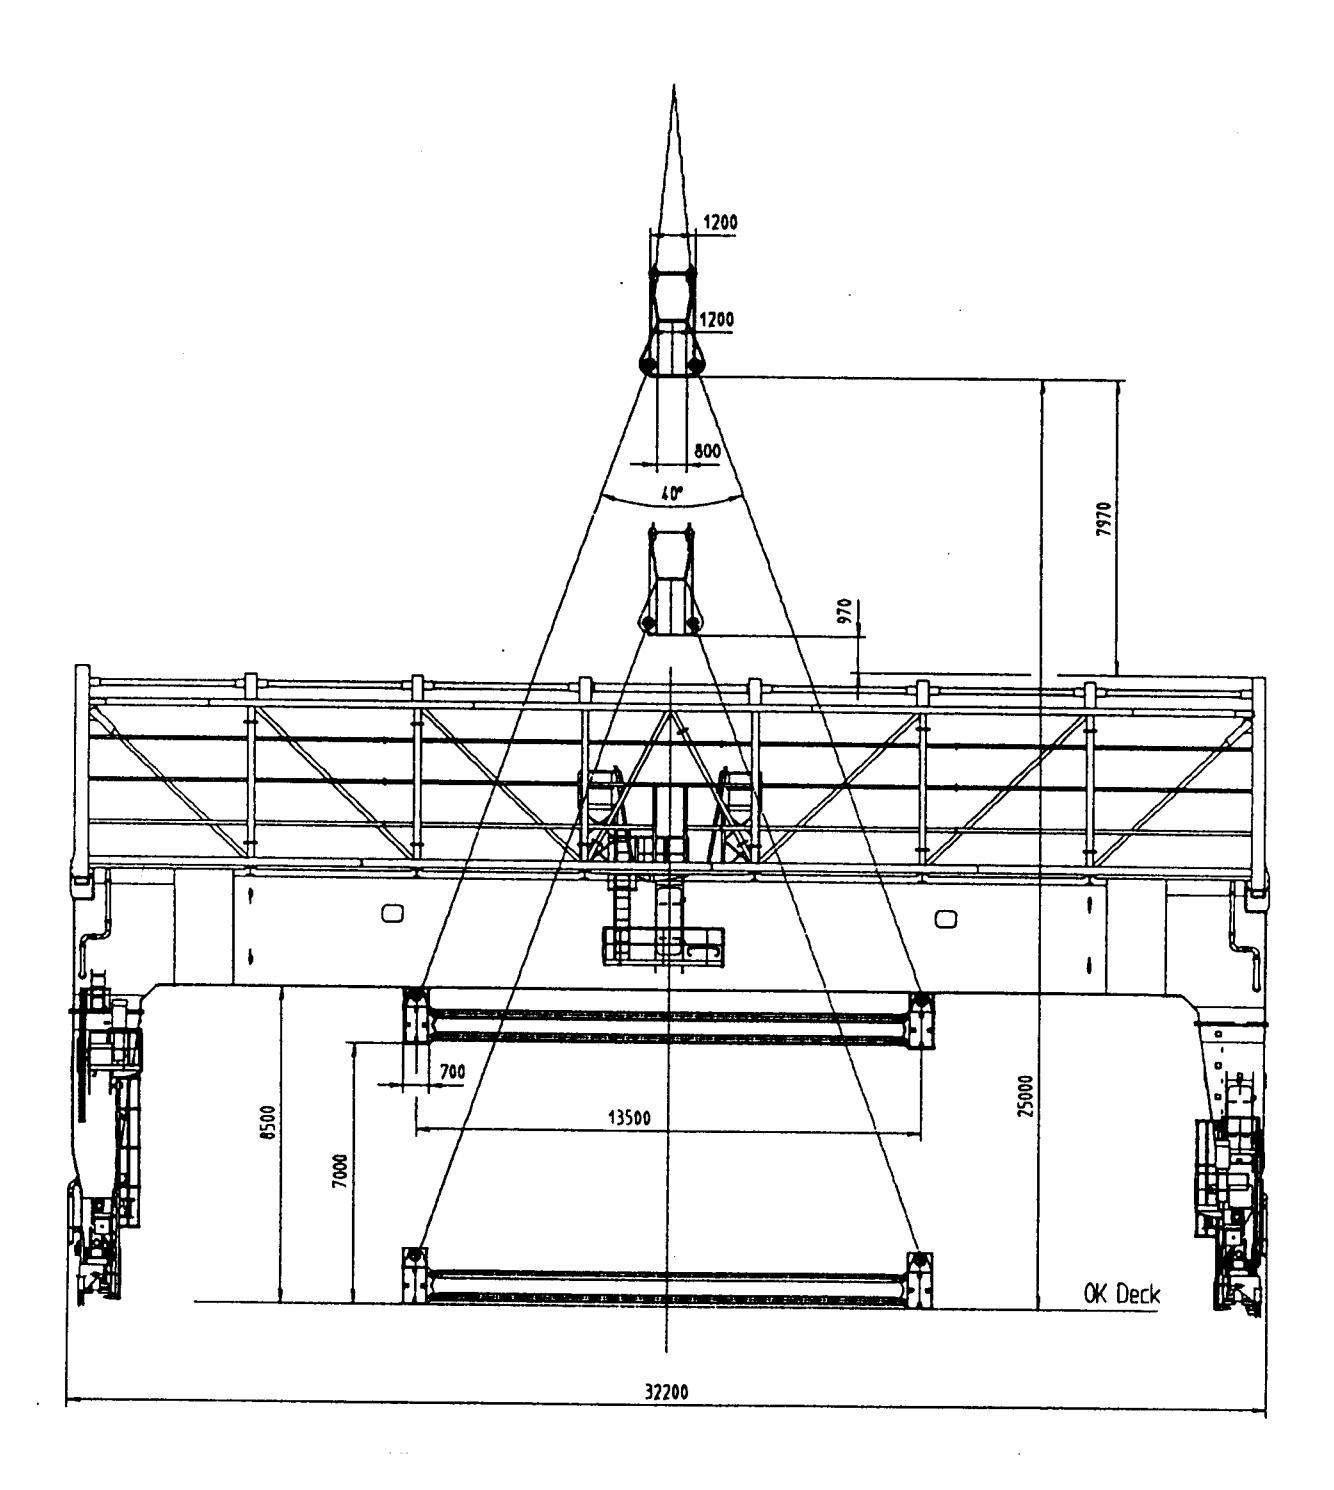
SIDE ELEVATION OF GANTRY SHOWING INITIAL PROPOSAL FOR A SINGLE LIFT PROCEDURE FOR LOWERING LIFTING FRAME
