**Collision between fishing vessels *SAPPHIRE STONE* and
KAREN resulting in the
loss of *KAREN*
11 miles south-east of Campbeltown
22 January 2014**

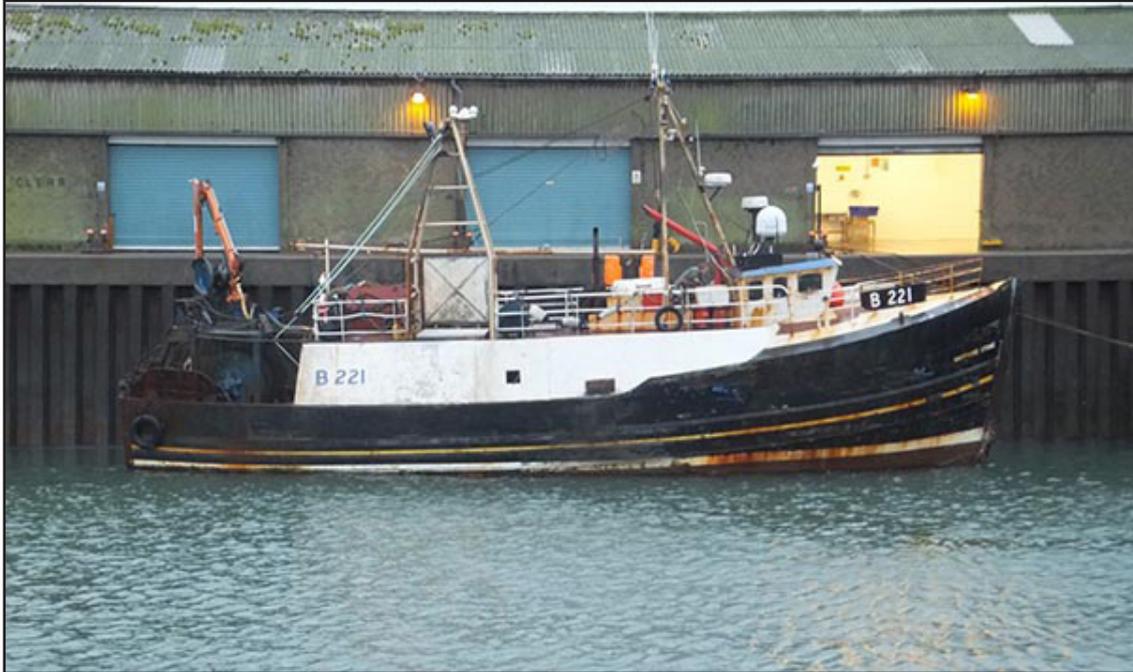
Figure 1: *Sapphire Stone*

Sapphire Stone (Figure 1) was a 20.58m⁶ twin-rigged stern trawler of wooden construction. It had been owned jointly by the skipper, mate and two other persons since 1999. The vessel fished for prawns during the day, normally landing its catch in the evening and remaining alongside overnight.

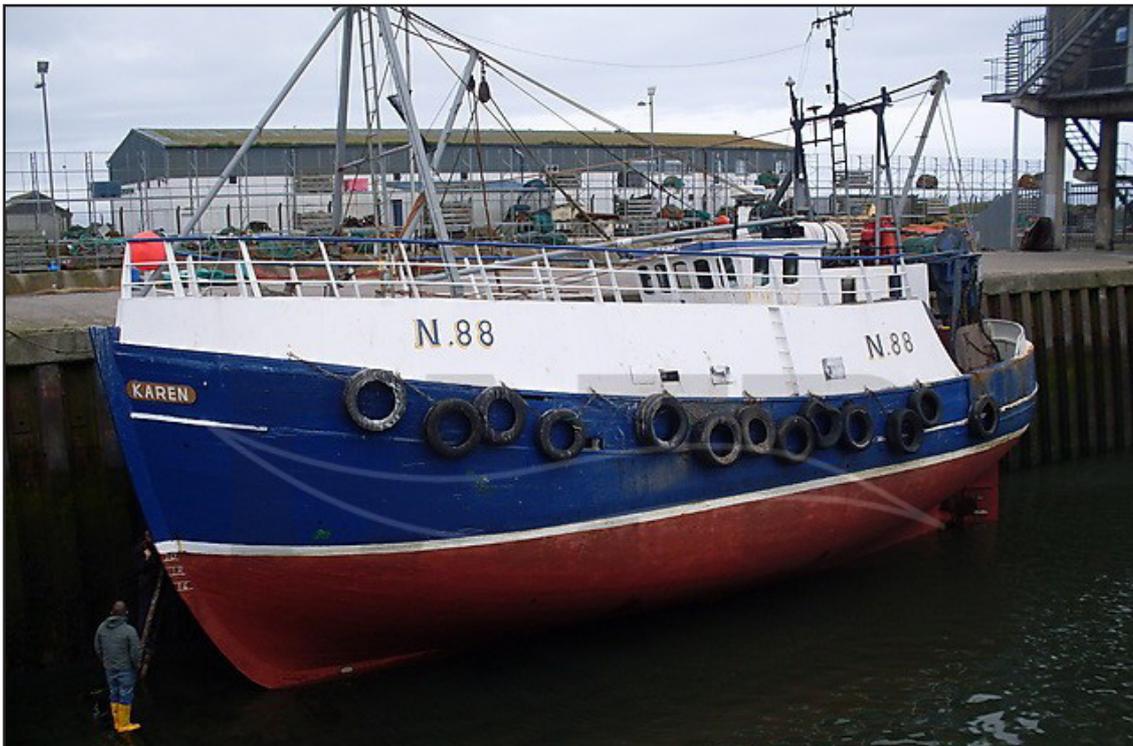
Figure 2: *Karen*

Karen (Figure 2) was a 17.58m stern trawler of wooden construction, and had been owned by its skipper for 5½ years. The vessel also fished for prawns and followed a similar pattern of day fishing to *Sapphire Stone*.
