Report on the investigation of
contacts made by the
high speed craft

Norman Arrow

with quays in Portsmouth International Port,

Report No 7/2011
May 2011

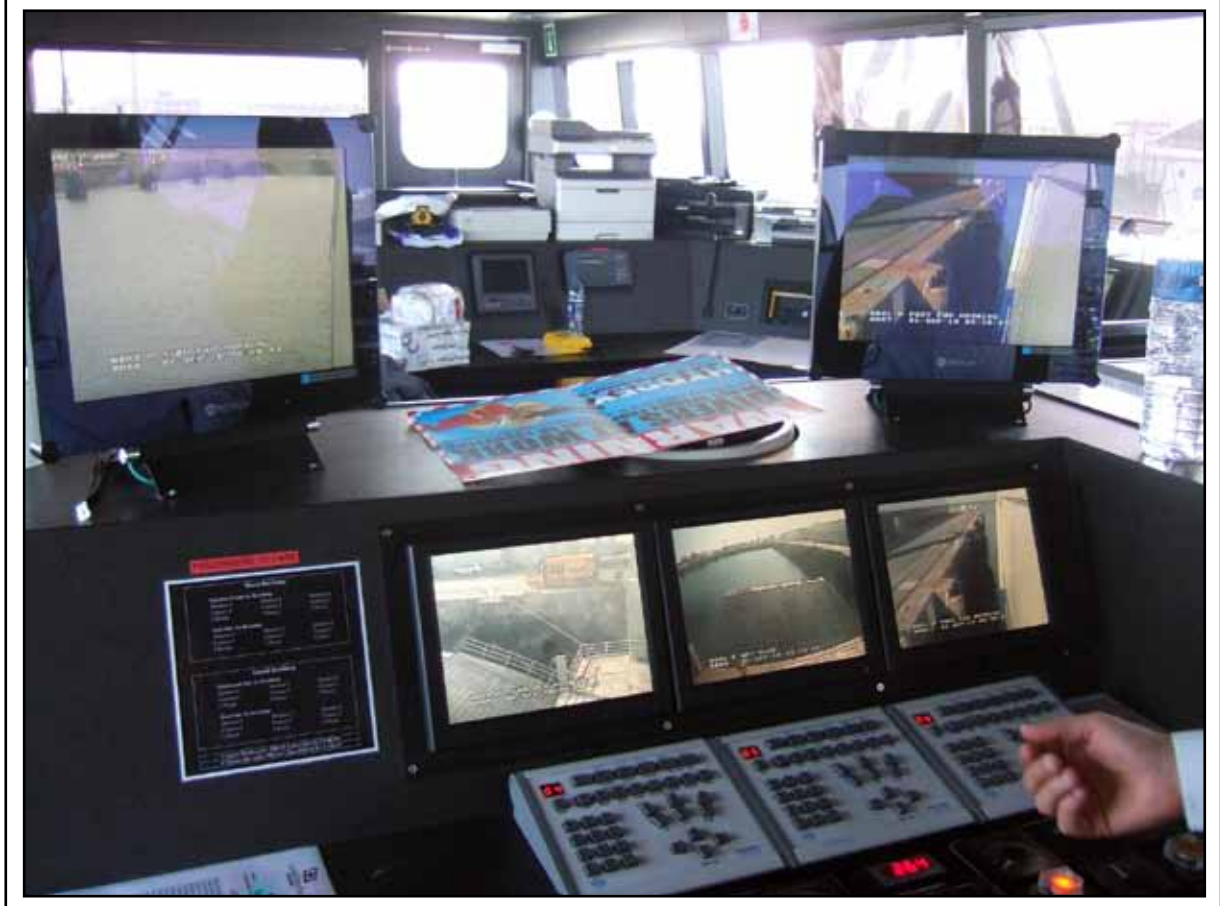
Two control stations were used to manoeuvre *Norman Arrow*. The "at sea" station was forward-facing and sited on the centreline of the vessel (**Figure 11**). The "manoeuvring" station was aft-facing and was sited immediately abaft the "at sea" station. *Norman Arrow* was fitted with a CCTV system that allowed personnel at the manoeuvring station to monitor the areas around the vessel's sides and stern, but not the forward prows. The CCTV system had seven cameras (**Figure 12**). It was originally provided with three CCTV monitors, but two additional CCTV monitors were fitted by Louis Dreyfus Armateurs at the request of the vessel's masters. **Figure 13** shows the location of the pan and tilt cameras and their viewing areas; however, it was not possible to view the whole of the indicated arcs at the same time and the vessel's masters had their own preferences for the positioning of the cameras when manoeuvring close to berths.

CCTV monitors from different heights of eye

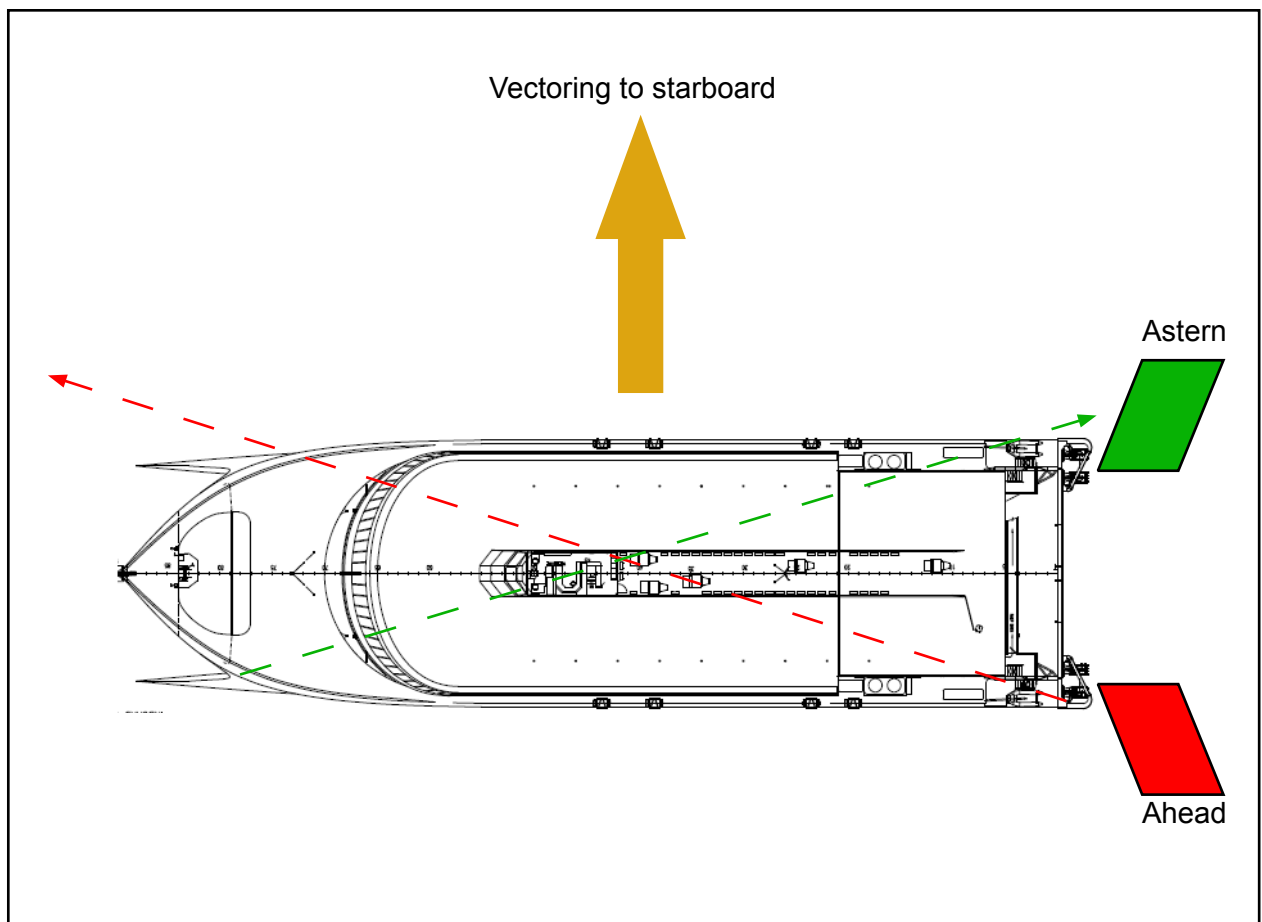
Figure 15

- In the vectoring mode, the water jets were turned outboard (toed-out). With the port jets operating ahead and the starboard jets operating astern (toed-out to starboard) (**Figure 15**), *Norman Arrow* moved bodily to starboard. When vectoring, the difference in the effectiveness of ahead and astern thrust was compensated by increasing the engine speed on the jetavators operating astern. *Norman Arrow* was vectored by moving the joystick to port or starboard (**Figure 2**).

Toed-out configuration (Vectoring)

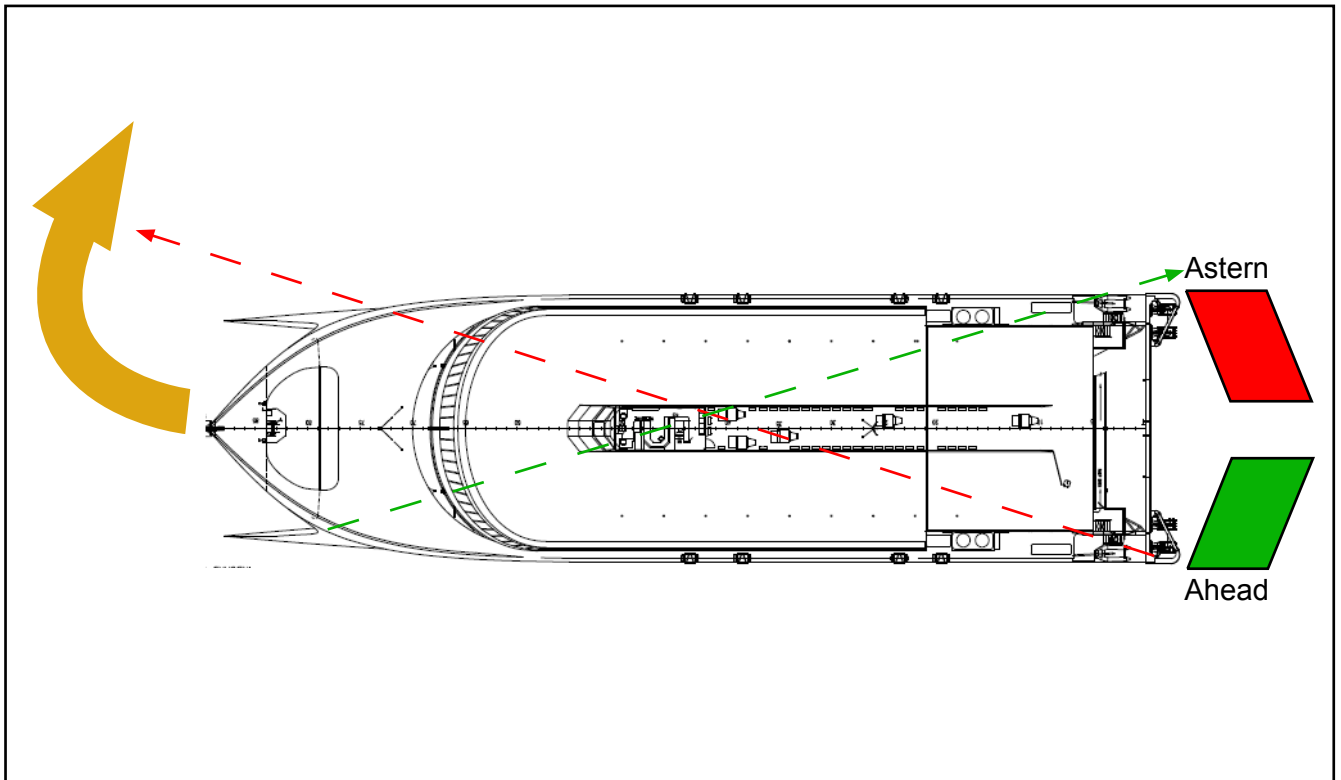
Figure 16

- In the azimuth mode, the water jets were turned inboard (toed-in). With the port jets operating ahead and the starboard jets operating astern (toed-in to starboard), the vessel's head turned to starboard (**Figure 16**). *Norman Arrow* was azimuthed by turning the spring-loaded azimuth dial at the manoeuvring station (**Figure 2**).

Toed-in configuration (Azimuth)
