Report on the investigation of  
contacts made by the  
high speed craft

***Norman Arrow***

with quays in Portsmouth International Port,

**Report No 7/2011  
May 2011**

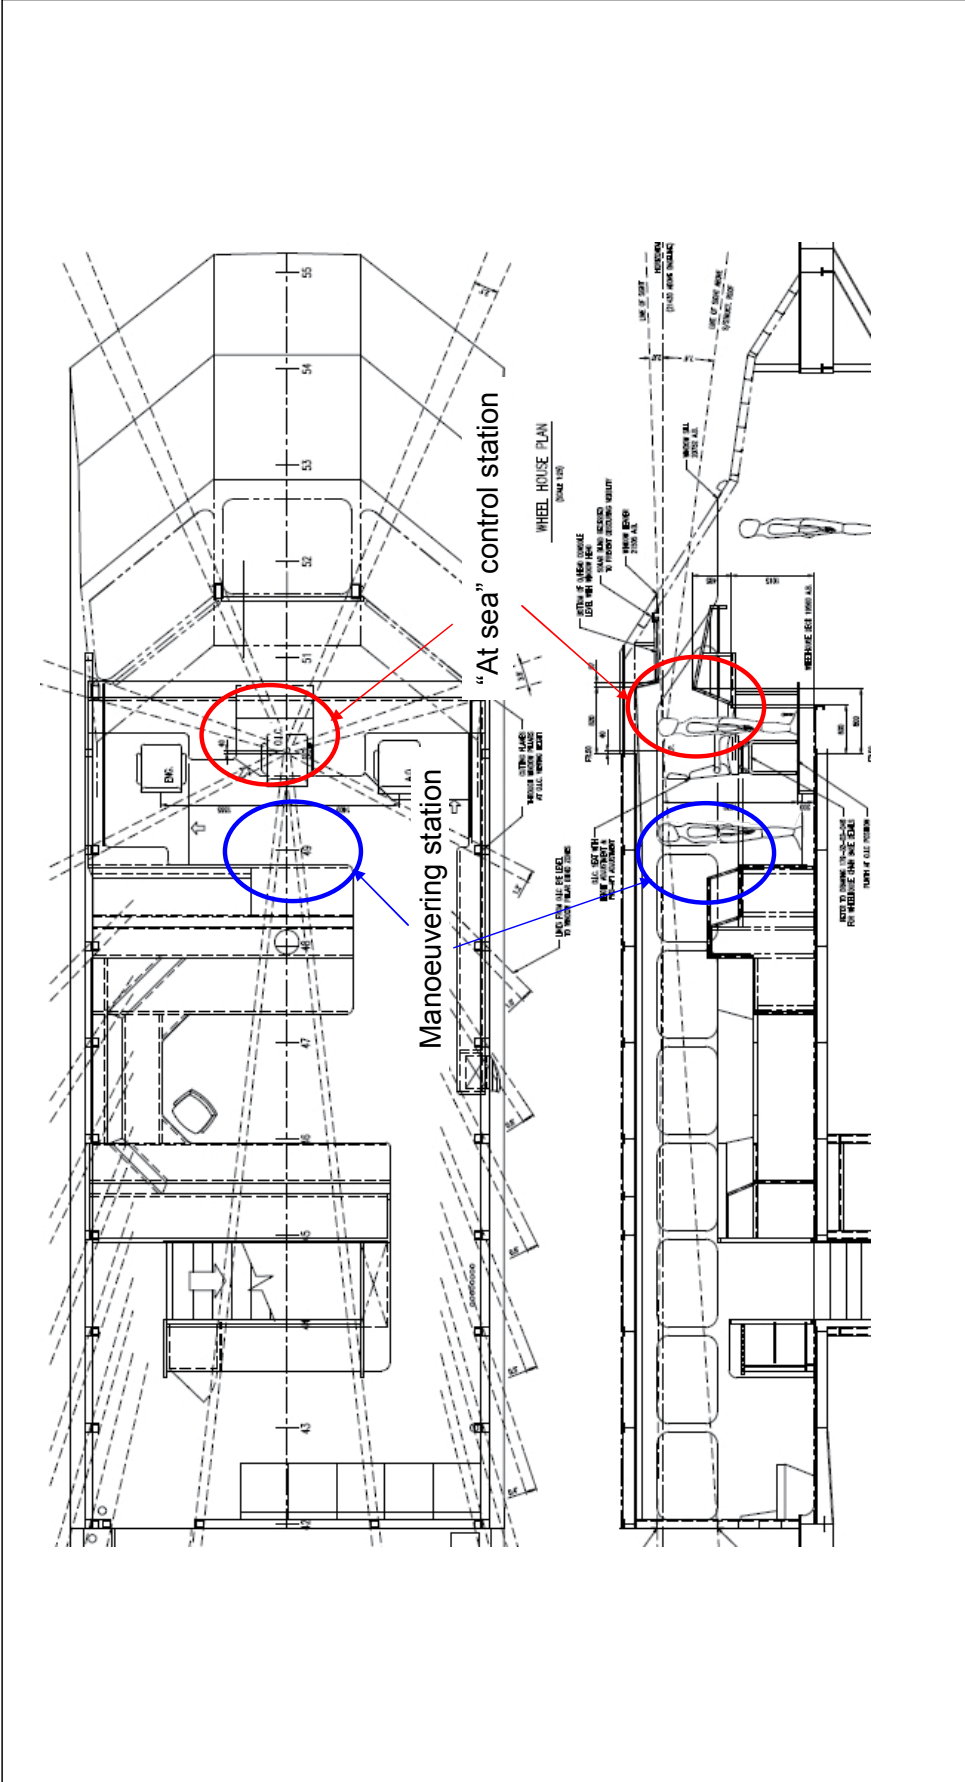
Two control stations were used to manoeuvre *Norman Arrow*. The "at sea" station was forward-facing and sited on the centreline of the vessel (**Figure 11**). The "manoeuvring" station was aft-facing and was sited immediately abaft the "at sea" station. *Norman Arrow* was fitted with a CCTV system that allowed personnel at the manoeuvring station to monitor the areas around the vessel's sides and stern, but not the forward prows. The CCTV system had seven cameras (**Figure 12**). It was originally provided with three CCTV monitors, but two additional CCTV monitors were fitted by Louis Dreyfus Armateurs at the request of the vessel's masters. **Figure 13** shows the location of the pan and tilt cameras and their viewing areas; however, it was not possible to view the whole of the indicated arcs at the same time and the vessel's masters had their own preferences for the positioning of the cameras when manoeuvring close to berths.

Location of control stations

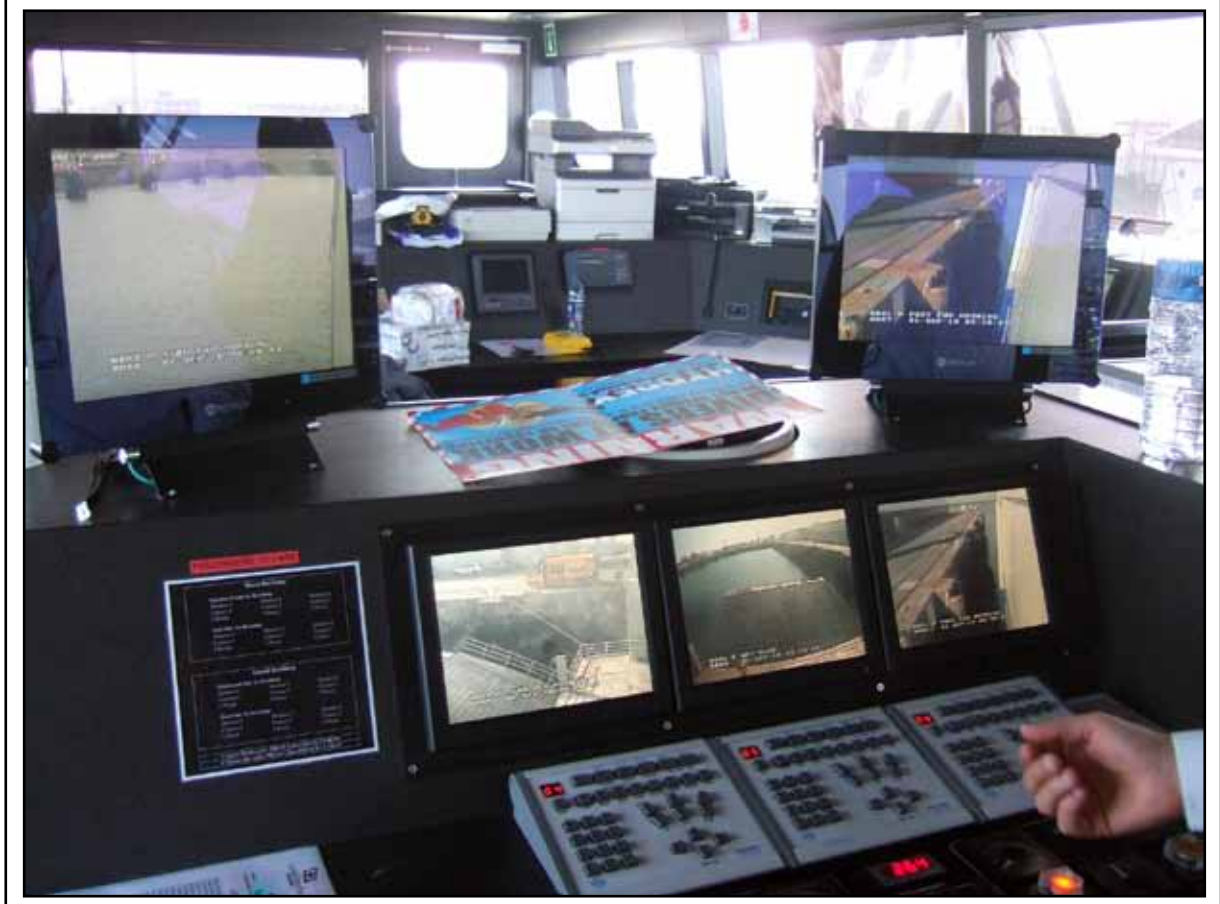
CCTV monitors from different heights of eye

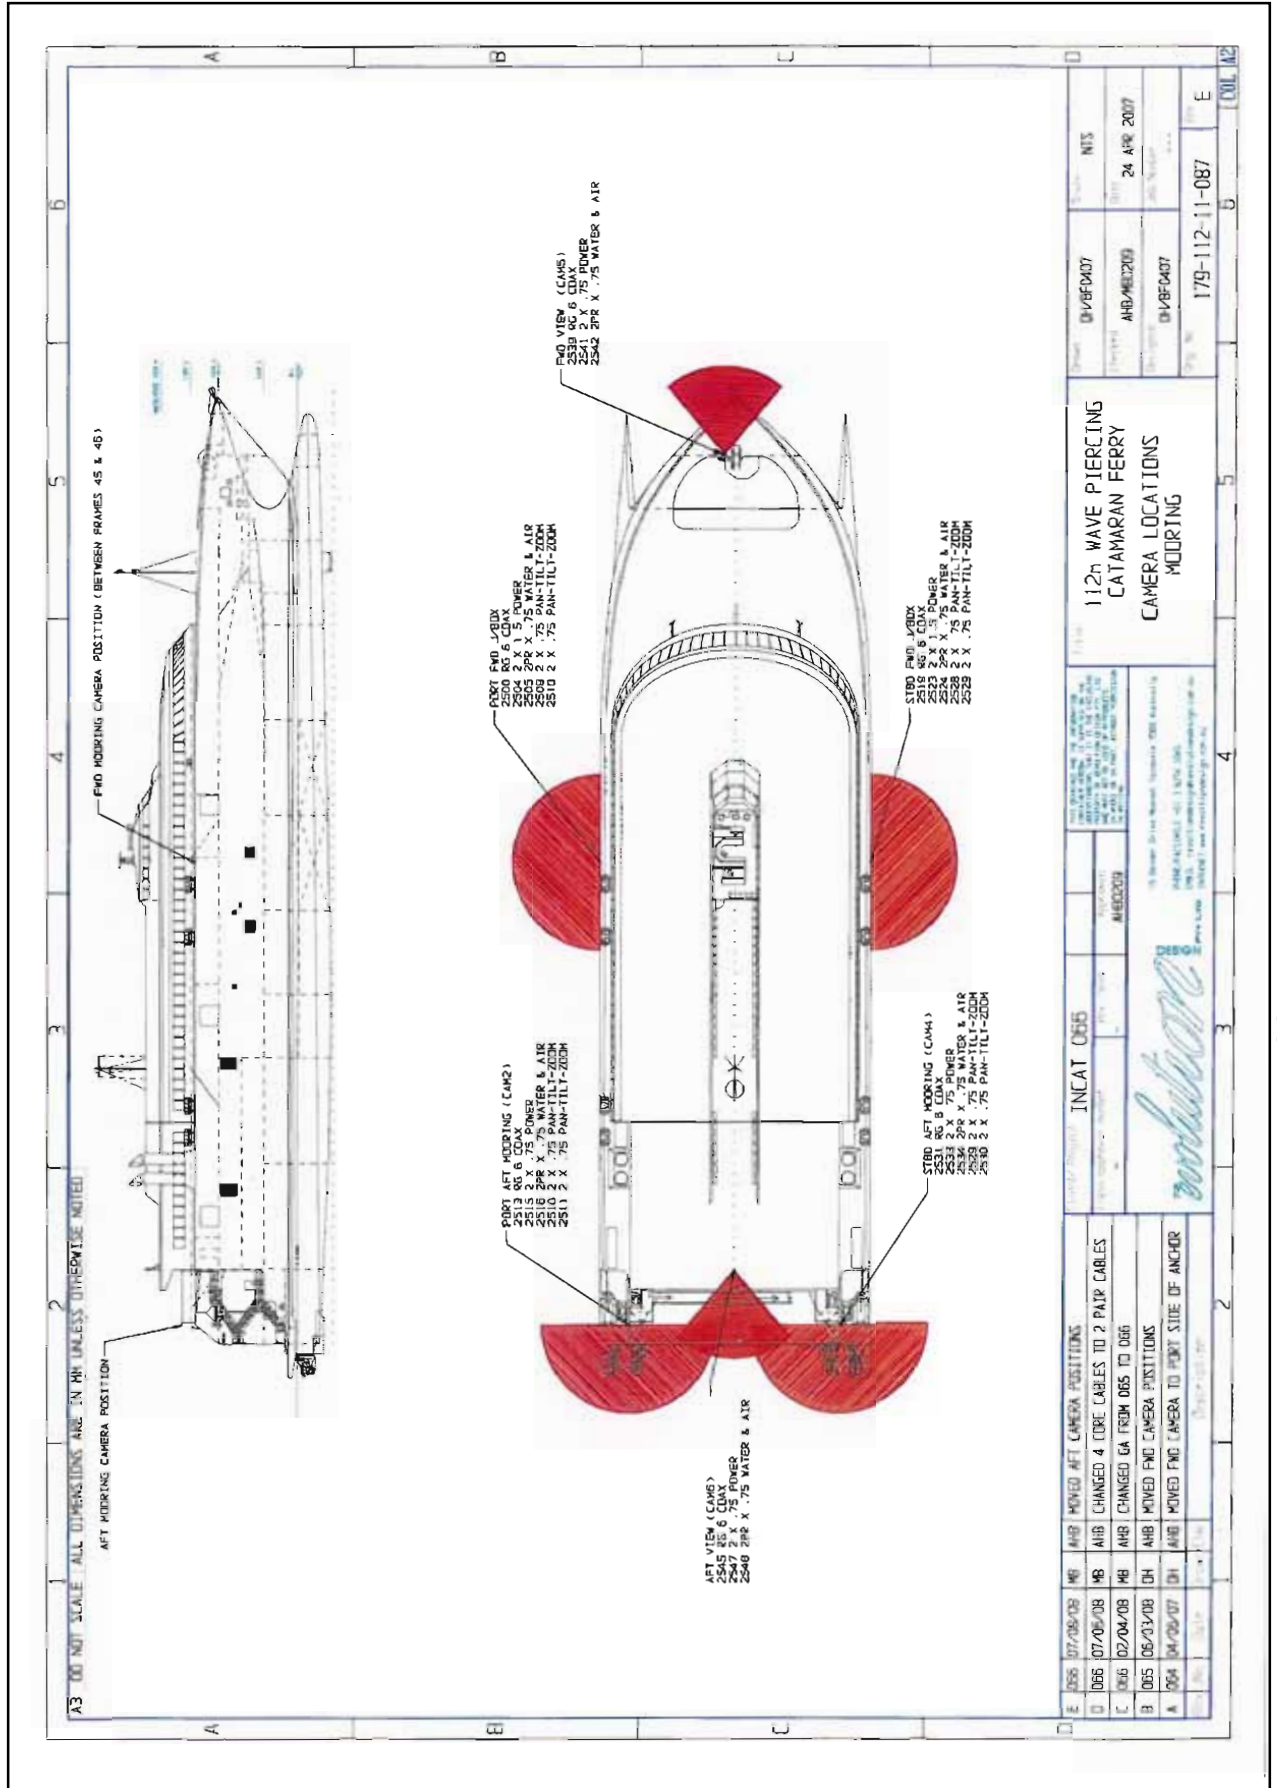
CCTV camera locations
