Report on the investigation of  
contacts made by the  
high speed craft

***Norman Arrow***

with quays in Portsmouth International Port,

**Report No 7/2011  
May 2011**

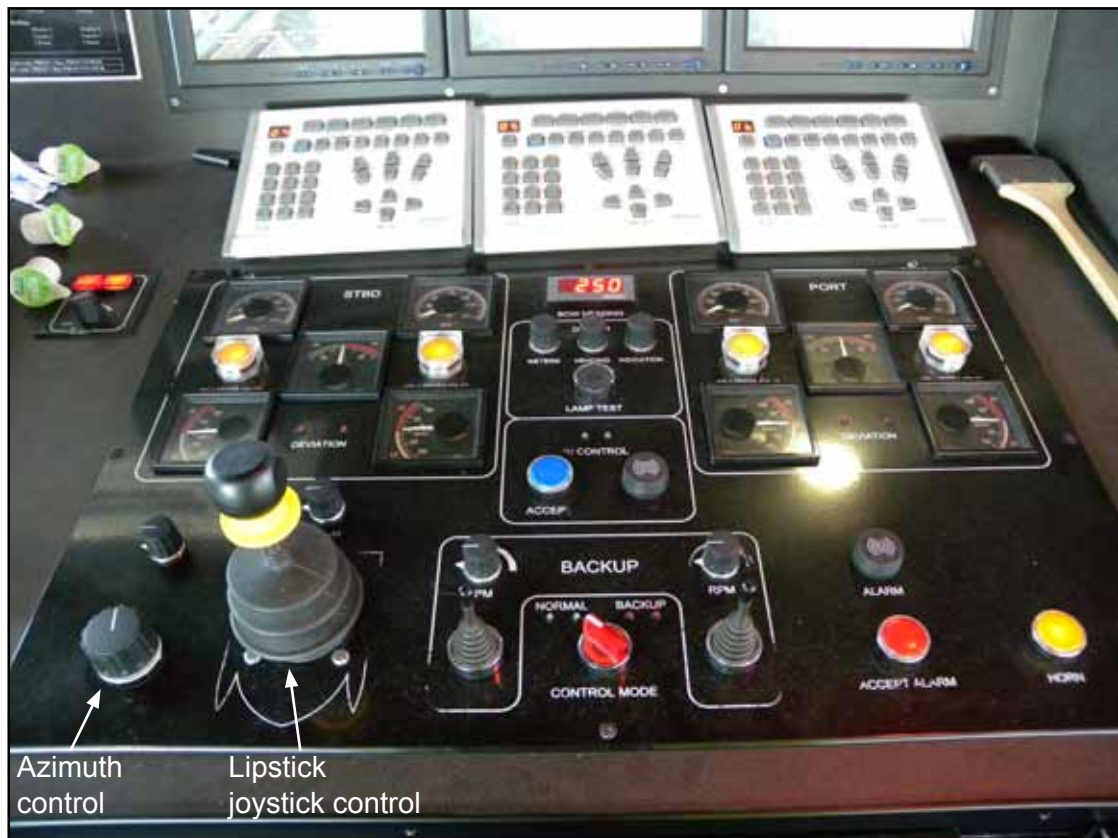
Figure 2

For the move, the master stood at the manoeuvring station (**Figure 2**), from where he was able to see the vessel's sides and stern via closed circuit television (CCTV) monitors. The chief officers and pilot stood close to the master, with the pilot standing on the outer edge of the group. The aft lines were let go at 1617, and 1 minute later the master ordered the forward lines to be cast off.

Manoeuvring station - *Norman Arrow*

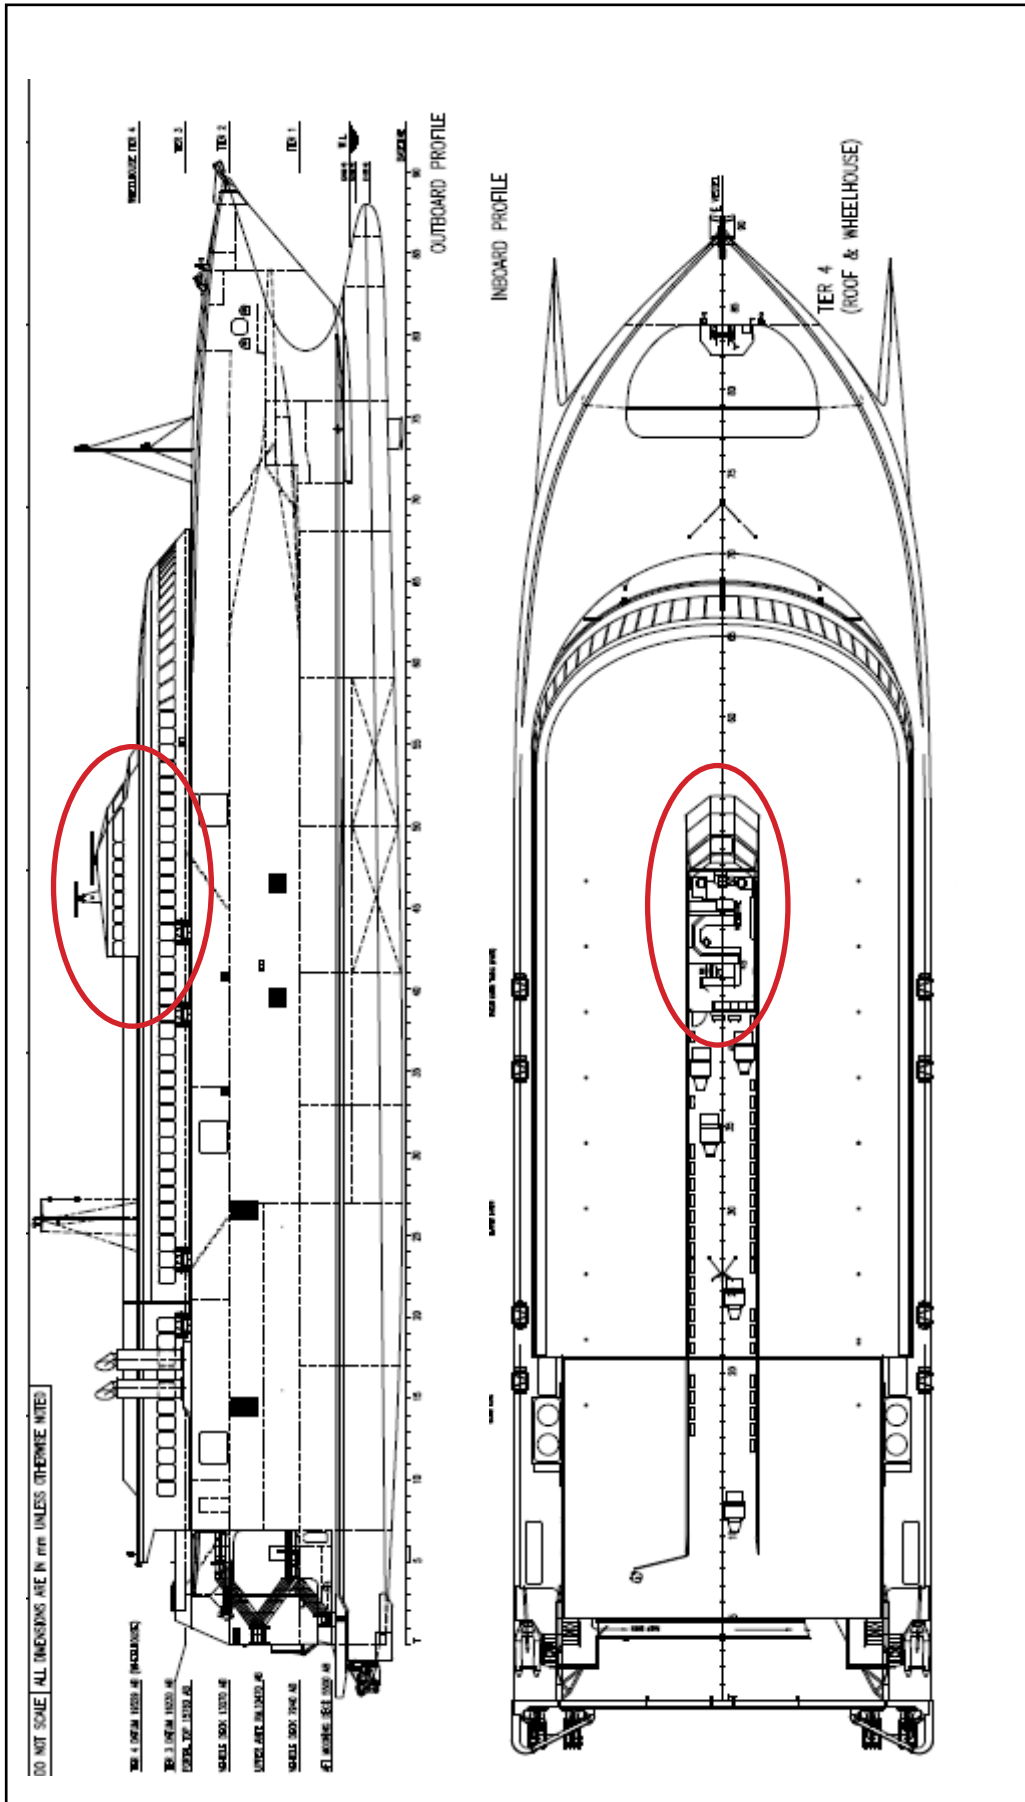
Figure 9

*Norman Arrow*'s bridge was located on the centreline above the passenger accommodation (**Figure 9**). The bridge was fully enclosed and, unlike a conventional ferry, did not have bridge wings extending to the vessel's sides. From within the bridge, an all round 360° view was possible, but the view of the sea surface close to the vessel was obscured by her superstructure (**Figure 10**).

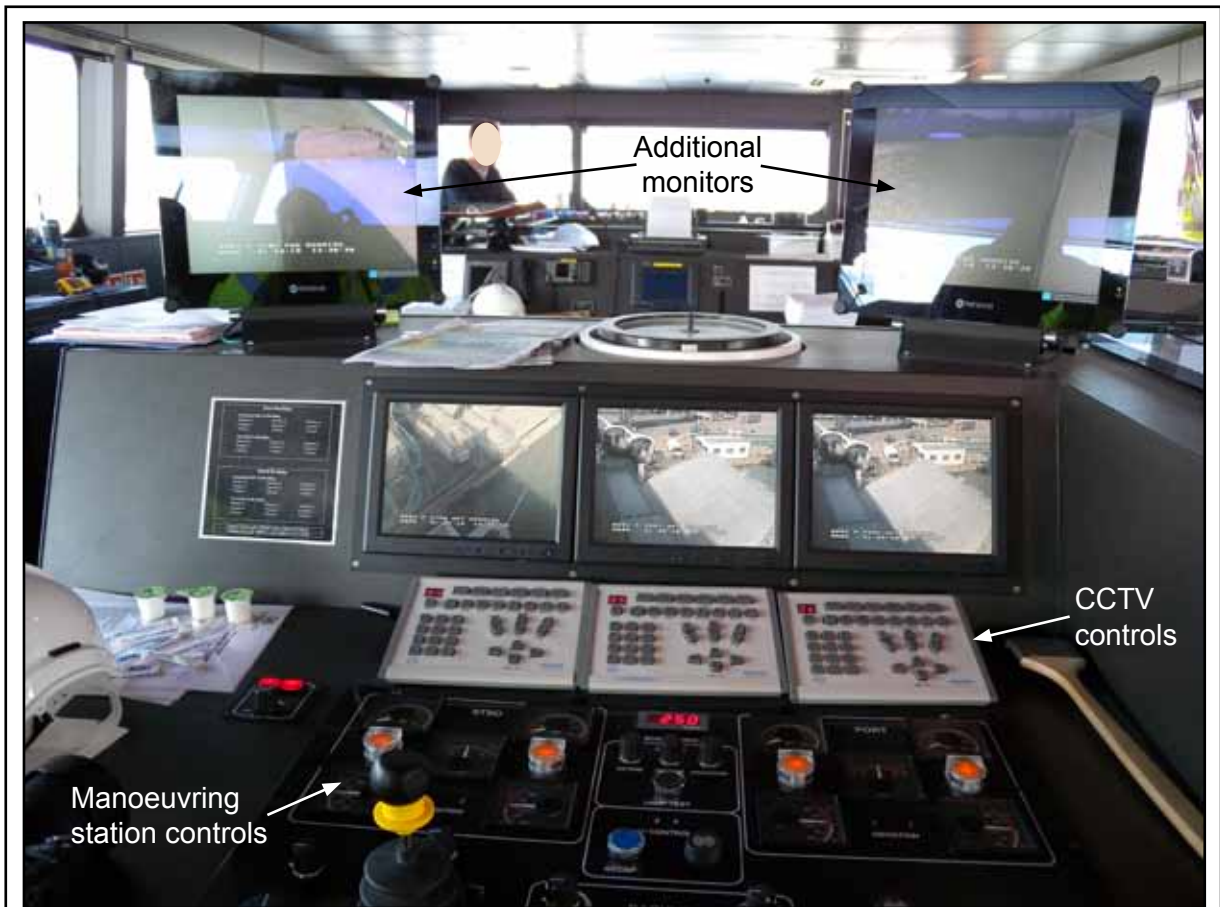
Two control stations were used to manoeuvre *Norman Arrow*. The "at sea" station was forward-facing and sited on the centreline of the vessel (**Figure 11**). The "manoeuvring" station was aft-facing and was sited immediately abaft the "at sea" station. *Norman Arrow* was fitted with a CCTV system that allowed personnel at the manoeuvring station to monitor the areas around the vessel's sides and stern, but not the forward prows. The CCTV system had seven cameras (**Figure 12**). It was originally provided with three CCTV monitors, but two additional CCTV monitors were fitted by Louis Dreyfus Armateurs at the request of the vessel's masters. **Figure 13** shows the location of the pan and tilt cameras and their viewing areas; however, it was not possible to view the whole of the indicated arcs at the same time and the vessel's masters had their own preferences for the positioning of the cameras when manoeuvring close to berths.

CCTV monitors from different heights of eye

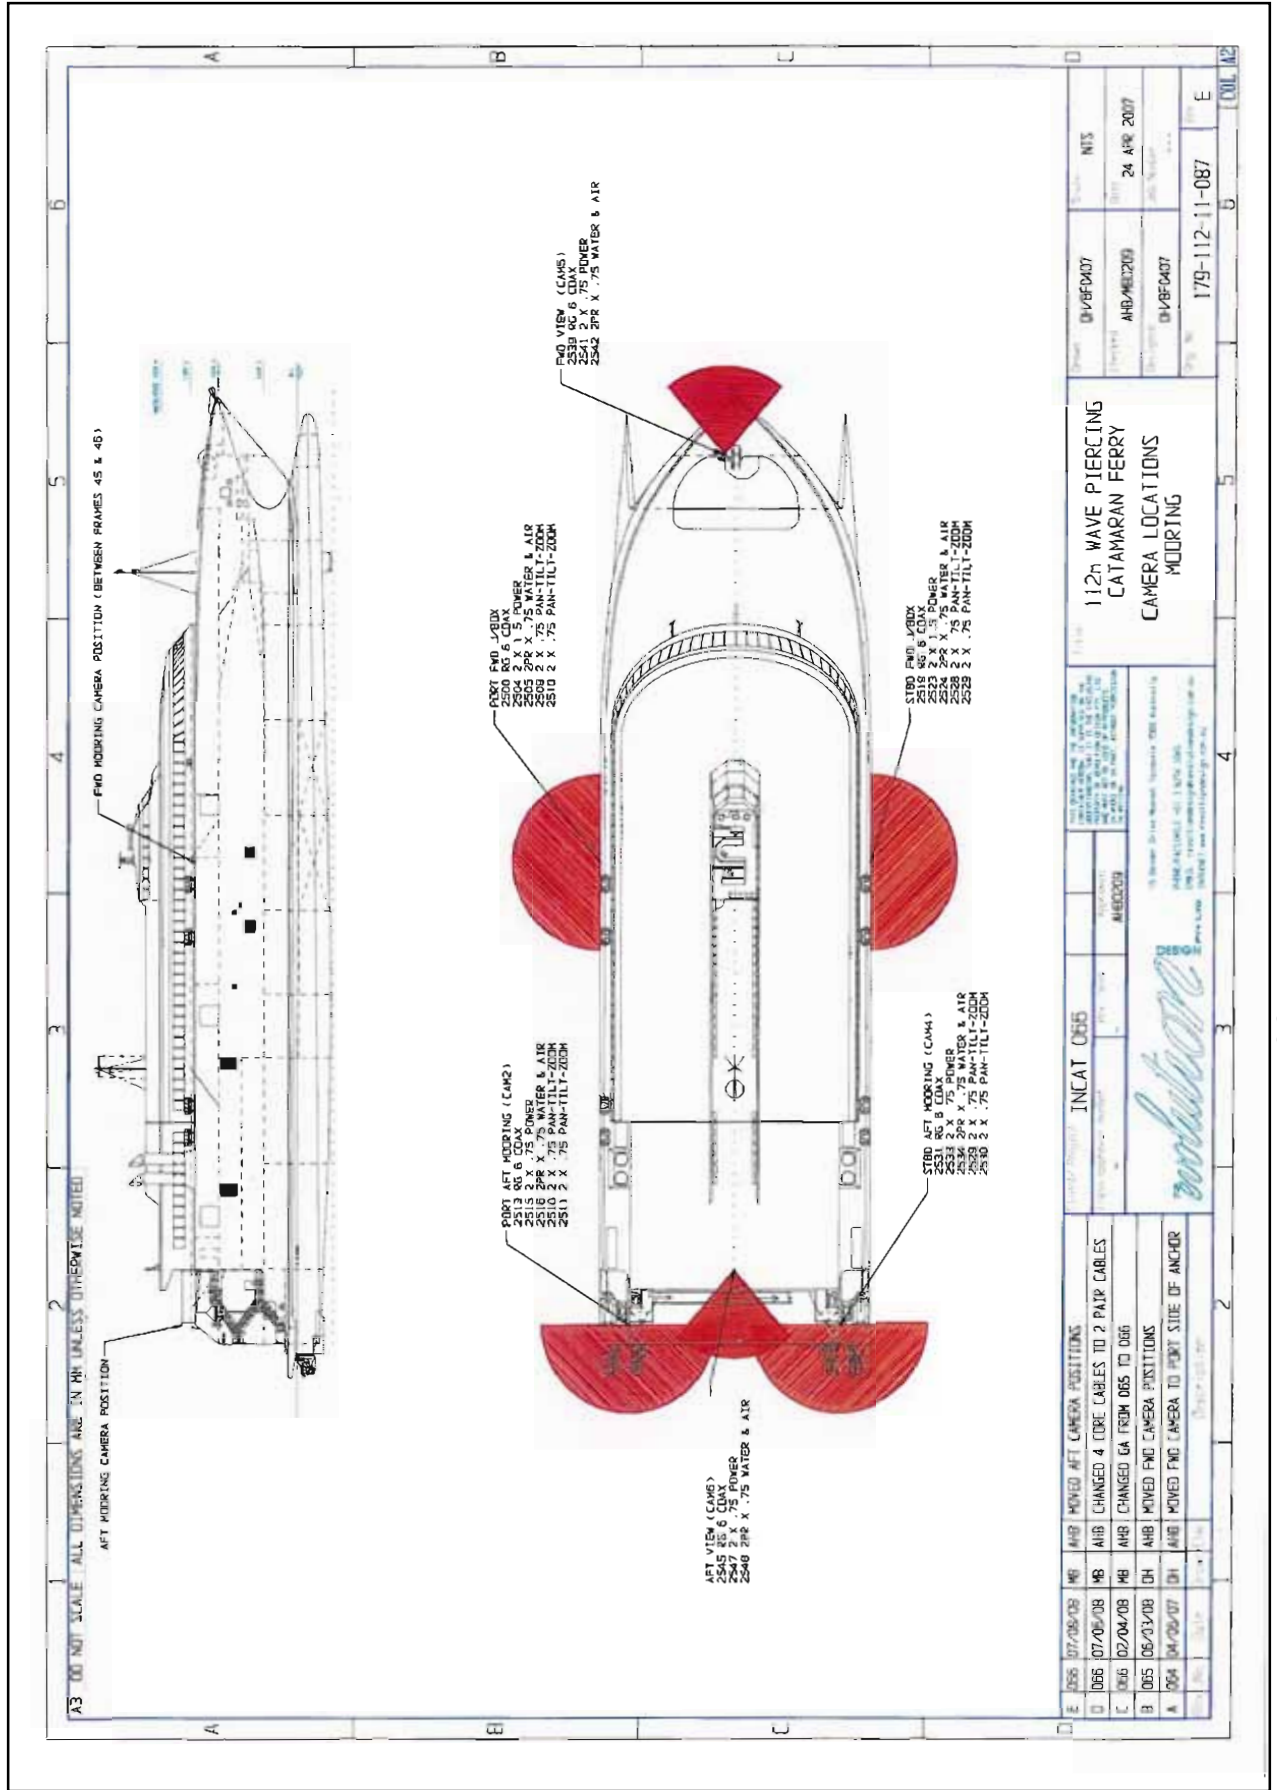
CCTV camera locations

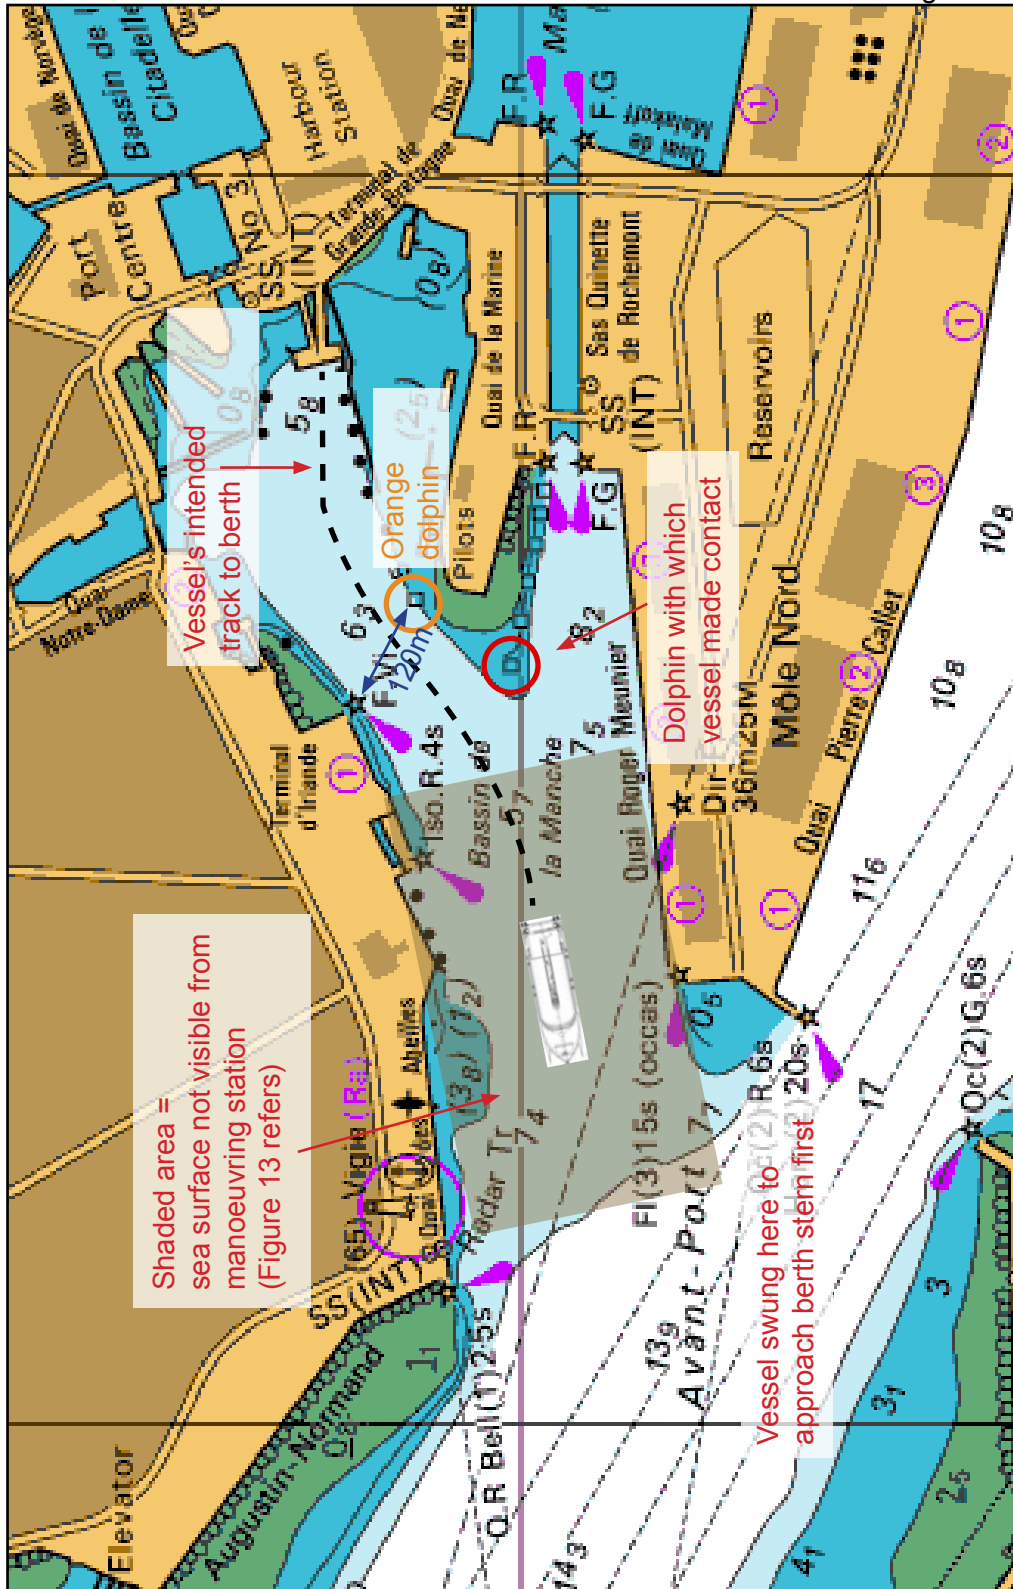
Figure 17

Le Havre port

The master moved to the manoeuvring station (**Figure 2**) and then commenced turning *Norman Arrow* to port. He was navigating the vessel by monitoring visual marks on the shore and by occasionally looking over his shoulder at the ECDIS and radar. By 1122, the vessel had turned through 180° and was moving stern-first towards her berth (**Figure 17**).

One minute later, when *Norman Arrow* was travelling at a speed of 3.2 knots astern, the bosun reported that the vessel's stern was about 100m from the first orange dolphin (**Figure 17**). Two minutes later, the bosun reported that the vessel was about 8m from the orange dolphin (**Figure 18**). The chief officer advised the master that the vessel was being set down onto the dolphin by the wind. The master stopped the astern thrust and gave a short thrust ahead. He then announced that he would vector the jets (**Figure 15**) to move the vessel bodily to starboard.
