Rail Accident Investigation Branch

# RAIB Bulletin 01/2014

## Engineering train collision at Kitchen Hill, near Penrith, 12 January 2014

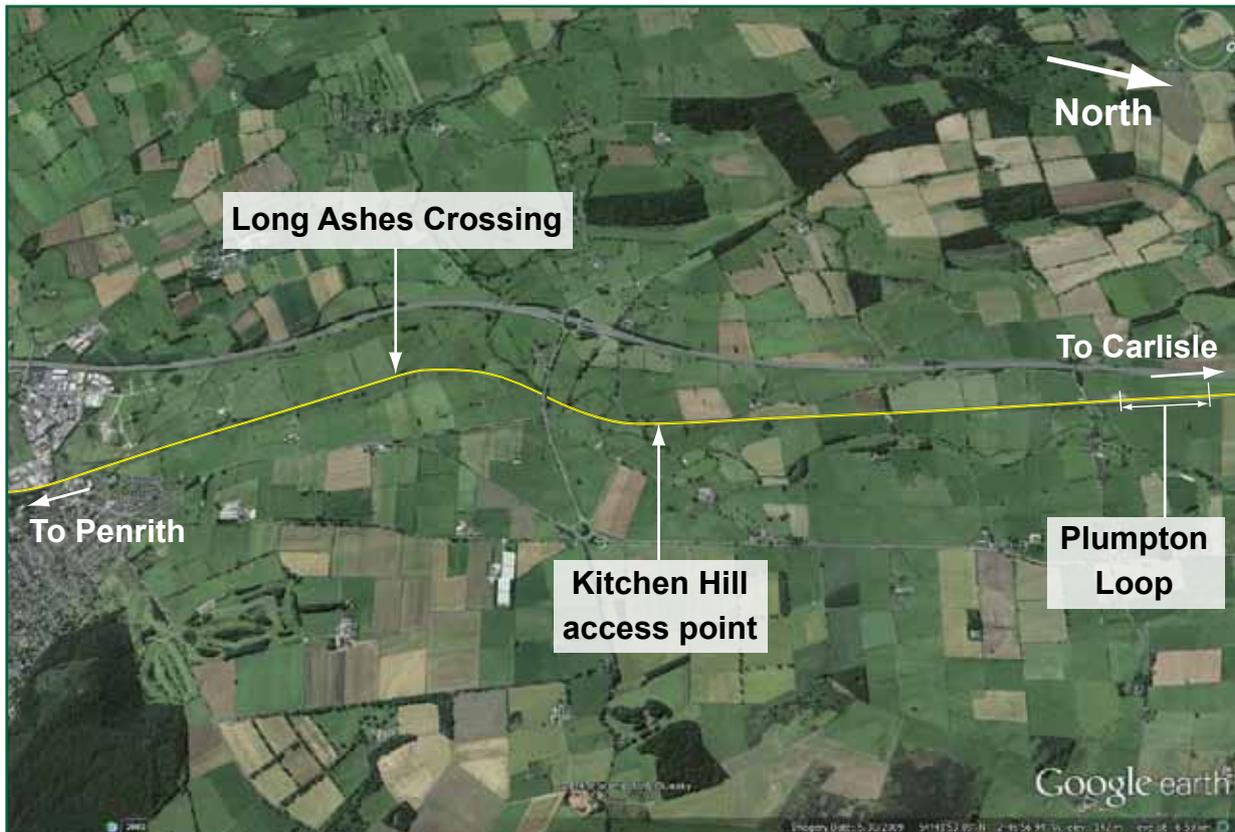
Figure 4: West Coast Main Line north of Penrith

- 18 Records from the OTDR on locomotive 66061 show that train 6L42 departed from platform 1 at 13:16 hrs and travelled at around 7 mph (11.3 km/h) for 0.3 miles (0.5 km) (past where the signalling staff were working); it then accelerated to a maximum speed of 28.6 mph (46 km/h). Near Long Ashes crossing is the start of a reverse curve, the railway turning first to the right and then to the left, after which, at Kitchen Hill access point, it continues straight for around three kilometres to Plumpton Loop (figure 4). On passing through the second (left-hand) curve at around 28 mph (45 km/h), according to the driver, he was surprised to see the rear of train 6L43. Although he had already started to brake for Plumpton Loop, he realised he was unlikely to stop before hitting the train in front and, at 13:25:07 hrs, he operated the emergency brake plunger.
