Rail Accident Report

Passenger train collision at Norwich 21 July 2013

Report 09/2014
May 2014

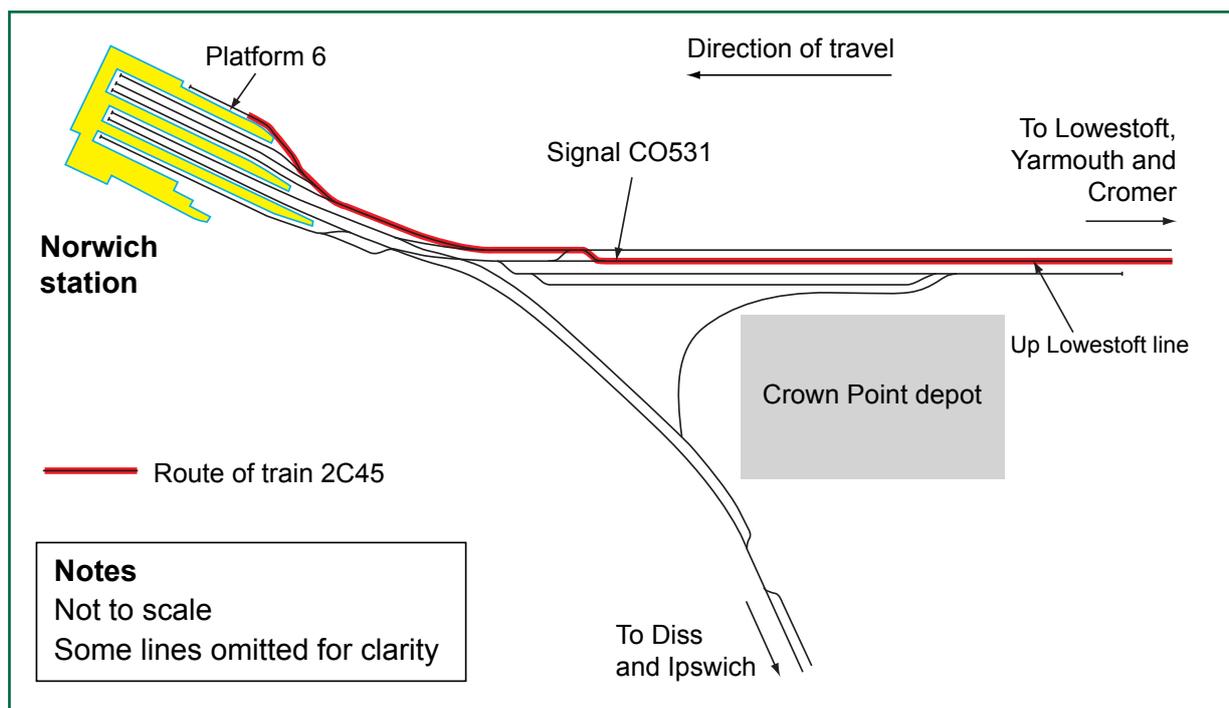
Figure 4: Schematic diagram showing location of accident and route of train 2C45

- 13 Signals in the Norwich area are mainly 2 or 3-aspect colour light signals. Train movements within the area are controlled by Network Rail's signal box at Colchester (51 miles 52 chains from London Liverpool Street via Chelmsford) using the *track circuit block* method of train working.
- 14 The driver of a train approaching the station from Great Yarmouth on the *Up* Lowestoft line is informed at signal CO531 whether the section ahead of him (in this case up to the buffer stops at the end of the line) is either occupied by train(s) or not. Signal CO531 is located 712 metres from the bottom of the *ramp* of platform 6 (figure 4).

- 24 Norwich station is located close to Crown Point train maintenance depot (figure 4). Crown Point depot is operated by Greater Anglia and is used to maintain and prepare its trains.
