Rail Accident Investigation Branch

Rail Accident Report

Near-miss at Llandovery level crossing, Carmarthenshire 6 June 2013

Report 11/2014
May 2014

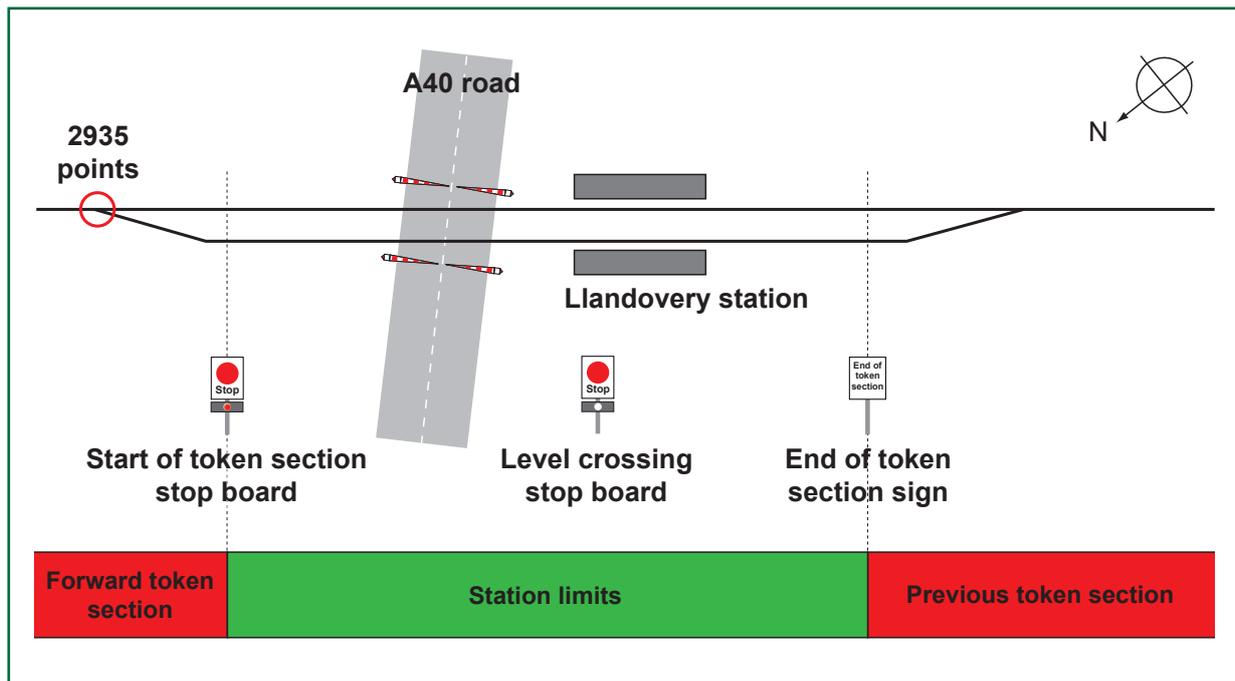
Figure 8: The station limits and single line sections at Llandovery (not to scale)

- the level crossing stop board was located outside the token section (figure 8);
 - it was considered that combining the two stop boards would reduce the usable length of the loop line at Llandoverly from about 400 metres long to around 300 metres, and this would have an operationally restrictive effect when long freight trains used the route¹¹;
