Rail Accident Investigation Branch

Rail Accident Report

**Passenger trapped in a train door and dragged
a short distance at Newcastle Central station
5 June 2013**

Report 19/2014
September 2014

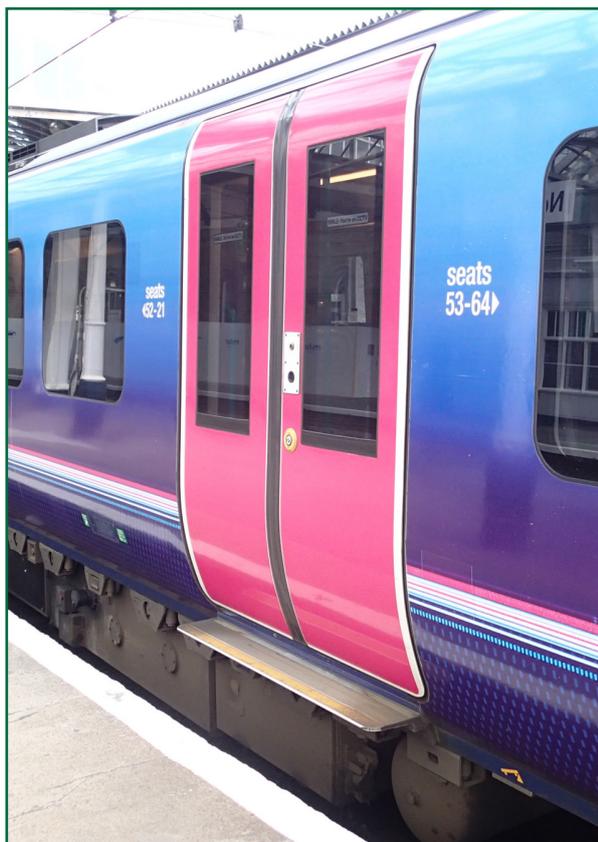
Figure 3: Class 185 double-leaf external passenger door

- 16 Each of the three carriages has two double-leaf passenger doors on each side. Each door leaf is fitted with a rubber leading edge. The leading edges meet in the centre of the doorway forming a seal when the door leaves are closed (figure 3). There is an electrical sensing element within each rubber edge designed to detect obstructions when the leaves are closing. This is known as a sensitive door edge. The control of the doors is such that the door will fully reopen if an obstruction is detected. The operation of the doors is explained more fully in paragraph 47.

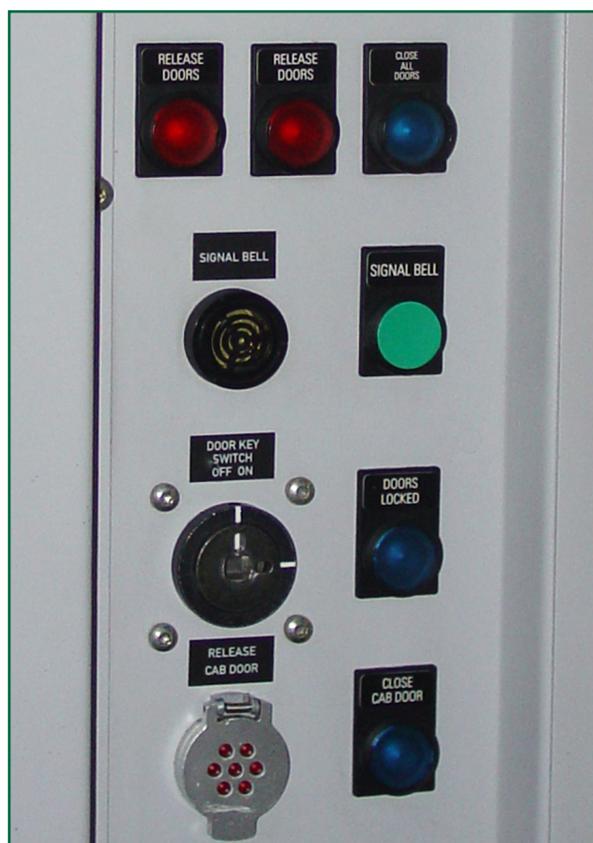
Figure 4: Class 185 rear cab door control panel

- 17 In the cabs of the train are two control panels (one on each side of the train) from which the conductor, when riding in the rear cab, can control the train doors and communicate with the driver (figure 4). The panel has illuminated buttons and indicators which show the status of the train doors. There is a *door key switch* (DKS) on the panel which, when turned to the 'on' position by a key, makes the buttons and indicators active.
- 18 There is a bodyside indicator lamp on each side of every carriage (figure 5). This illuminates orange if the passenger doors on that particular carriage are not closed and locked, and extinguishes if they are. There are also door control panels in the centre carriage known as the guard's operating panel, or GOP. The bodyside indicator lamp will flash on the carriage where the DKS has been turned on to activate the door control panel.

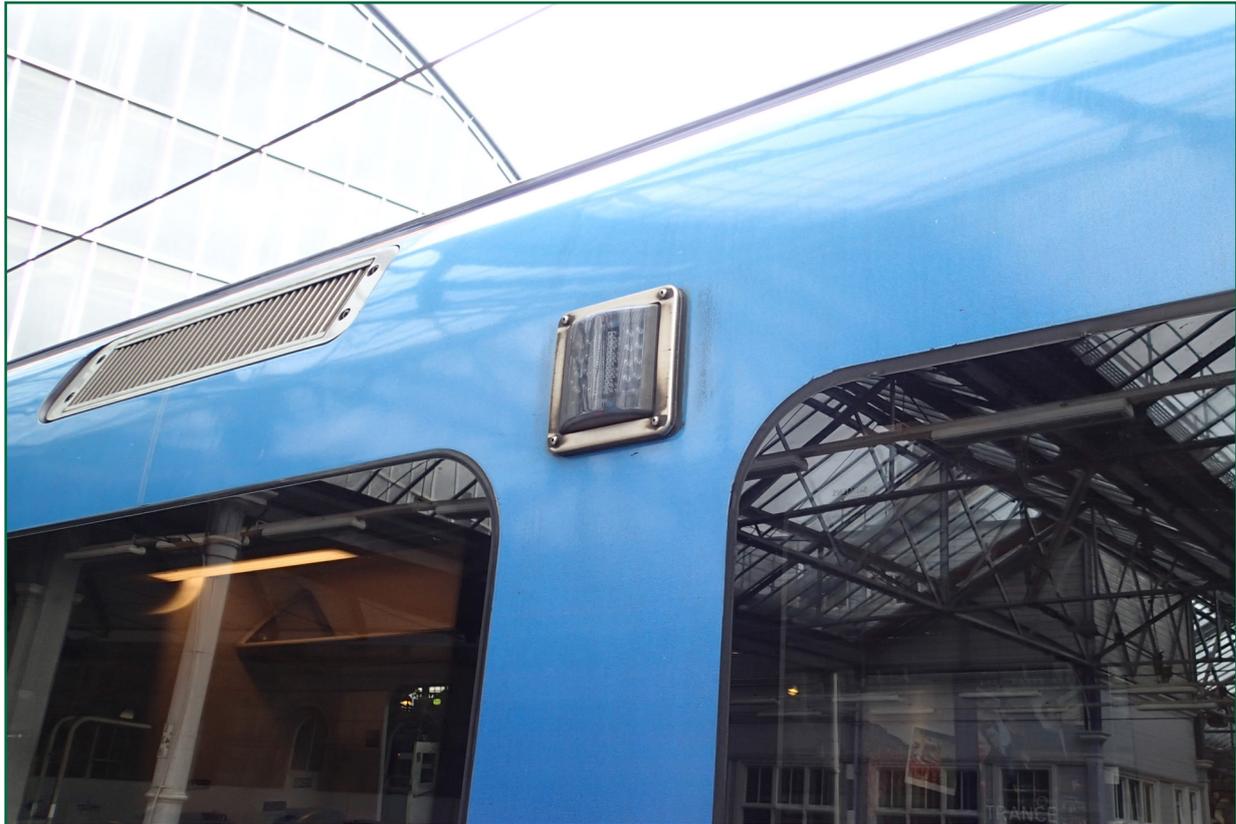
Figure 5: Class 185 bodyside indicator lamp

- g. The conductor should also check the bodyside indicator lamps. When the doors are closed the lamps will be extinguished, except for the one on the rear carriage where the DKS has been turned on and the cab door is open; this will be flashing.

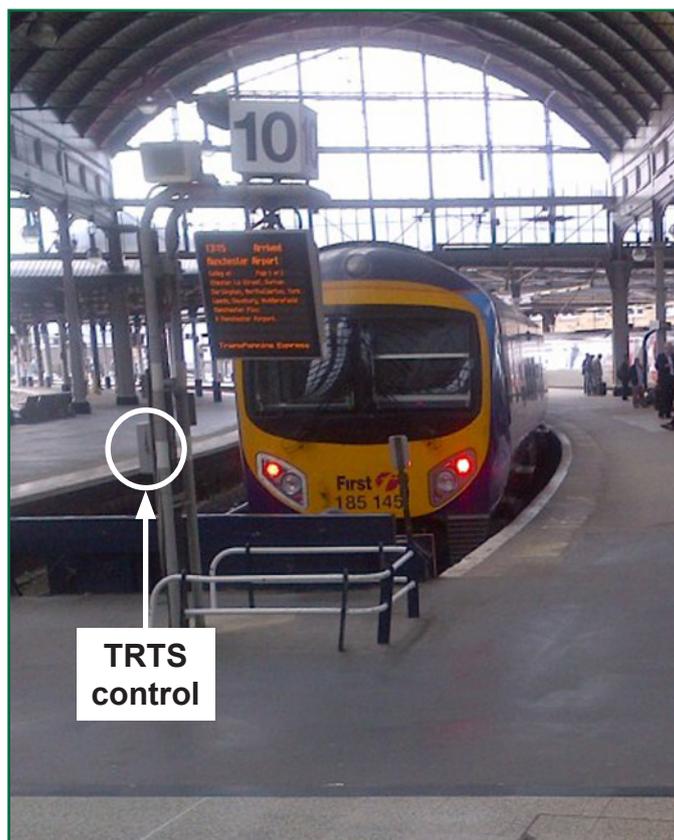
Figure 6: Platform 10 TRTS control (Image courtesy of First TransPennine Express)

- 19 To assist with train dispatch, platform 10 is fitted with a *train-ready-to-start control*, or TRTS (figure 6). The conductor operates this by pressing a button a few minutes before the departure time. This informs the signaller, or the signalling system if *automatic route setting* is in operation, that the train is ready to depart.

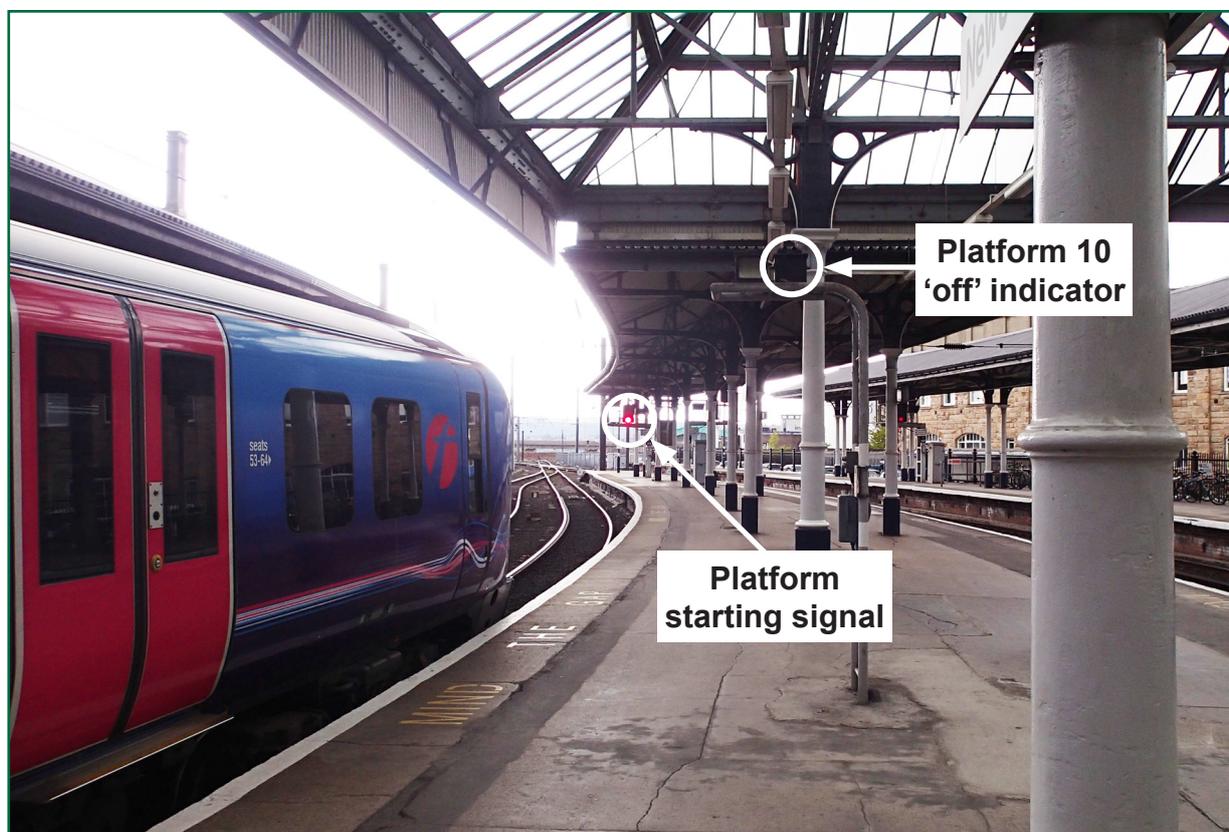
Figure 7: Platform 10 starting signal and 'off' indicator as seen from the rear of front vehicle

- 20 If the route ahead is clear, the signaller or signalling system sets the platform starting signal, which is beyond the front of the train, to a proceed aspect (yellow or green) indicating the train may depart (figure 7). At platform 10, the TRTS control is located on a post close to the terminal end of the platform.

- 21 Approximately two-thirds along the length of the platform from the terminal end, is an '*off*' indicator (figure 7). When illuminated, this informs the conductor that the route ahead is clear for the train to depart. The '*off*' indicator is necessary as the conductor cannot easily see the platform starting signal from the rear of the train because of the curvature of the platform.

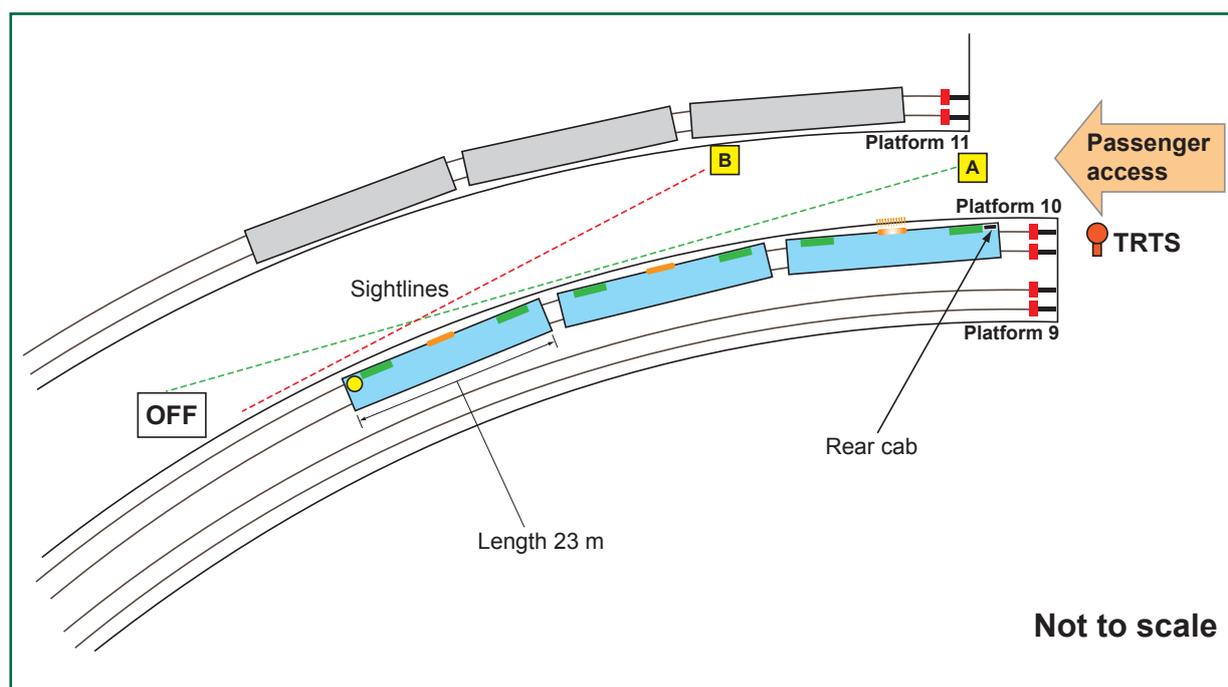
Figure 8: First TransPennine Express model dispatch procedure for self-dispatch from platform 10 from the rear cab

- 44 Figure 8 illustrates FTPE's expected method for conductors dispatching a Class 185 from the rear cab at platform 10 at Newcastle Central. The steps are:
