Rail Accident Investigation Branch

Rail Accident Report

Runaway of a road rail vehicle and the resulting collision in Queen Street High Level Tunnel, Glasgow 21 April 2013

Report 15/2014
July 2014

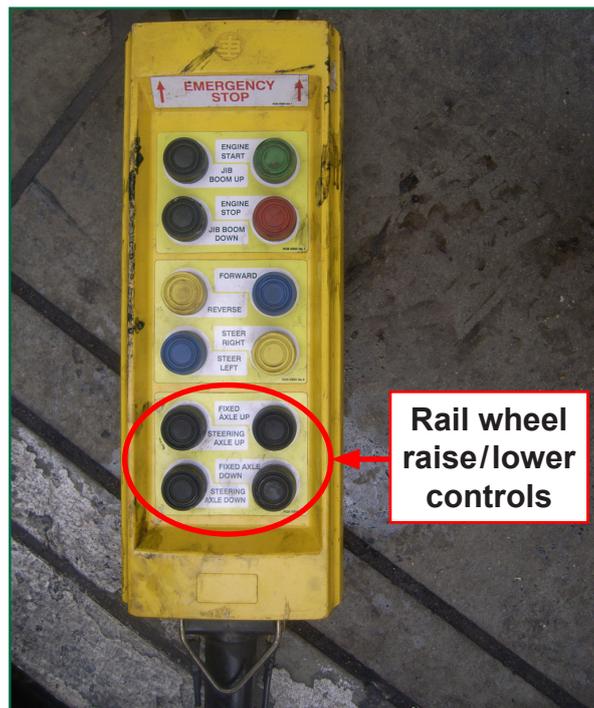
Figure 8: Control pendant

- 39 The machine operator was controlling the RRV during on-tracking using the remote-control pendant, which was connected to it by a cable (figure 8). The machine controller assisted the machine operator in aligning the RRV with the track, having gained permission to on-track from the *engineering supervisor*, who was with the *Plant Operator Licence holder* representative⁴ and near to the RRAP at the time. Neither of these individuals was required to, or did, closely supervise the on-tracking process.

- 42 The RRV engine shut down as it accelerated down the gradient. It is possible that this was because the operator stopped the engine, or that vibration or damage from the pendant bouncing along the track disturbed either the engine stop or emergency stop pushbutton contacts (paragraph 70).

- 74 The damage sustained by the control pendant meant that it was not possible to ascertain its condition before the accident. Witness evidence indicates that the machine operator had not had any problems in operating the rail wheels prior to the runaway. In addition, the RRV controls were found to be operating correctly after the accident (when operated with a replacement control pendant).

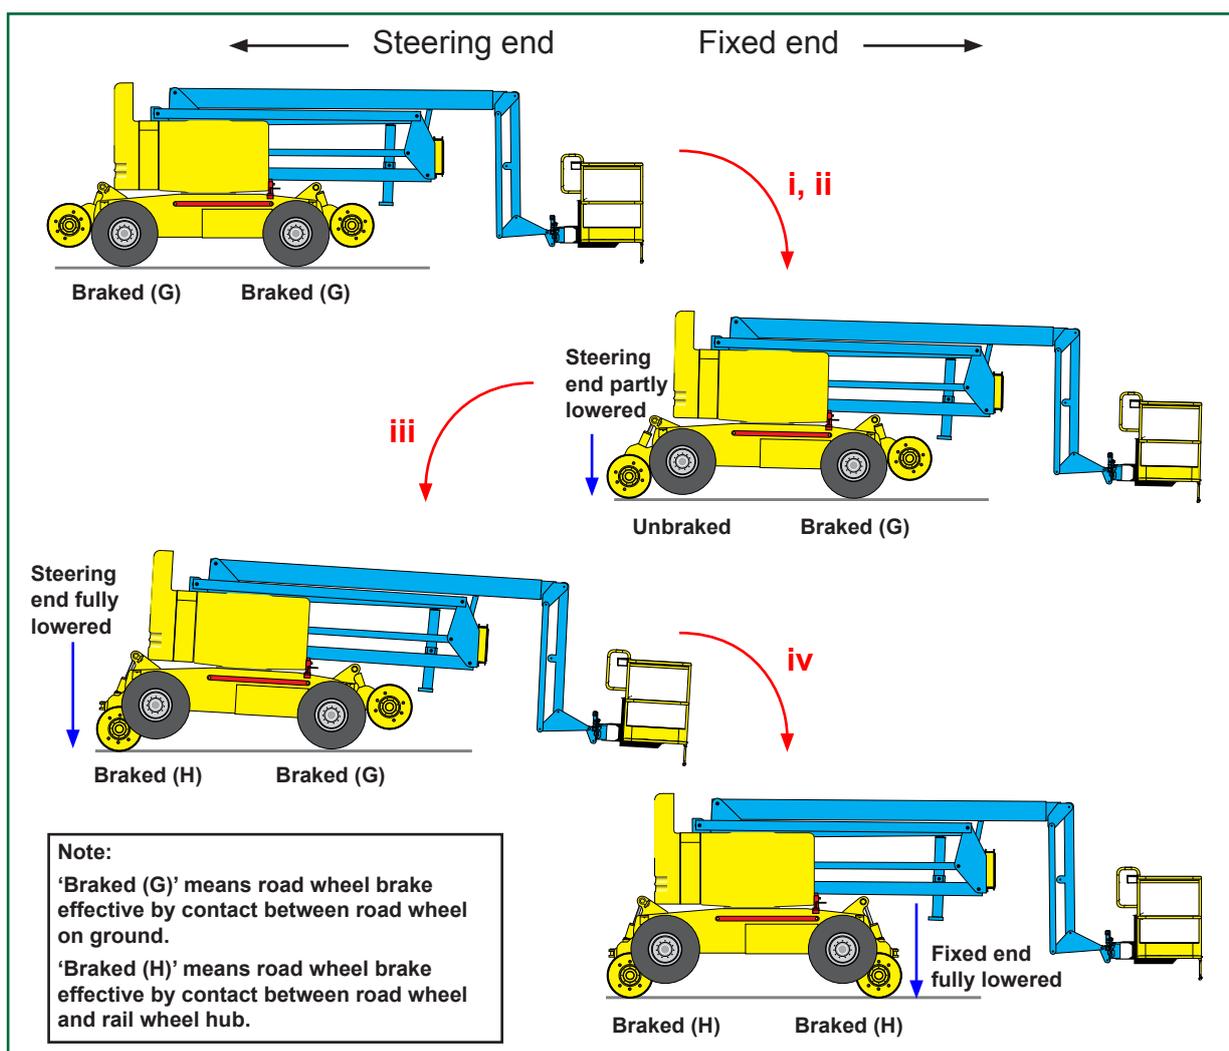
Figure 10: Rexquote operation and maintenance manual on-tracking procedure

- 60 A procedure for on-tracking the RRV was described in the Rexquote operation and maintenance manual and in the cab instructions which were kept on the RRV. This procedure was as follows (illustrated in figure 10, showing which road wheels are providing braking at each stage):

- iii. ensure that the steering end road wheels are straight, then fully lower the steering end rail wheels so that the road wheels come into contact with the rail wheel hubs; then

- iv. fully lower the fixed end rail wheels to lift the road wheels from the ground and into contact with the rail wheel hubs.

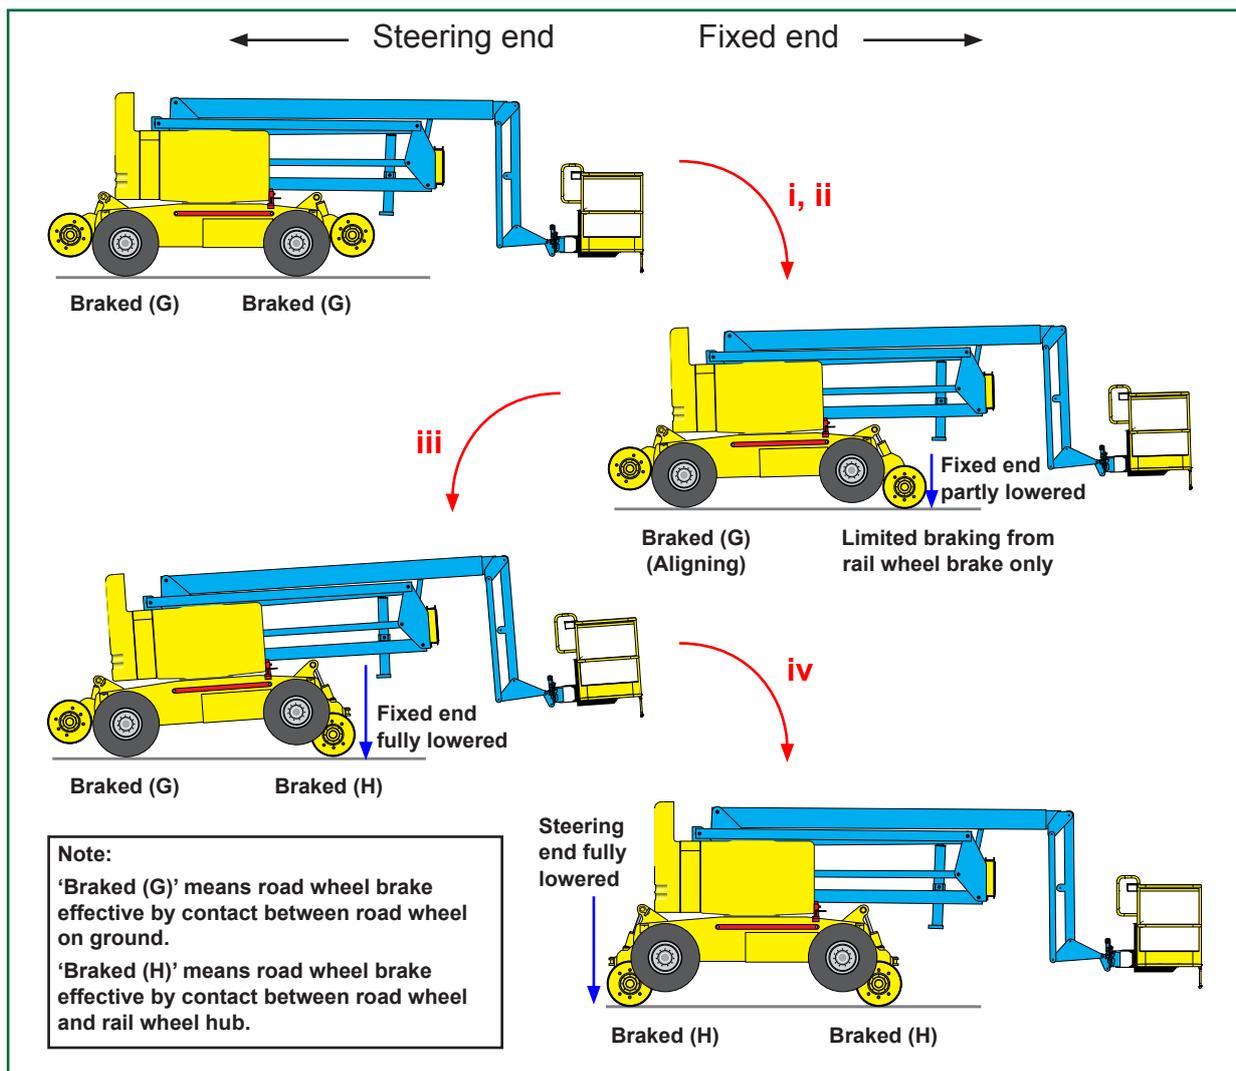
Figure 11: TXM Plant on-tracking procedure

61 TXM Plant considered that this procedure was flawed because, in the second step, manoeuvring the RRV to align the steering end rail wheels with the track would normally disturb the alignment of the fixed end rail wheels. As a result, TXM Plant adopted a revised on-tracking procedure, which had been briefed to all of its operators and incorporated into their training and assessments. This procedure was used for all of the high rise RRVs that TXM Plant operate, and was as follows (illustrated in figure 11):

- i. manoeuvre the RRV so that the fixed end rail wheels are in line with the track, and lower the fixed end rail wheels part way to lift the fixed end road wheels from the ground (this ensures that the fixed end rail wheels stay aligned with the track during alignment of the steering end);
- ii. manoeuvre the RRV so that the steering end rail wheels are in line with the track;
- iii. fully lower the fixed end rail wheels so that the road wheels come into contact with the rail wheel hubs; then
- iv. ensure that the steering end road wheels are straight, before fully lowering the steering end rail wheels to lift the road wheels from the ground and into contact with the rail wheel hubs.

- 62 RAIB considers that the TXM Plant procedure was more practical to implement than the Rexquote procedure, because it kept the fixed end aligned with the track while the steering end was being aligned (paragraph 61), and that it was no less safe. Neither of these two procedures relied on the correct operation of the rail wheel holding brake.

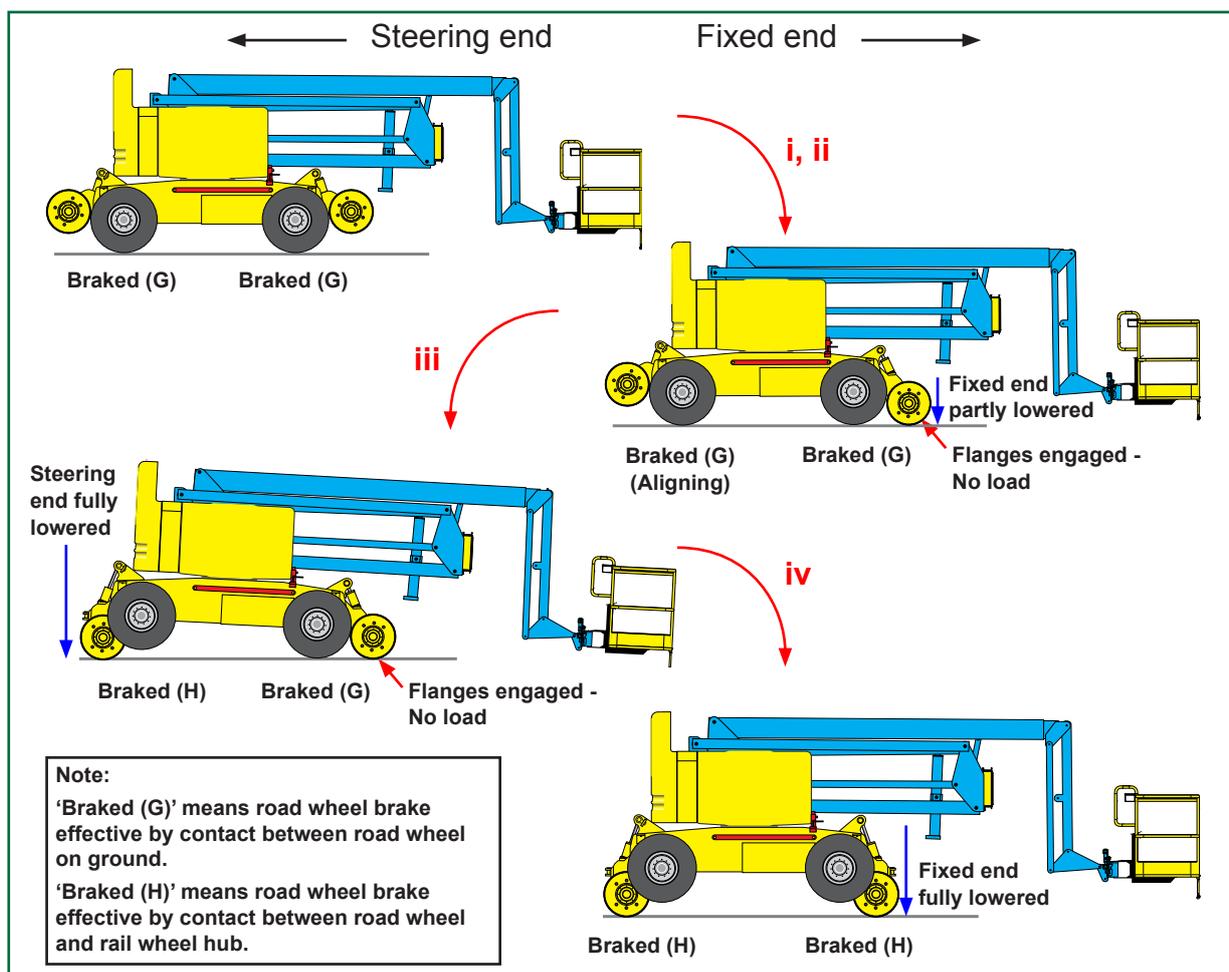
Figure 12: On-tracking sequence intended by machine operator

- 63 Witness evidence indicates that the machine operator was attempting to on-track the RRV in a sequence that was different from that specified in both the Rexquote and TXM Plant procedures. He reversed the third and fourth steps of the TXM Plant procedure, and his intended sequence was as follows (illustrated in figure 12):

- ii. manoeuvre the RRV so that the steering end rail wheels are in line with the track;
 - iii. ensure that the steering end road wheels are straight, before fully lowering the steering end rail wheels so that the road wheels come into contact with the rail wheel hubs; then

- iv. fully lower the fixed end rail wheels to lift the road wheels from the ground and into contact with the rail wheel hubs.

64 If done correctly, this procedure did not rely on the rail wheel holding brake to prevent movement of the RRV. However, this procedure relied on the machine operator accurately positioning the fixed end rail wheels during stage i, so that they were not taking any weight. On the night of the accident, the machine operator unintentionally put the RRV into the position where only the holding brake was acting to prevent movement, as follows (illustrated in figure 13):

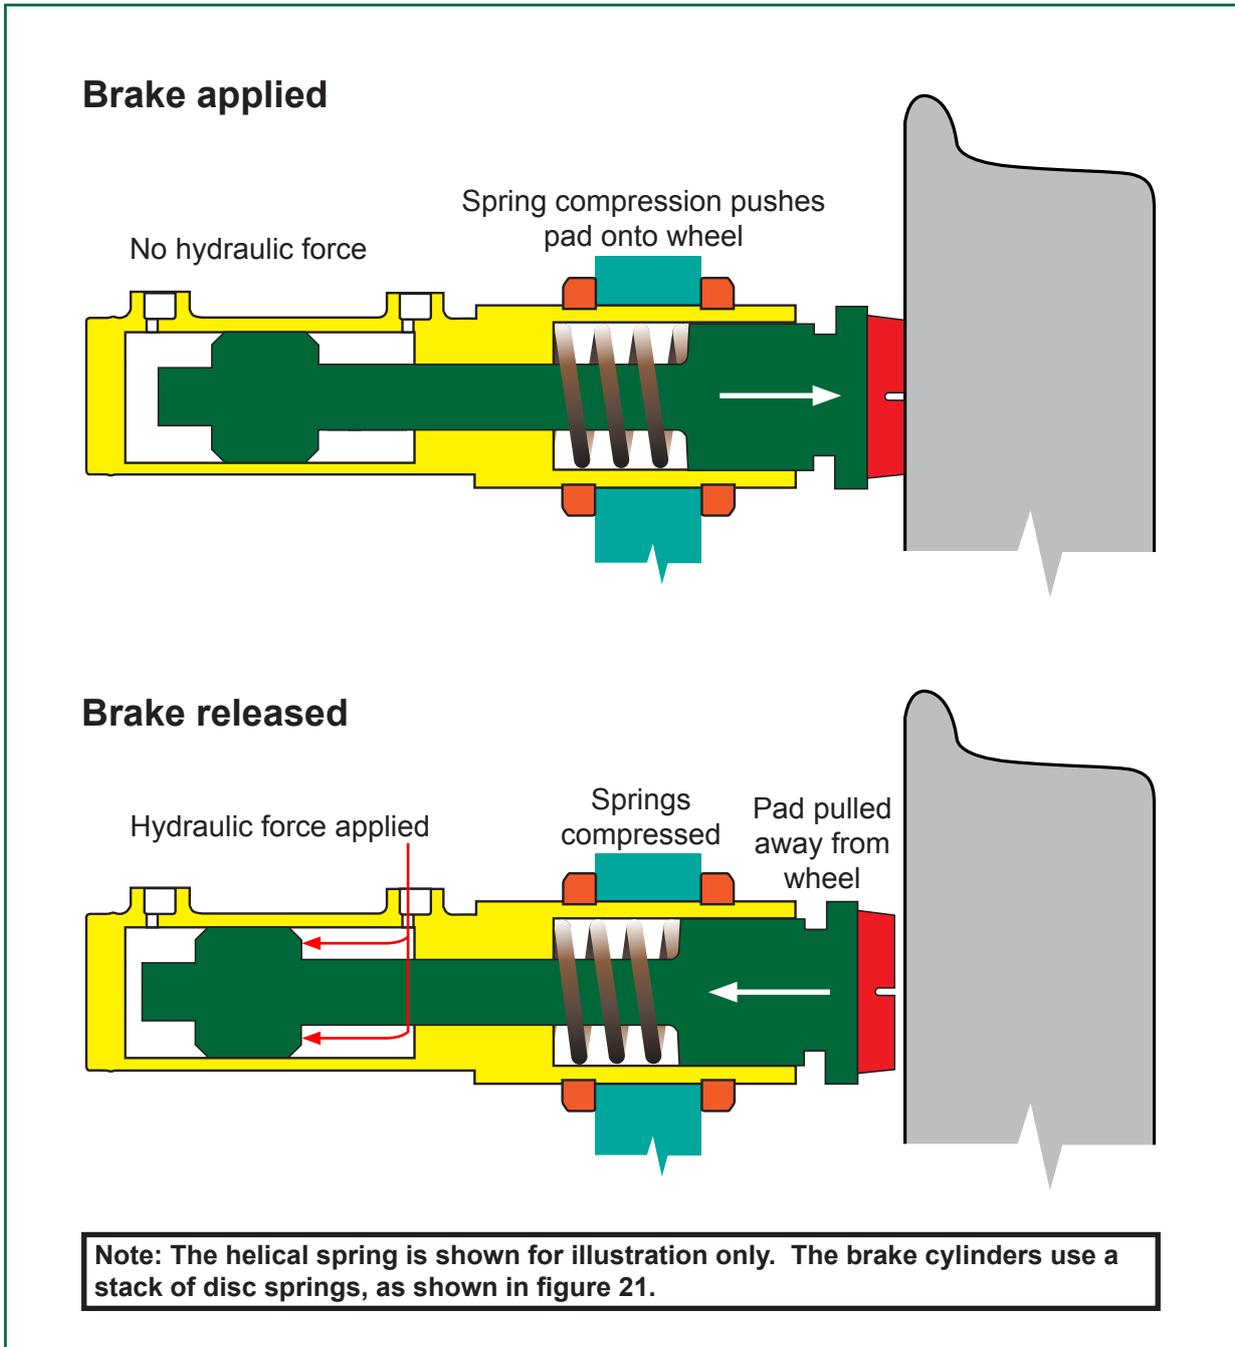
Figure 14: Sketch showing operation of the rail wheel holding brake cylinder

- 84 The RRV rail wheel holding brake is provided by two brake cylinders, one operating on each of the two fixed end rail wheels. There is no rail wheel holding brake fitted to the steering end rail wheels.
- 85 Each rail wheel holding brake cylinder contains a spring assembly which pushes a brake pad against the inside face of the rail wheel (figure 14). Friction between the brake pad and the wheel causes a brake retarding force, which is dependent on the magnitude of the force applied by the spring assembly, and on the coefficient of friction between the brake pad and the rail wheel. The force applied by the spring assembly is related to the amount by which it is compressed. The brake retardation force is released by operation of a hydraulic piston which applies a fixed force to pull the brake pad away from the rail wheel, thus compressing the spring assembly⁹.

⁹ Note that the available hydraulic force is less than that required to fully compress the spring assembly.

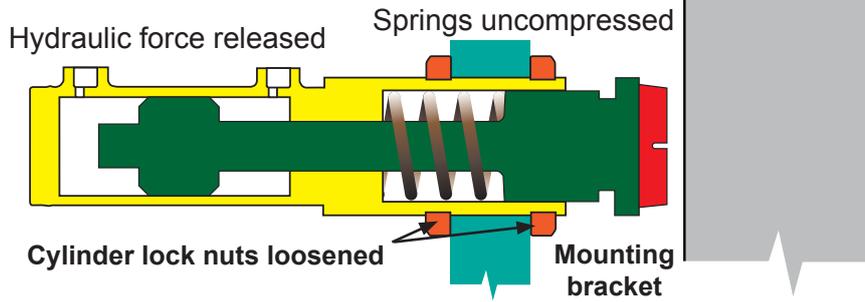
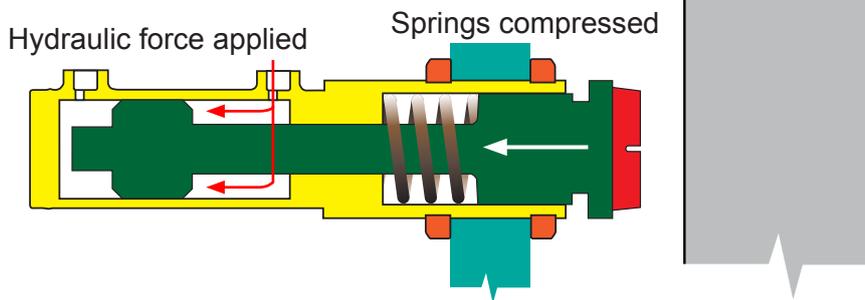
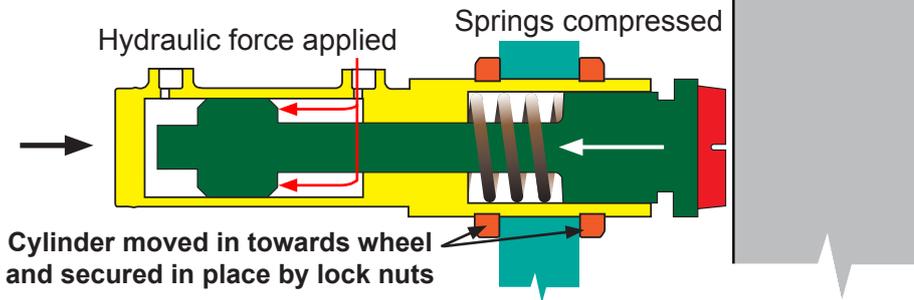
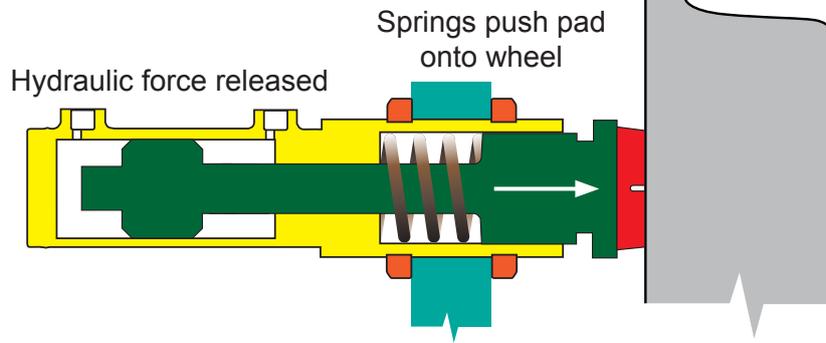
Figure 15: Sketch showing a practical optimal setup procedure for the rail wheel holding brake cylinders

- 86 In order to maximise the available braking force, the cylinders need to be positioned relative to the rail wheels so that the maximum practical spring compression is present when the brake is applied. This is described as the optimal position in this report¹⁰. The maximum practical spring compression is limited by the force that the hydraulic piston applies to compress the springs. This is because the hydraulic force must overcome the spring force to release the brake. A practical way of achieving the optimal brake cylinder position is to set them up as follows (figure 15):

¹⁰ The spring compression associated with the optimal position for the left-hand brake cylinder would have been different from that for the right hand brake cylinder because its springs were assembled incorrectly (paragraph 112).

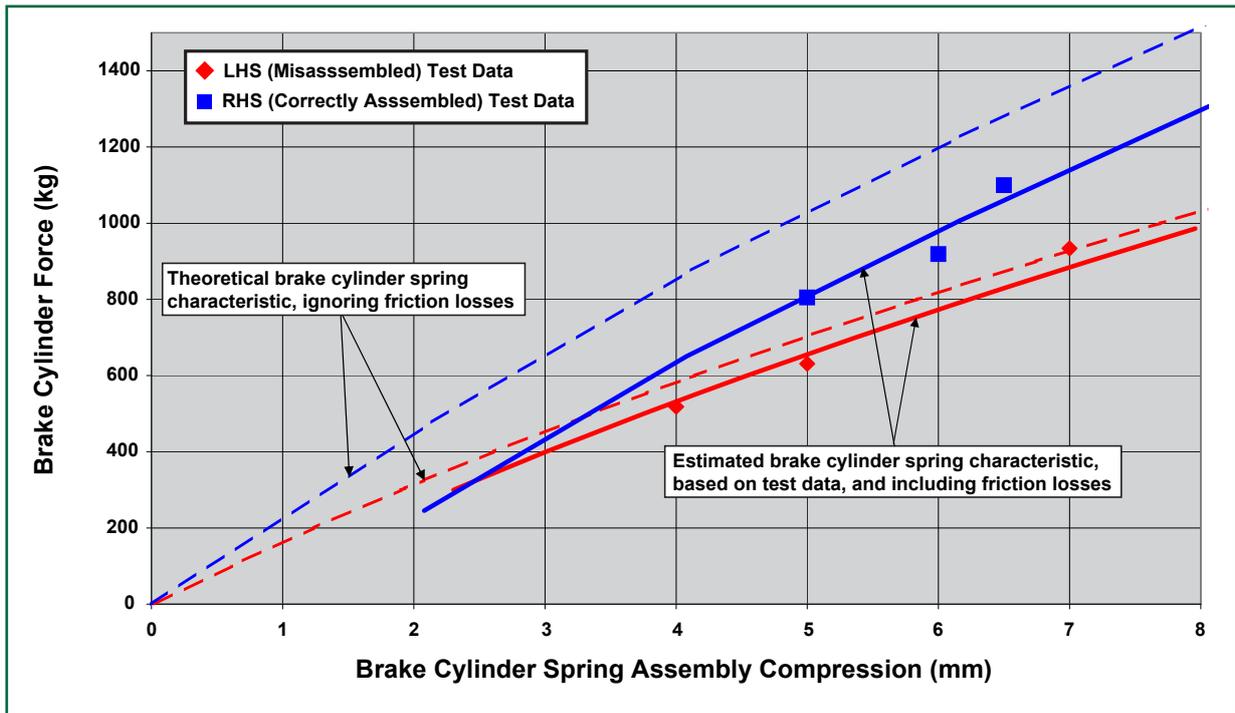
Figure 19: Rail wheel holding brake cylinder spring characteristics

- i. manoeuvre the RRV so that the fixed end rail wheels are in line with the track, but do not lower the rail wheels into contact with the rails;
 - ii. manoeuvre the RRV so that the steering end rail wheels are in line with the track and lower the steering end rail wheels part way to lift the steering end road wheels from the ground;

- 99 The effect of differing amounts of brake pad wear has been assessed using relationships between compression of the brake cylinder spring stacks and the force applied to the brake pad. These are based on manufacturer's published data for the springs with allowances for misassembly of the LHS spring assembly (paragraph 112) and for friction in the cylinder determined from RAIB testing (figure 19 and appendix D).

- 100 The effect of pad wear is shown in figure 20, assuming a layer of surface rust on the brake pads. This is the most likely condition when the runaway started, because the RRV had been standing unused at the RRAP for two weeks before the runaway. Figure 20 is based on direct pull tests (appendix D), the slope of the brake cylinder force characteristic (figure 19) and the post-accident position of the brake cylinder (paragraph 101).

- 101 Post-accident examination of the incident RRV showed that the left-hand cylinder was positioned 8 mm away from the optimal position (paragraph 86) with 3.5 mm of pad wear and 4 mm of spring compression. The right-hand cylinder was positioned 5.5 mm away from the optimal position with 2.5 mm of pad wear and 5 mm of spring compression.
