Rail Accident Report

Derailment at Castle Donington, Leicestershire 21 January 2013

Report 02/2014
January 2014

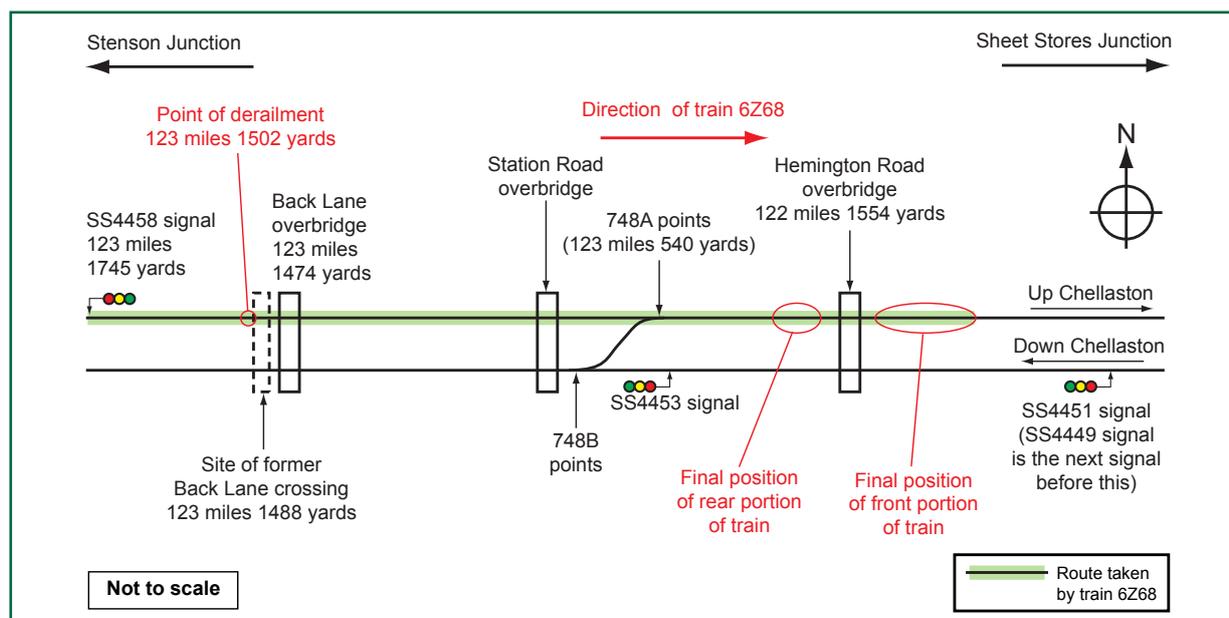
Figure 3: The up and down Chellaston lines at Castle Donington showing the path followed by train 6Z68

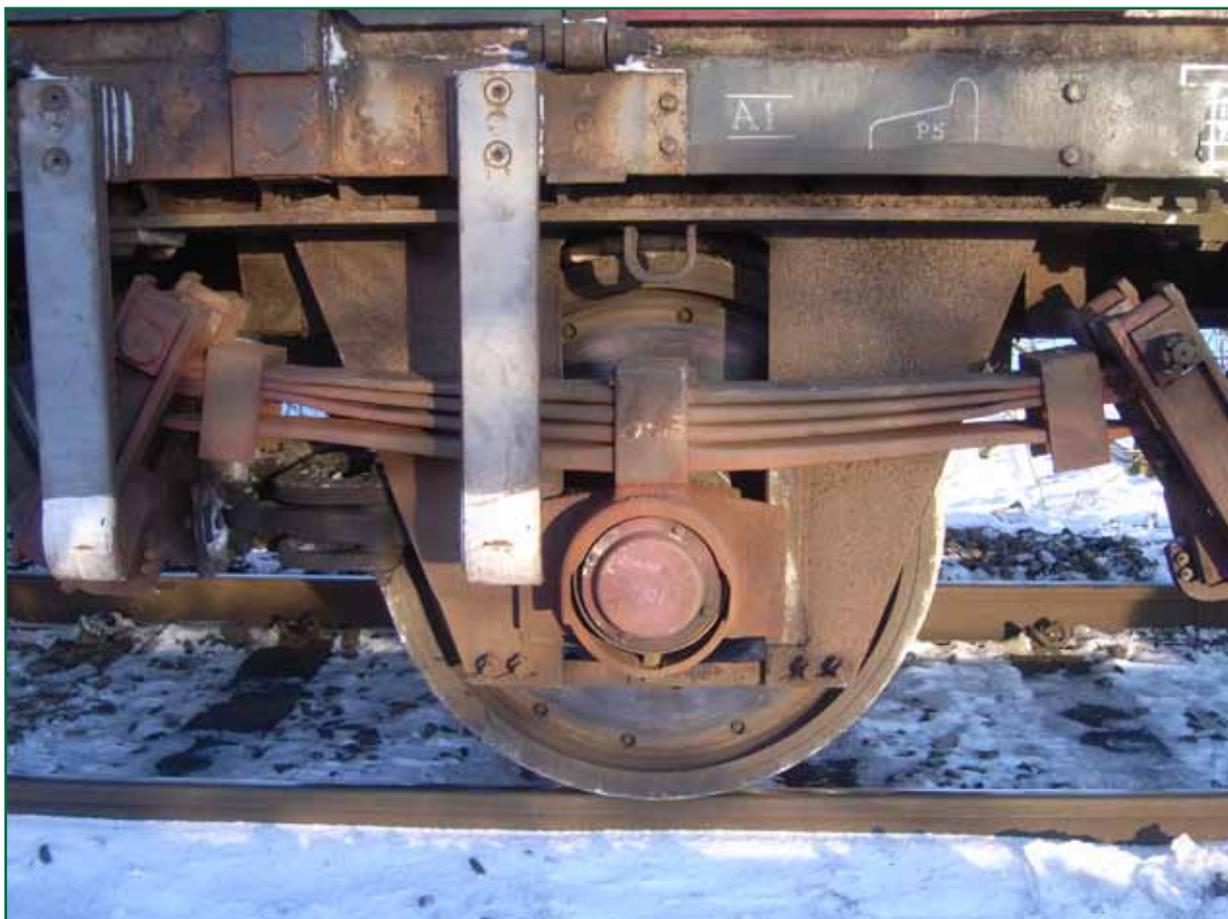
- 19 The three wagons that derailed were all two-axle open wagons with drop down doors. The first wagon to derail (figure 5), OBA110223, was built in 1977. It had a wheelbase of 6.32 metres, and was fitted with *parabolic leaf spring suspension* (figure 6). The third wagon that derailed was also fitted with this type of suspension.

Figure 6: Parabolic leaf spring suspension
