Rail Accident Investigation Branch

Rail Accident Report

Accident at Charing Cross station 24 November 2012

Report 10/2013
July 2013

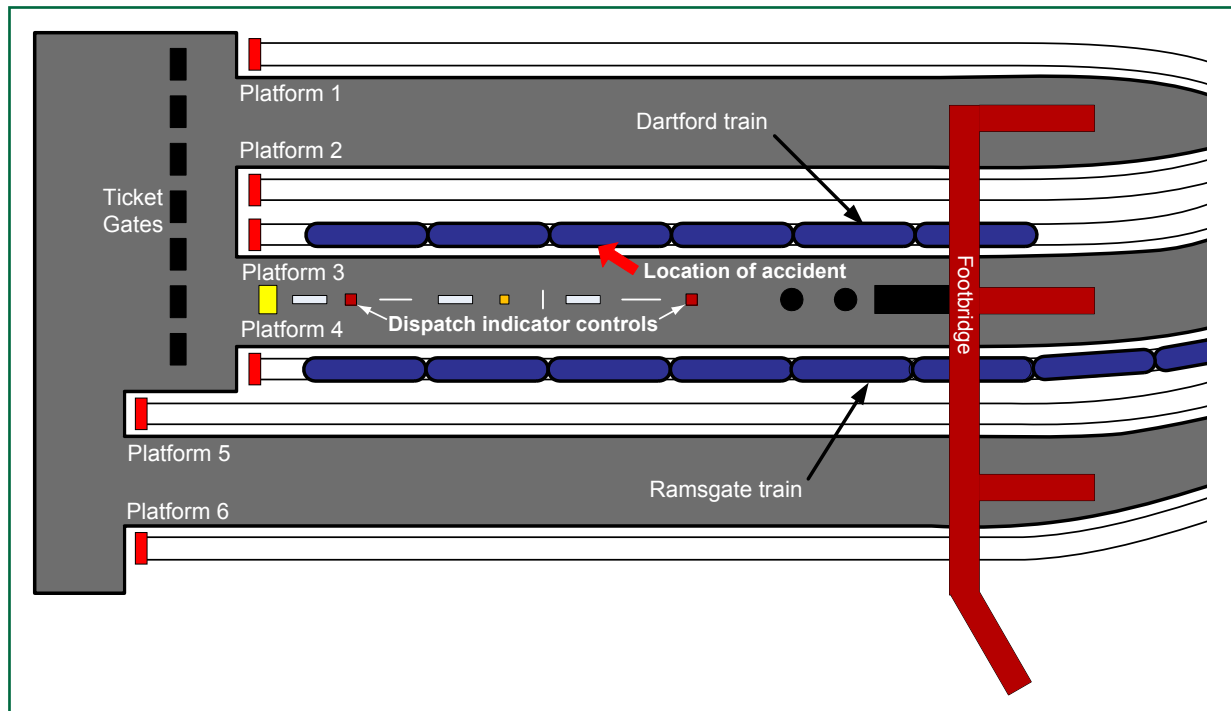
Figure 2: Layout of platforms at Charing Cross (not to scale - detail shown on platforms 3 & 4 only)

- 8 Charing Cross is the terminus of main line and suburban services from south-east London and Kent, all of which are operated by *electric multiple unit* trains. It has six platforms, numbered from north-east to south-west. Platforms three and four are opposite faces of a platform which, at the point where the accident occurred, is straight and approximately 9 metres wide.
- 9 The platforms are covered by an overall raft, with a commercial office building above it, which extends as far as the footbridge about 110 metres from the buffer stops. The covered area is lit all the time that the station is open.
