Rail Accident Investigation Branch

# Rail Accident Report

**Collision between a stoneblower and ballast  
regulator near Arley, Warwickshire  
10 August 2012**

Report 12/2013  
August 2013

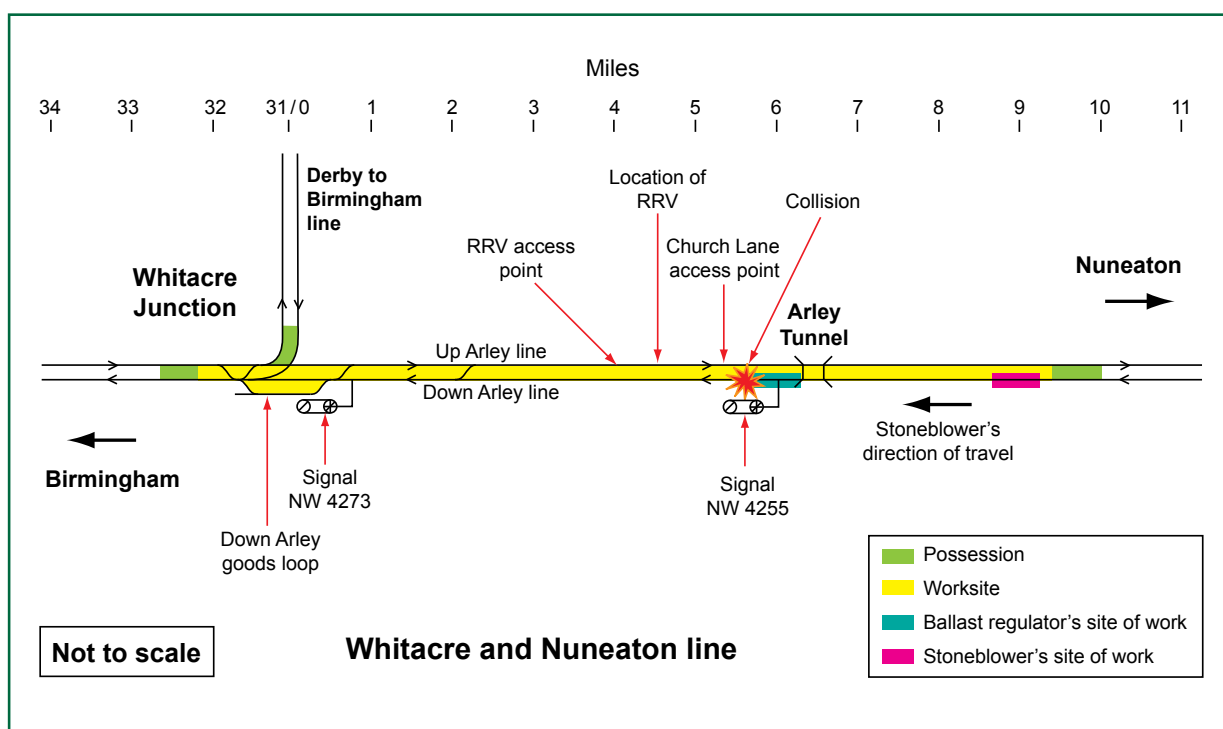
Figure 4: Schematic layout of possession and worksite

- 13 The collision occurred on the Down Arley line at around 5 miles 55 chains, approximately 1 km west of the Arley tunnel (figure 4). The railway at that location comprises two tracks and has a maximum linespeed of 70 mph (113 km/h). The down line from Nuneaton follows a rising gradient of 1:120 and 1:135 and changes to a falling gradient of 1:125 approximately 300 metres before the point of collision. The collision occurred on a left-hand curve in the track (viewed facing the direction of travel).

- 14 The *Up* and Down Arley lines were under *possession* for engineering work planned by Network Rail, which meant that normal train services were not running. The stoneblower and regulator were within an area of the possession, known as a *worksite* (figure 4).
- 15 The possession was due to commence on Friday 10 August at 00.30 hrs and end at 05:30 hrs.
- 16 Mobile telephones were used for all communications by those managing and working in the possession. This is accepted custom and practice for on-track machine staff.

- 40 At 00:54 hrs the PICOP ES telephoned the driver of the stoneblower to authorise him to drive on the Down Arley line to his site of work and, on the way, to pick up the COSS (stoneblower) who was waiting at Church Lane access point (figure 4). The regulator driver was then similarly instructed to proceed to his site of work on the Down Arley line (figure 4) and departed shortly after the stoneblower.

- 42 At 04:00 hrs the COSS (stoneblower) telephoned the PICOP ES to advise that the stoneblower's work was complete and was told by the PICOP ES to await further instructions. The stoneblower was then standing at about 9 miles 17 chains (figure 4). Around this time the RRV, which was in the vicinity of the stoneblower, set off on the Up Arley line for an access point around the 4 mile post, where it was to leave the track and revert to being a road vehicle (figure 4).
