Rail Accident Investigation Branch

Rail Accident Report

**Train ran onto a washed-out embankment near
Knockmore, Northern Ireland
28 June 2012**

Report 14/2013
September 2013

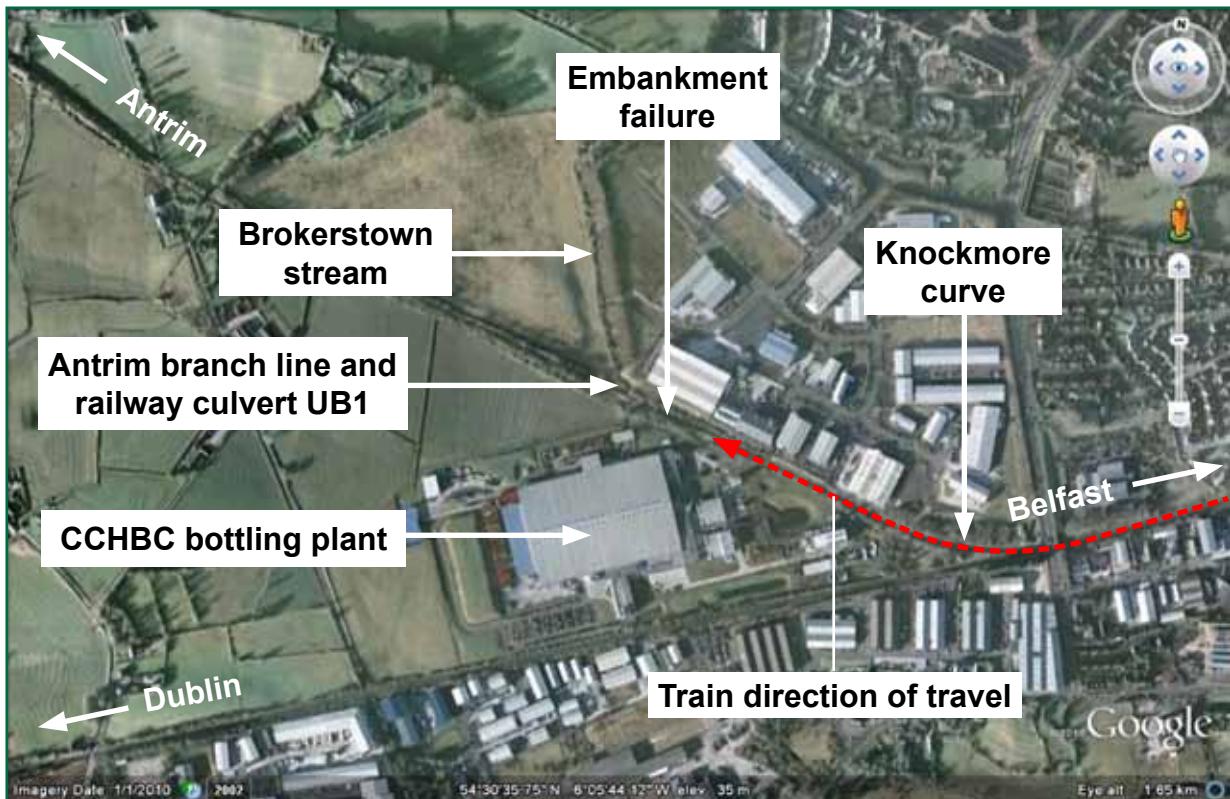
- 10 The washed out embankment was located at around 0 miles 29 chains (580 metres) from a datum located just before the start of the Knockmore curve (figure 3). Its position was around 80 metres from a culvert, the NIR bridge reference of which is '*underbridge 11.001*' (hereafter referred to as 'UB1'). Adjacent to the southern boundary of the railway at the location of the washout is a soft drinks bottling plant, which covers an area of around 45 acres and was built between 2006 and 2008 on previously rural land.

- 11 The Brokerstown Road stream (hereafter referred to as the Brokerstown stream) flows under the railway through UB1, and almost perpendicular to it (figure 3). It originates in an area called the 'White Mountain', north of the site, and runs over a total distance of around 4.4 km in a southerly direction under the Antrim branch line and the Belfast to Dublin main line and discharges into the River Lagan. Its *catchment area* is around 6 km², and around 3.2 km of the watercourse lies north of the Antrim branch line. The watercourse is *culverted* along 35% of its length by 11 *culverts* of different lengths from around 1 metre to 880 metres; five culverts lie to the south and downstream of UB1 (figure 4). It is a designated watercourse which means that the Rivers Agency is responsible for its inspection and maintenance.

Figure 3: Google Earth image showing location of the failed embankment, UB1, and environs

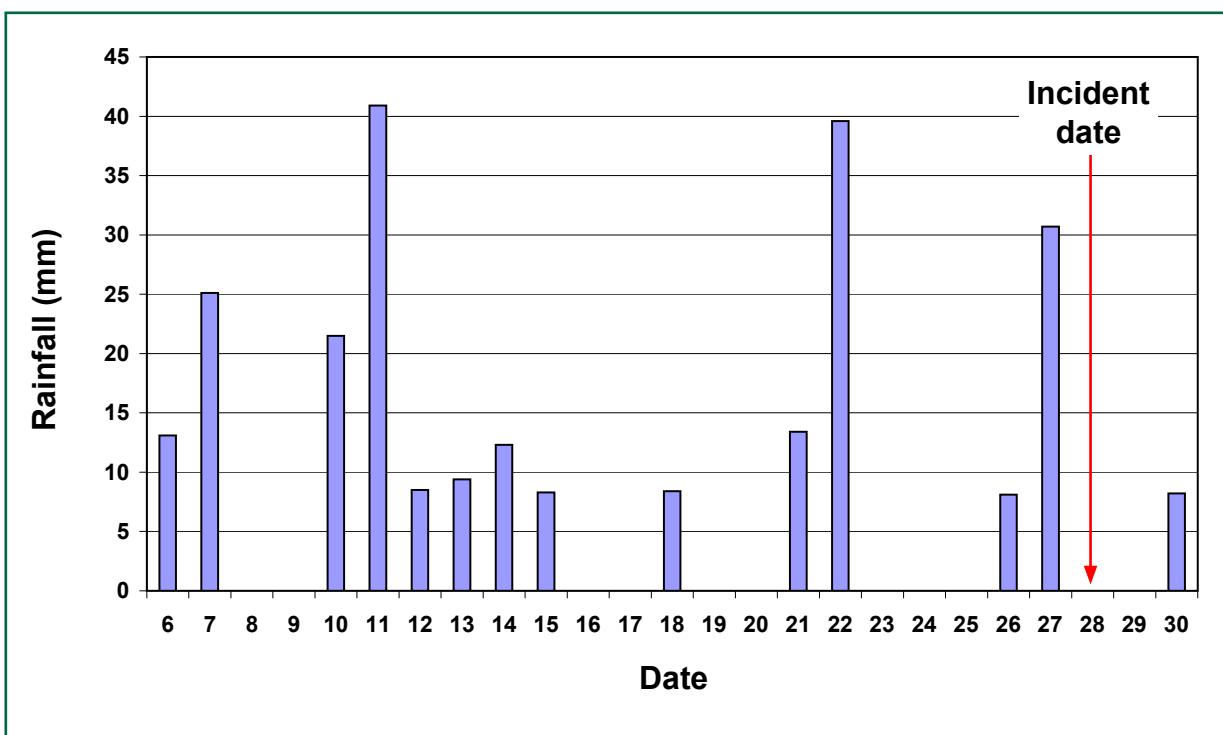
- 47 The nearest rainfall monitoring station to the incident site is at Tullynacross, located about 5 km east north-east of the incident site and outside the catchment area of the Brokerstown stream. Daily rainfall records there, for the period 6 to 30 June 2012 (figure 5), indicate that 27 June was the third wettest day, with 31 mm rainfall. More rain fell on 11 and 22 June (around 40 mm rainfall each) than on 27 June but no flooding was reported on these two days, either at the railway embankment or the CCHBC plant. This could be because the rainfall for Tullynacross on those days did not reflect the conditions in the Brokerstown stream catchment area. Alternatively, it is also possible that the intensity of rainfall and the state of the ground water saturation on 27 June in the catchment were higher, resulting in higher water flows in the Brokerstown stream than on 11 and 22 June.

Figure 5: Daily rainfall at Tullynacross, 6 - 30 June 2012

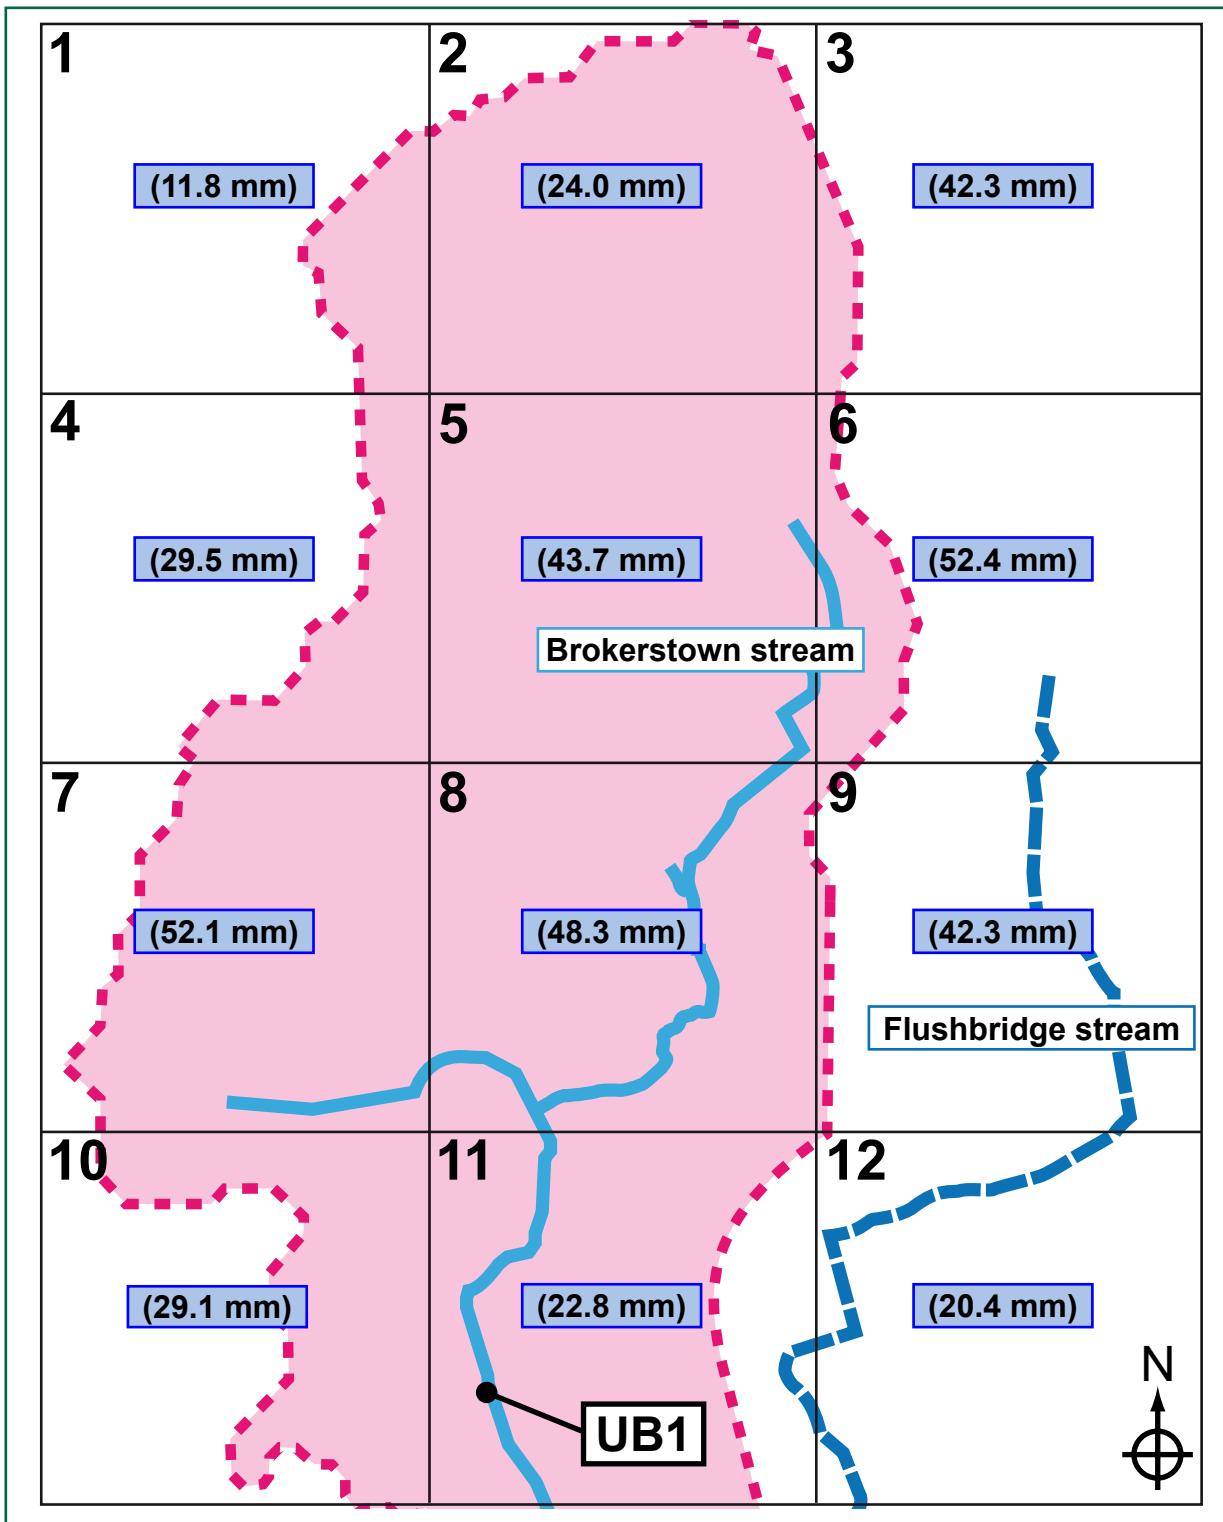
- 48 To better understand the nature of the rainfall on 27 June for the catchment area of the Brokerstown stream, hourly rainfall data for that area, derived from radar images, was obtained from the Met Office. Rainfall radar is routinely used by the Met Office to estimate rainfall in areas where there are no physical gauges. The catchment area was divided into 1 km square grid boxes as shown in figure 6. The data shows that the main rainfall event occurred between 17:00 hrs and 19:00 hrs. The amount of rain that fell in each grid box during this two hour period is shown in figure 6.

- 49 Figure 6 shows that there was a wide variation in rainfall within the catchment area. The greatest amount of rain fell in the central part of the catchment area nearest to the watercourse (grid boxes 5 to 8), where between 43.7 and 52.4 mm fell in the two hour period, corresponding to hourly rainfall rates of around 22 - 26 mm. These rates are around five to six times greater than the four mm per hour threshold used by the Met Office to describe heavy rain. The frequency of occurrence of rainfall events is often expressed as the average interval between events of a given magnitude. For example an event with an estimated probability of occurrence of 0.1 per year is said to have a *return period* of 10 years. The rainfall rates in grid boxes 5 to 8 correspond to return periods of between 171 - 373 years. The average for the whole of the catchment has been estimated by the RAIB to have been around 1 in 100 years. The result of this intense rainfall was an abnormally large water flow in the Brokerstown stream.

Figure 6: Rainfall in the Brokerstown stream catchment area on 27 June 17:00 - 19:00 hrs
