Rail Accident Investigation Branch

Rail Accident Report

**Fatal accident at Grosmont, North Yorkshire
Moors Railway
21 May 2012**

Report 23/2012
October 2012

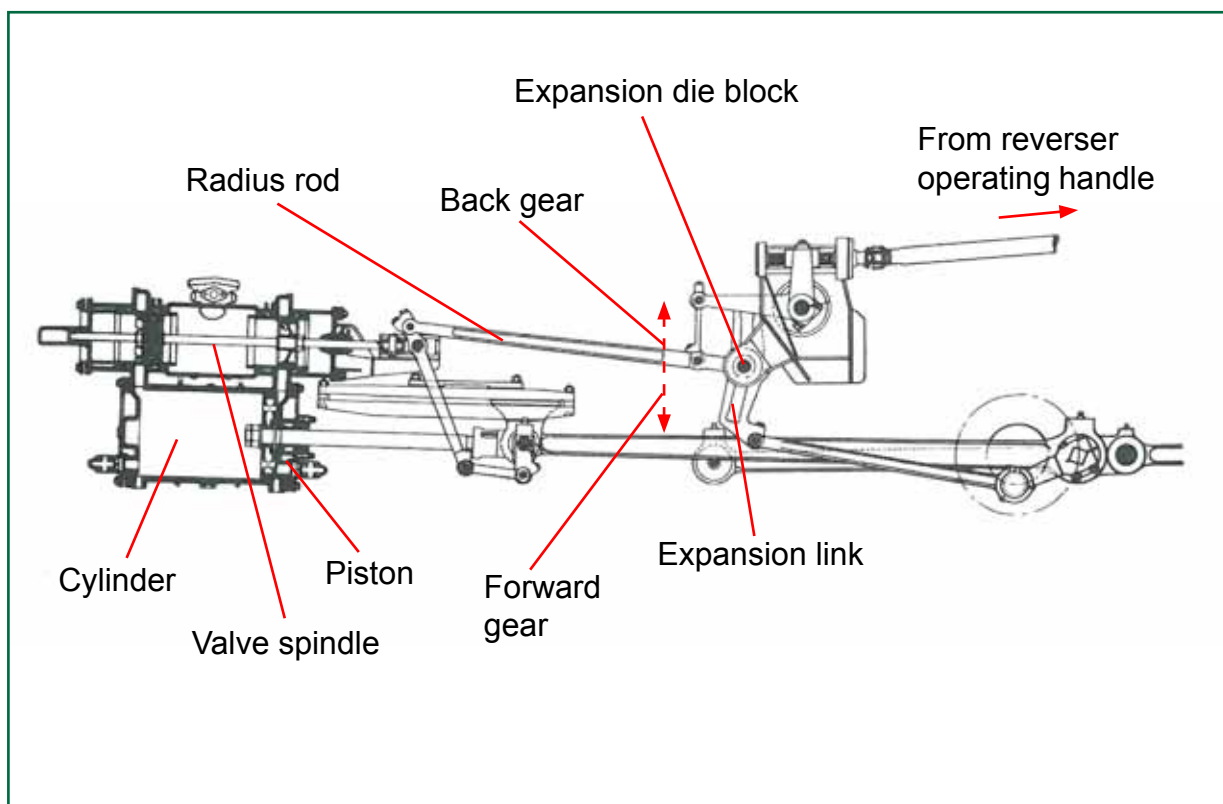
- 12 When the reverser is operated to alter the position of the valve gear from full forward gear towards mid-gear and then (if the locomotive is required to go backwards) into reverse (back) gear, its mechanism lifts one end of both radius rods, each of which is able to slide in its associated expansion link (figure 6). If the reverser is not restrained, the weight of the radius rods then acts to try and pull the valve gear to full forward gear, altering the position of the reverser. To prevent this movement, screw reversers are fitted with locking devices.

Figure 6: Diagram of typical valve gear (as fitted to S15 class locomotive no.825) shown in the mid-gear position
