Rail Accident Investigation Branch

# Rail Accident Report

**Signal passed at danger at Stafford**  
**26 April 2012**

Report 16/2013  
September 2013

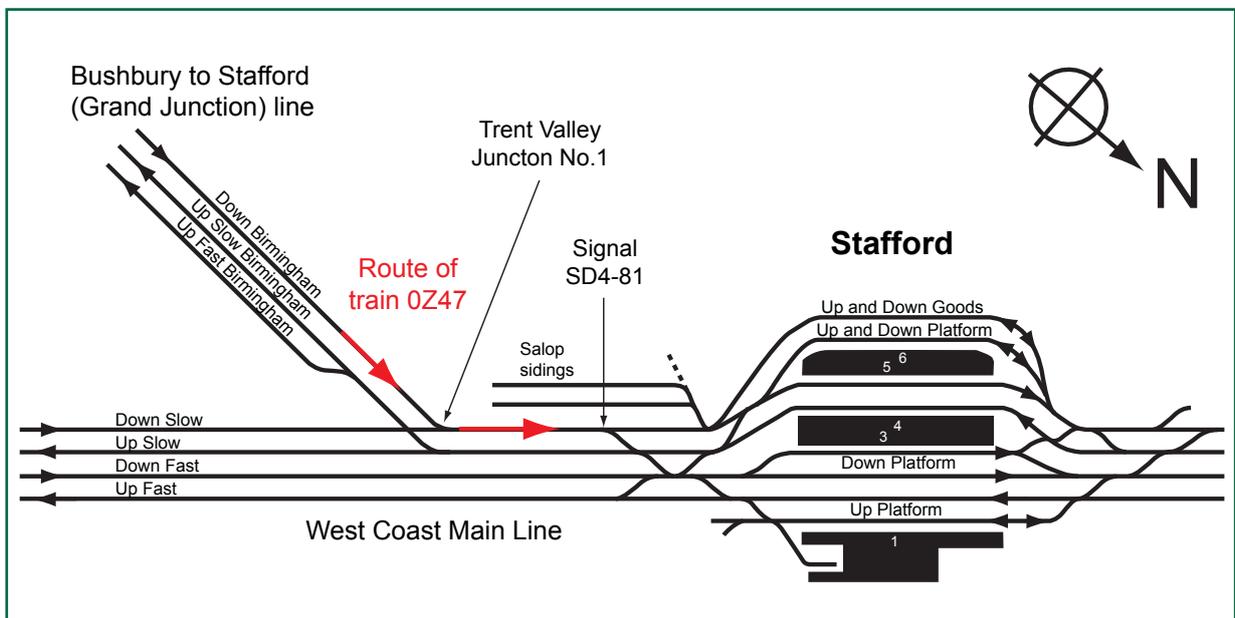
Figure 3: Track layout

- 30 The driver and technician state that DCR management initially instructed them to continue their journey to Crewe. However, they alleged that the brakes on the locomotive were defective, and the technician contacted an independent engineer from URS<sup>6</sup>; arrangements were then made for him to come to Stafford to examine the locomotive. Locomotive 47843 was then moved into platform 6 at Stafford station, and was later stabled nearby in the Salop sidings (figure 3).

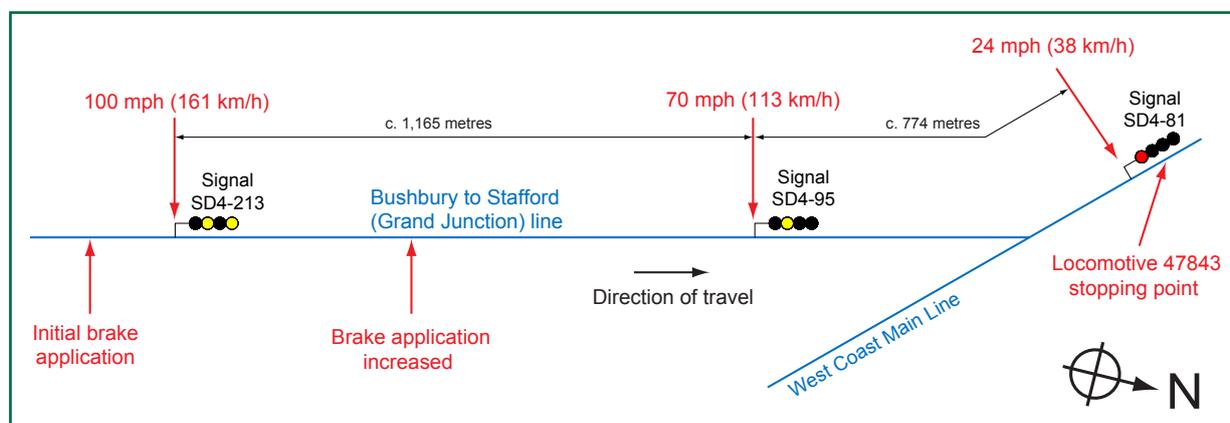
Figure 6: Diagram showing the approach of locomotive 47843 to Stafford

- 28 The driver made a partial brake application as the locomotive approached signal SD4-213, which was displaying a double yellow (*'preliminary caution'*) aspect, (figure 6); the brake application was increased 16 seconds later. The locomotive subsequently passed signal SD4-95, which was displaying a single yellow (*'caution'*) aspect, at approximately 70 mph (113 km/h) and signal SD4-81, which was displaying a red (*'danger'*) aspect at approximately 24 mph (38 km/h).
