Rail Accident Investigation Branch

Rail Accident Report

**Dangerous occurrence involving an engineering train at Blatchbridge Junction, near Frome,
19 March 2012**

Report 15/2013
September 2013

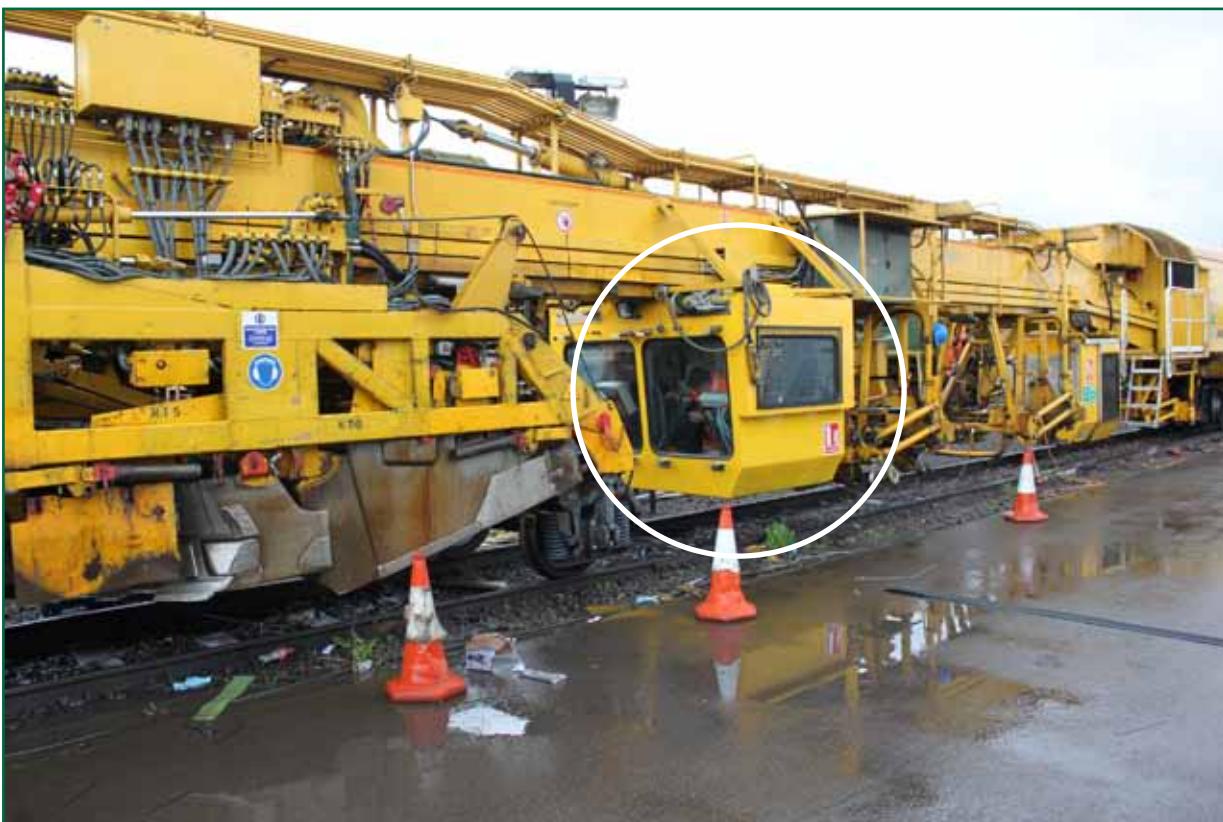
Figure 4: The P3 operators cab (circled)

- 22 The P3 cab is suspended from the vehicle using a supporting frame which is welded to an overhead beam. To minimise transmission of vibration to the occupants of the P3 cab when the machine is working, the cab is secured to the supporting frame by eight flexible mounts. Each flexible mount is secured to the frame by two steel bolts. Each flexible mount secures the P3 cab to the supporting frame by one steel bolt (figure 5). It was the failure of these bolts that allowed the P3 cab to fall onto the track.

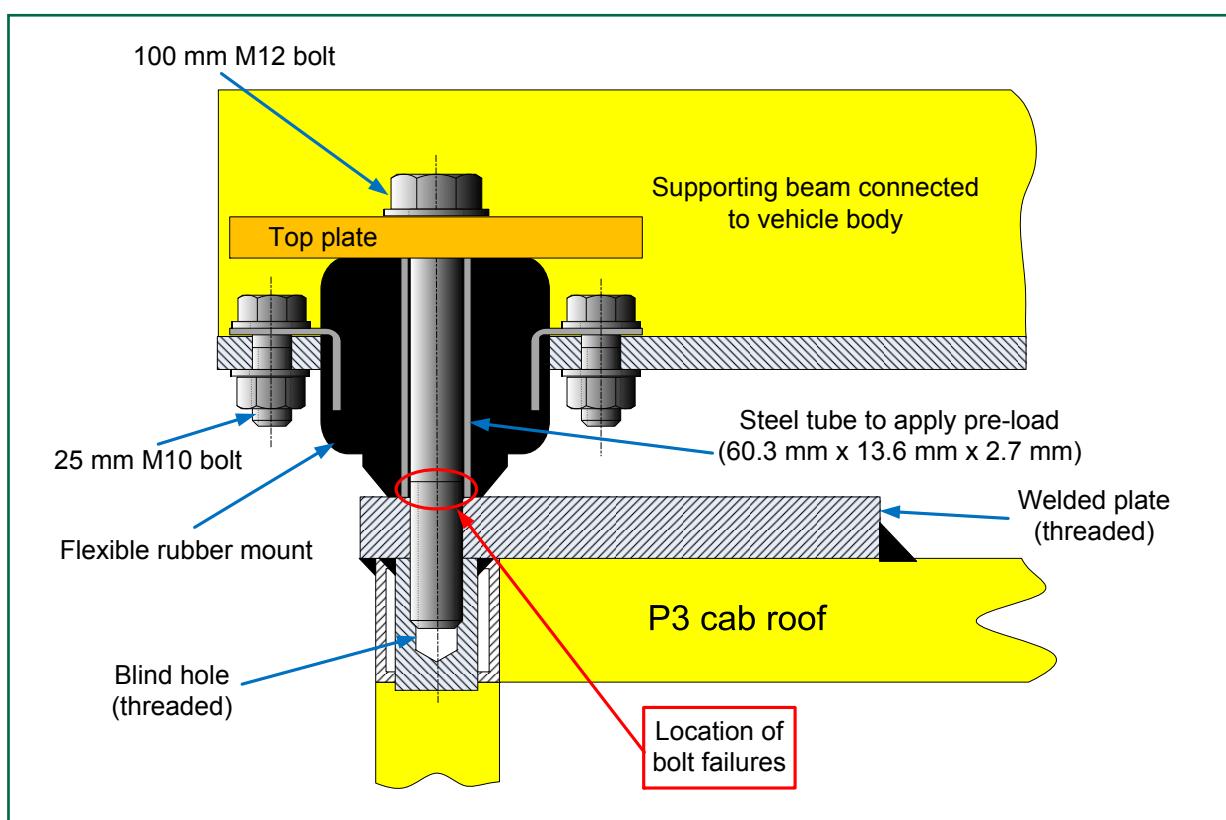
Figure 8: Representation of the flexible mounting arrangement (not to scale)

- 38 The P3 control cab is suspended from the supporting framework of its vehicle by eight flexible mounts: four at the front relative to the direction of travel (referred to in the report as F1 to F4) and four at the rear (referred to in this report as R1 to R4).
- 39 Each flexible mount is bolted to the control cab roof by means of one 100 mm long M12, grade 8.8 steel bolt passing through a steel washer and steel top plate into a threaded *blind hole* in the roof via a steel tube incorporated within the rubber mount (figure 8). The steel tube serves as a spacer, against which the bolt is tightened in order to generate a *preload* without compressing the rubber mount. The rubber mount is attached to the vehicle's supporting structure by two 25 mm M10 steel bolts. Witness evidence indicates that the bolts supplied to Matisa were zinc plated, for protection from corrosion.

- 62 The corrosion on the threads was most likely to have been caused by moisture ingress through capillary action at imperfections around the interface between the bottom of the flexible mount (which was not designed to seal against the P3 cab) and the cab roof (figure 8). Bolts that had corrosion along their shanks, right up to the bolt heads, may have been exposed to moisture ingress from the interface between the bolt head and the top of the flexible mount, once the bolt had failed and the joint was no longer tightly clamped. Although the bolts were zinc plated for corrosion protection, contact between the threads of the bolt and the threaded hole of the cab roof appears to have removed this protection (figure 19 insert). It is also possible that the corrosion protection was imperfect at the thread roots. In either case, unprotected metal could have been exposed to moisture, allowing corrosion to develop and fatigue cracks to initiate from some of the corrosion pits in the presence of service stresses (paragraphs 50 to 54) until the affected bolts eventually fractured.

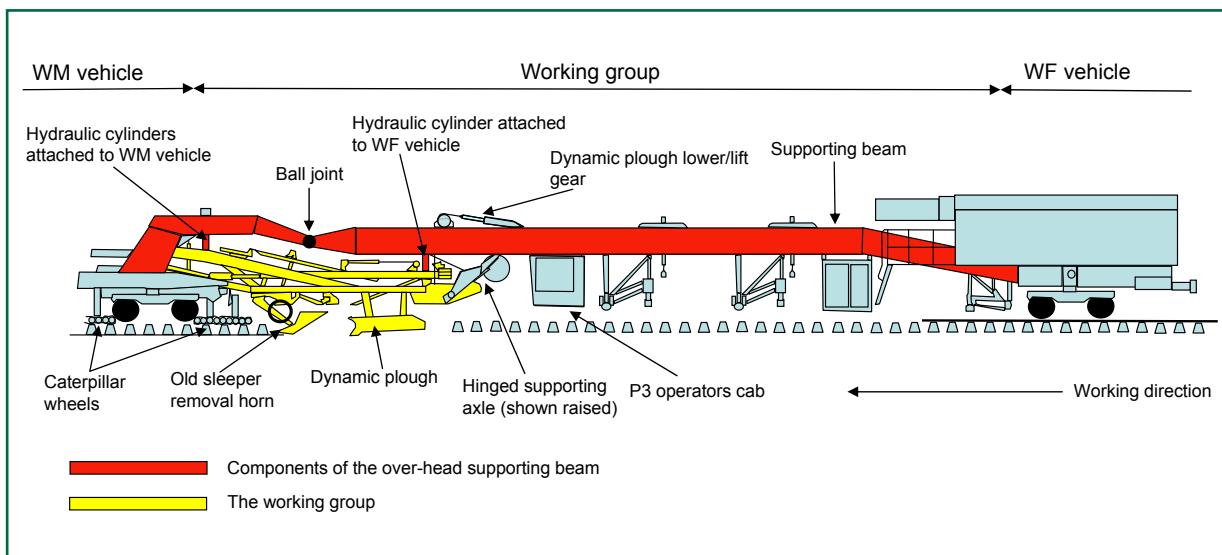
Figure 15: Simplified plan of the working group and adjacent vehicles, including the working group (yellow) and overhead supporting beam (red)

- 58 The dynamic plough and old sleeper removal horn are two of the tools attached to the P95/1 UK (figure 15). These tools are attached to a two-part overhead supporting beam. The front of the plough and horn assembly is supported by two hydraulic cylinders attached to the supporting beam, and the rear of the plough and horn assembly is suspended by a single hydraulic cylinder. The two parts of the overhead supporting beam are connected by a ball joint which permits movement between the two parts of the overhead supporting beam when the caterpillar wheel sets are deployed on the vehicle ahead of the working group. Loading of the bolts during operation of the machine in working mode was not considered in the original design of the cab mounts (paragraph 97).

- 59 When the plough and horn are deployed, the forces acting on them may be reacted through the overhead supporting beam. Data from the service tests (paragraph 50) appears to indicate that these forces may cause the beam to flex in such a way as to cause high strains in the cab mounting bolts without significant accelerations in the cab (paragraph 52). However, it was not possible from the measurements to determine exactly how the bolts were becoming loaded and it is not known if the bolts on the other P95 machines experience the same loading as the P95/1 UK machine.
