Rail Accident Investigation Branch

Rail Accident Report

Fatal accident at James Street station, Liverpool 22 October 2011

Report 22/2012
October 2012

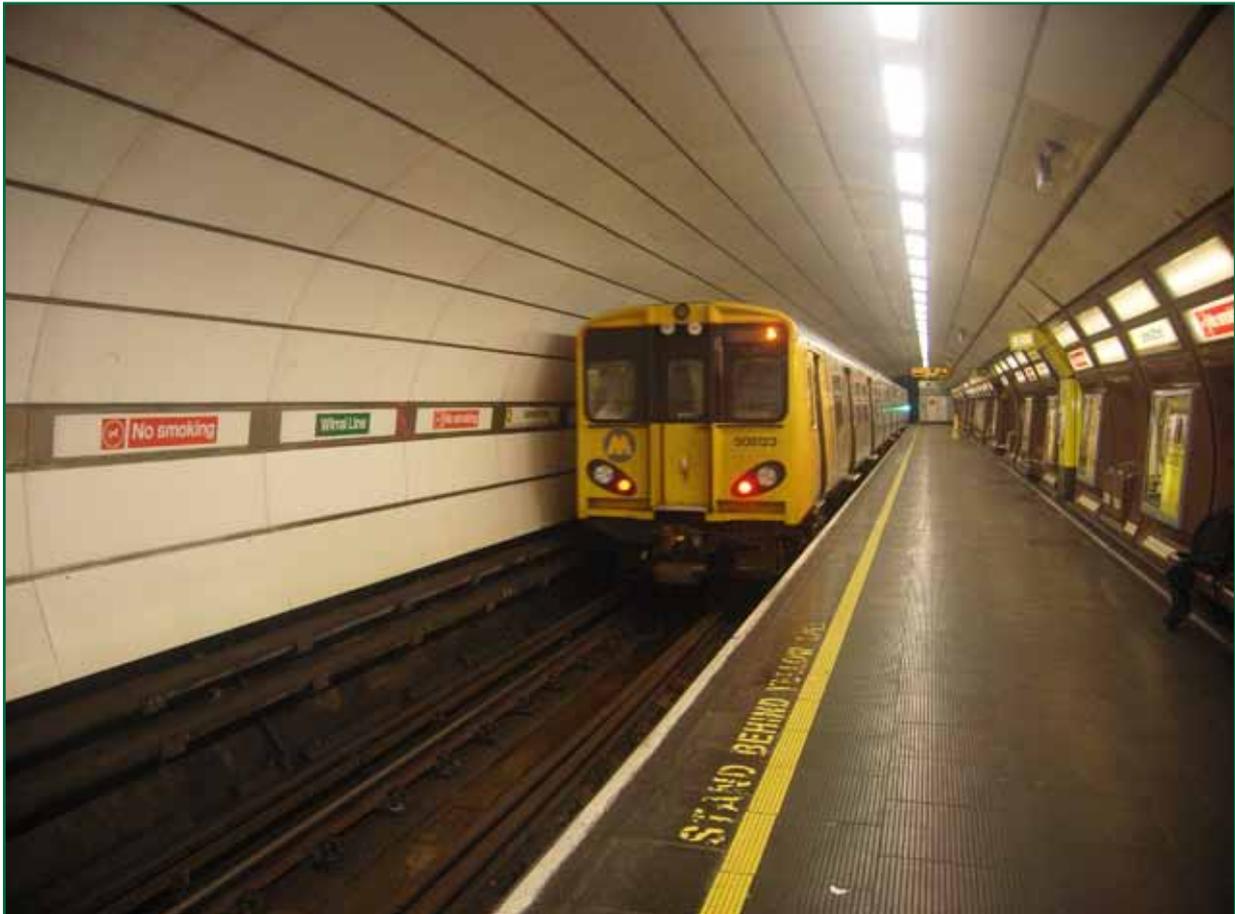
Figure 2: James Street station platform 1

- 4 James Street is an underground station on the city centre loop line of the Merseyrail network, which is made up of the Wirral and Northern Lines (see figures 1 and 2). The Mersey Railway Tunnel opened in 1886 and connects Liverpool with the Wirral; the underground loop line opened in 1977 and connects Liverpool's city centre stations (James Street, Moorfields, Lime Street and Liverpool Central) with the Wirral lines that converge at Hamilton Square.

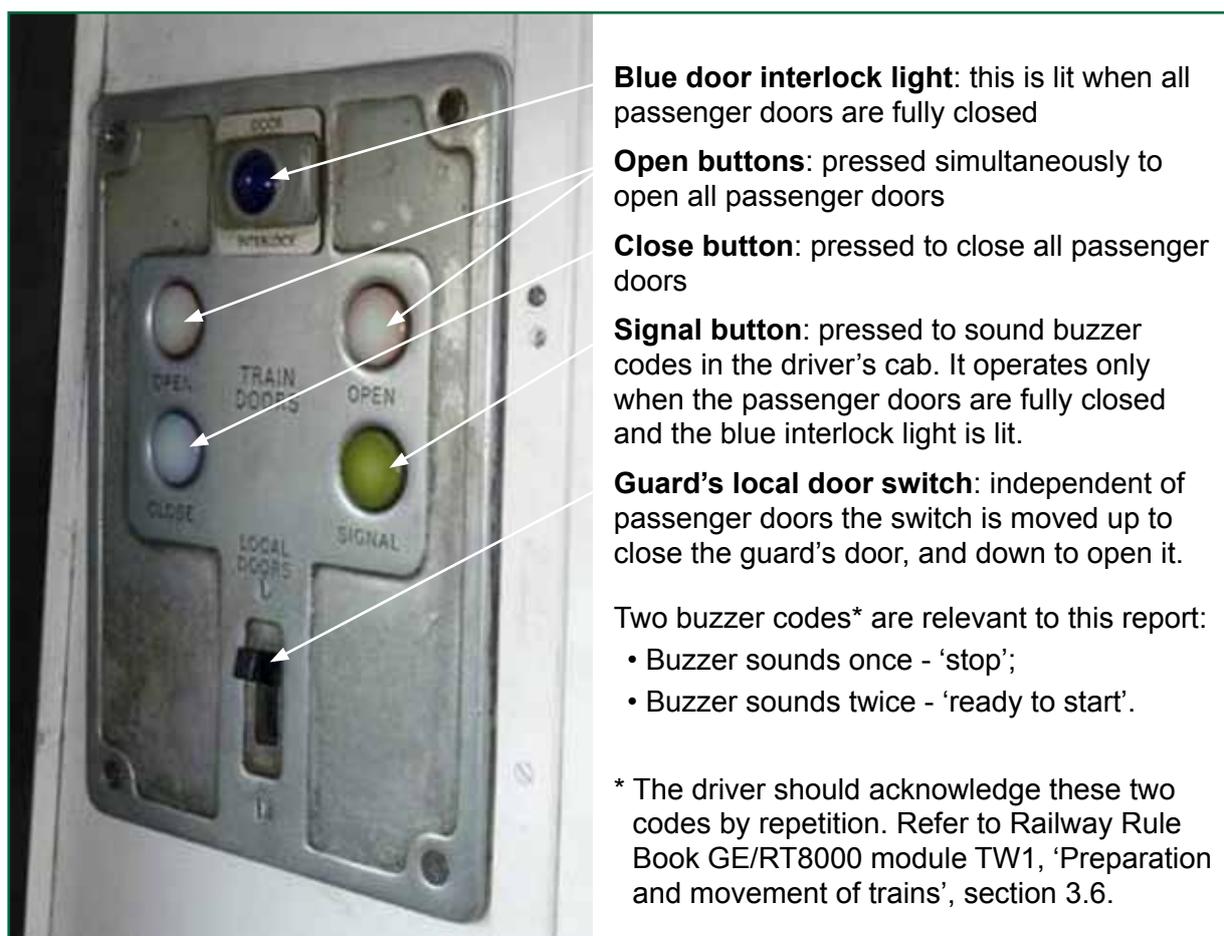
Figure 3: The guards' control panel

- 8 The young person first left the train at Meols, the first stop after Manor Road. When the guard pressed the door close button on his control panel (figure 3), the young person's friends held the passenger doors open and called for her to rejoin the train. The guard walked down the platform from his position at the rear of the train to investigate why the passenger doors had not closed. However, the young person had boarded the train and the doors had closed before he reached them, so he returned to his control panel and dispatched the train. The guard recalled seeing the young person on the platform before she got back on board and recalled that she appeared to be under the influence of alcohol. Figure 4 shows the train's layout and the guard's position at the rear of the train in an area separate from the passenger saloon.

- 23 At the time of the accident, Merseyrail's published procedure for dispatch⁵ was the same as the procedure for dispatch in the Railway Rule Book⁶. The procedure requires a guard to close all doors except the door at which they are working, check that the door interlock light illuminates (see figure 3) and then stand on the platform to carry out a safety check along the whole length of the train. The guard then boards the train, closes the adjacent door and, once it is closed, sends the 'ready to start' code.

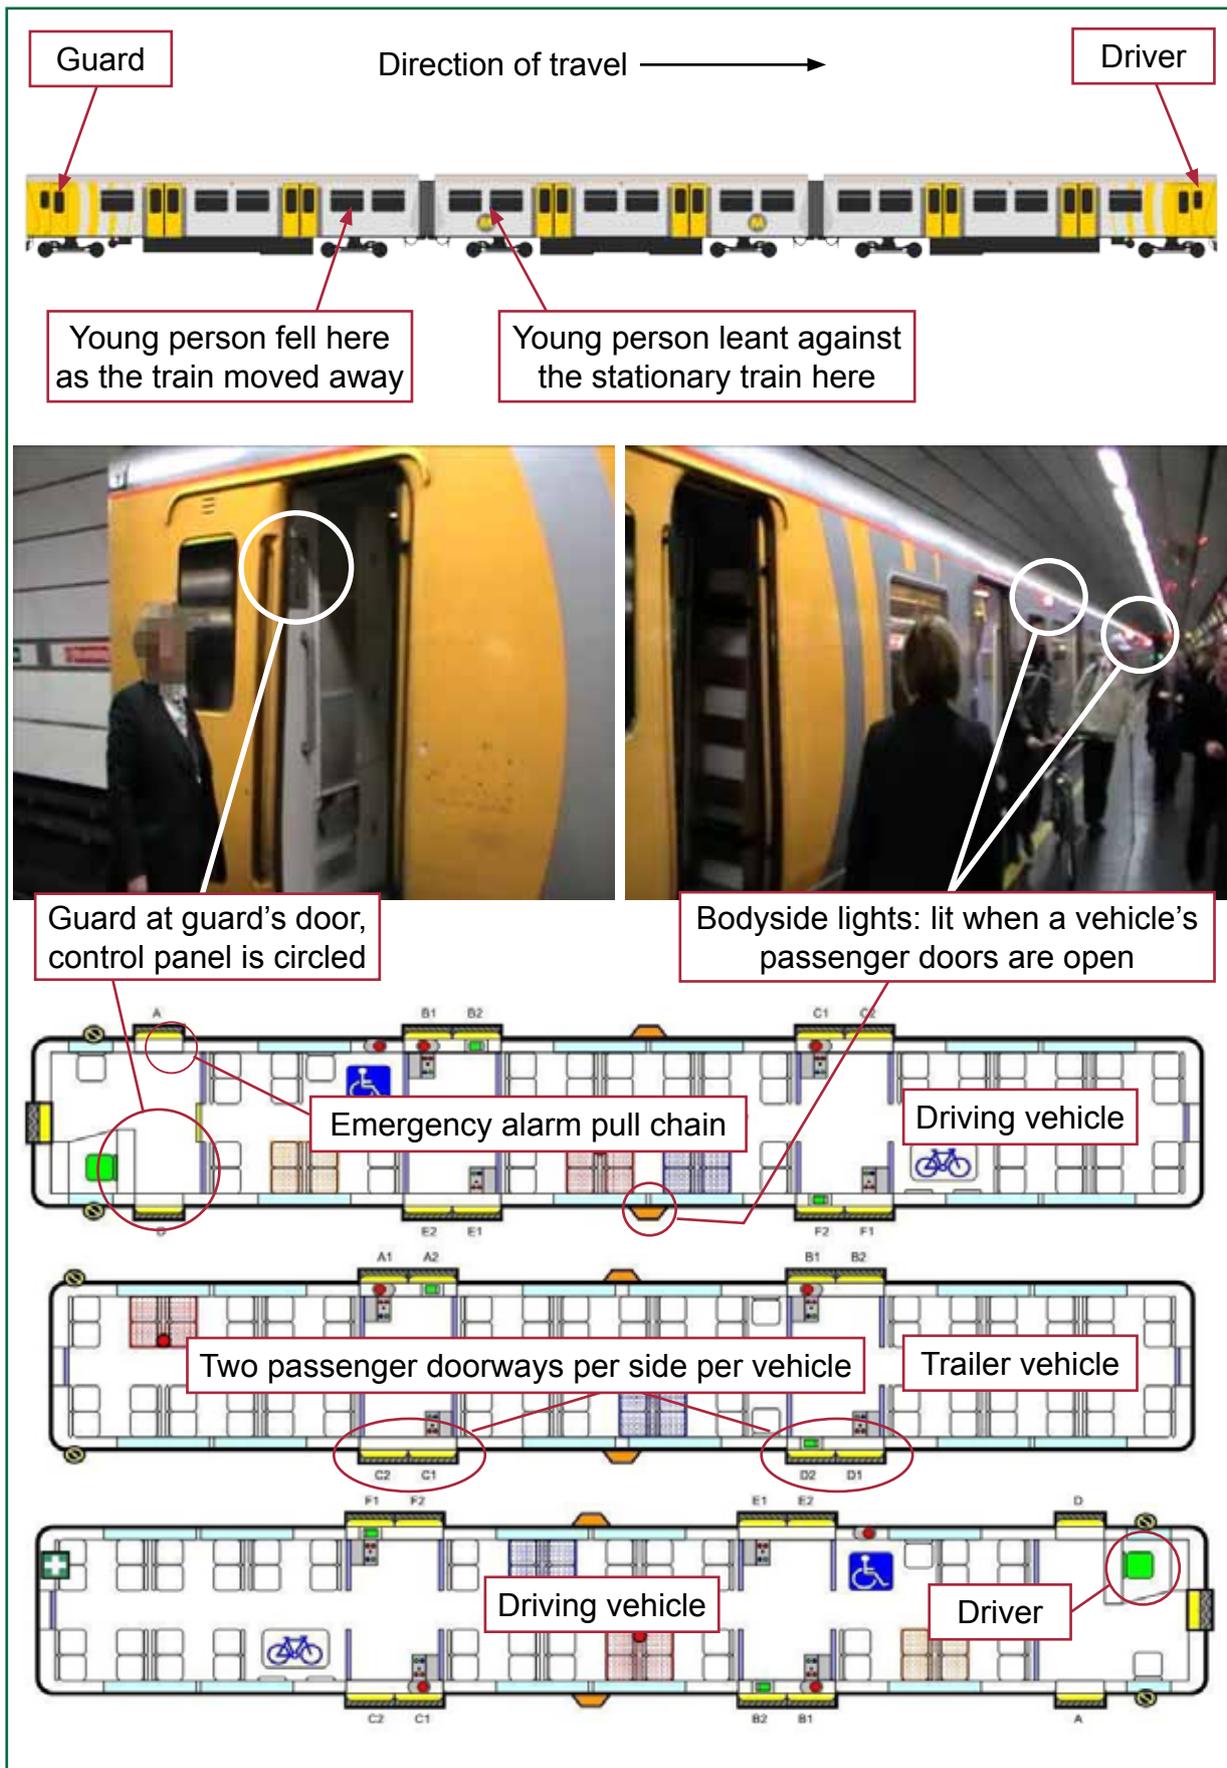
Figure 4: The Merseyrail unit and the locations of those involved in the accident (reader note – the people in the photographs were not involved in the accident)

- 13 From his position at the rear of the train the guard can only communicate with the driver by using the control panel to send and receive codes. The train's design ensures that the guard cannot send codes until the passenger doors are closed, the bodyside lights have gone out (see figure 4) and the blue interlock light is lit (see figure 3). Platform video camera footage shows that the young person placed her hands on the train before the doors had fully closed because the bodyside lights had not gone out. Therefore, the guard must have sent the 'ready to start' code after the young person had placed her hands on the train. The driver repeated the 'ready to start' code, released the train's brakes and prepared to set off.

- 45 The guard could have pulled the emergency alarm chain (see figure 4) instead of warning the young person to stand back. When the trains were first built this device interrupted the brake control wire and fully applied the train's brake. However the trains were modified for the device to sound an alarm in the cab warning the driver that an automatic brake application will take place within 3 - 4 seconds. Within this time the driver may brake immediately or override the automatic brake application and continue to a better place to stop. Crossing to the other side of the vehicle to pull the emergency alarm chain would not have affected the outcome of the accident because it would have resulted in the driver receiving the alarm later than she received the 'stop' code.

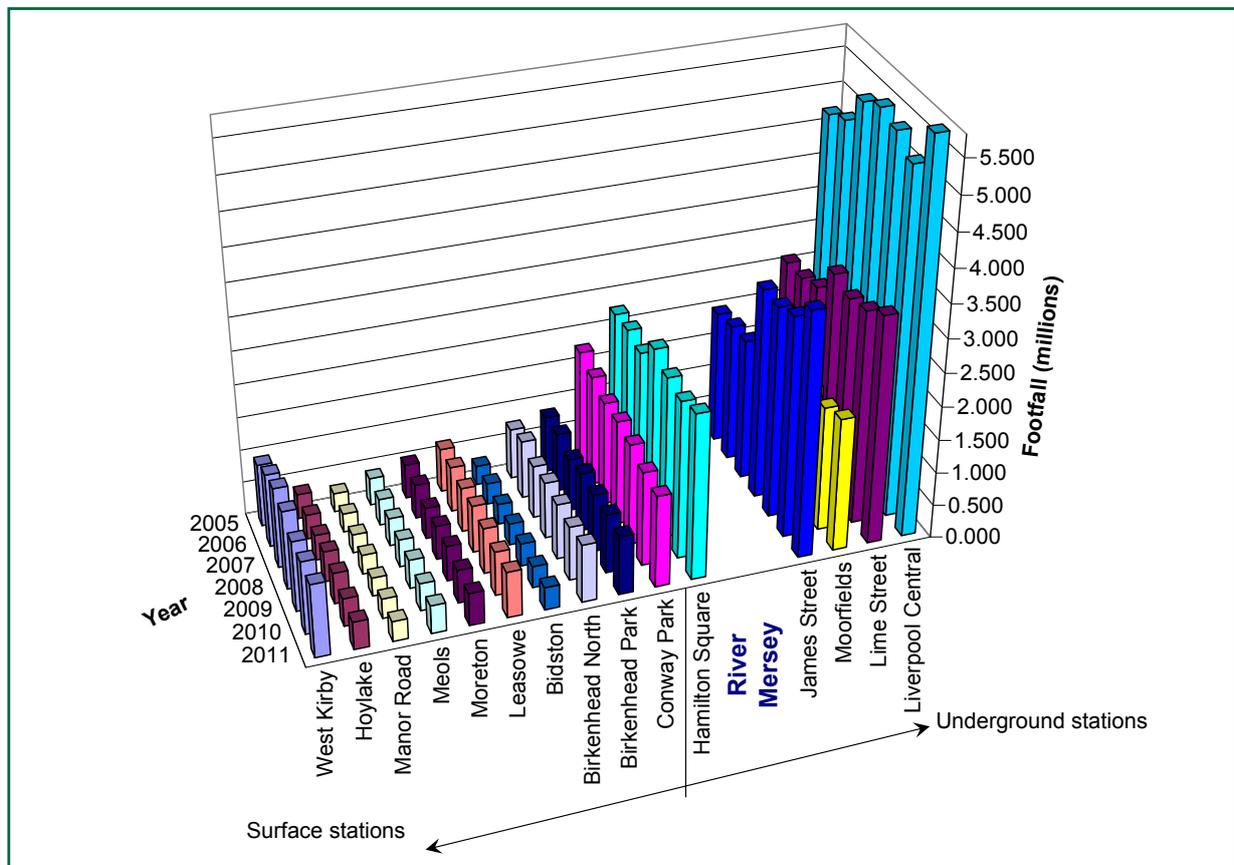
Figure 6: Passenger numbers using the stations on the West Kirby line

- 21 Figure 6 shows that since 2008, James Street has seen the greatest increase in passenger numbers at an underground station. It also shows that since 2009 it has been the second busiest station on the loop line after Liverpool Central. This is because James Street is the nearest station to a recently redeveloped part of the city with attractions including Liverpool ONE², the Echo Arena³, the docks and city nightlife. The platforms at Merseyrail's underground stations are often more congested than those at its surface stations because trains are more frequent, many more people get on and off those trains and space to stand is limited.

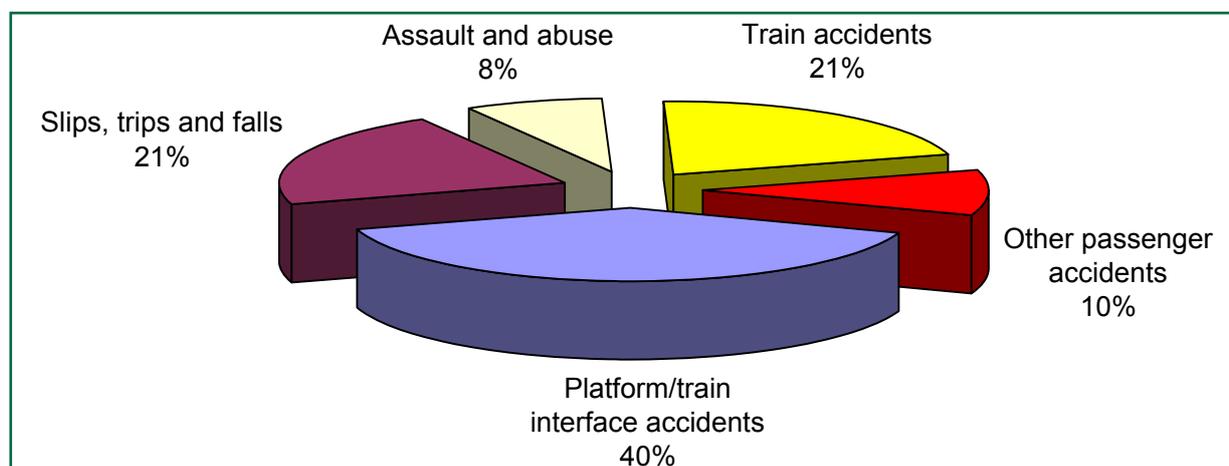
Figure 13: Passenger fatality risk. Information courtesy of RSSB's Safety Risk Model v7

- 50 Platform/train interface accidents represent the most significant fatality risk for passengers on the main line (see figure 13). RSSB records show that in the five years between April 2007 and March 2012, accidents at the platform/train interface were responsible for 14 fatalities (excluding four cases of electrocution) and over 6000 injuries. The RAIB carried out a review of this accident data to identify which of the accidents involved persons falling through the platform edge gap and found that this type of accident resulted in:

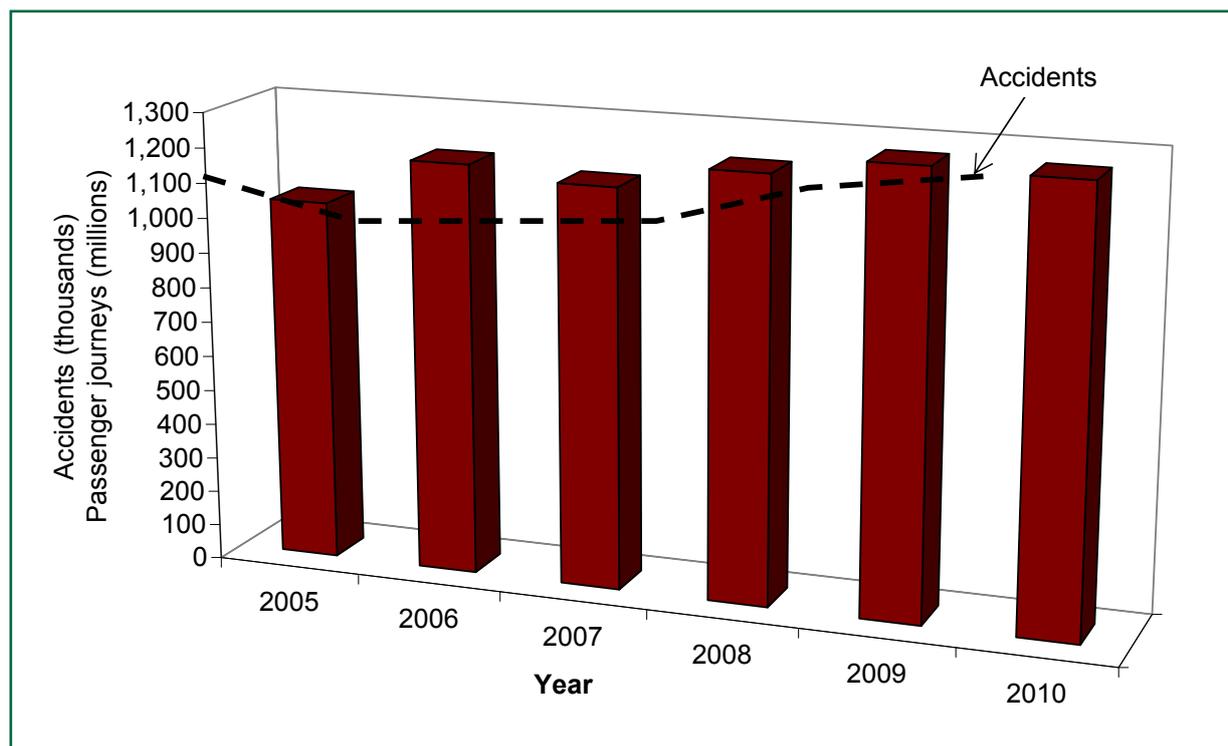
Figure 14: Passenger journeys 2002 to 2010²³ and accidents at the platform/train interface²⁴

56 While the rail industry's overall safety record has improved in recent years, RSSB research shows that accidents at the platform/train interface have increased since 2005/2006, even when accounting for an increased number of passenger journeys²². The increase in this type of accident has taken place over a period of time which saw a known industry hazard (trains with slam doors but no central locking) withdrawn from service (see figure 14). The increase indicates that the industry's focus on operational matters has not delivered improved safety at the platform/train interface, which suggests that there is a need to consider technical solutions to reduce the risk.

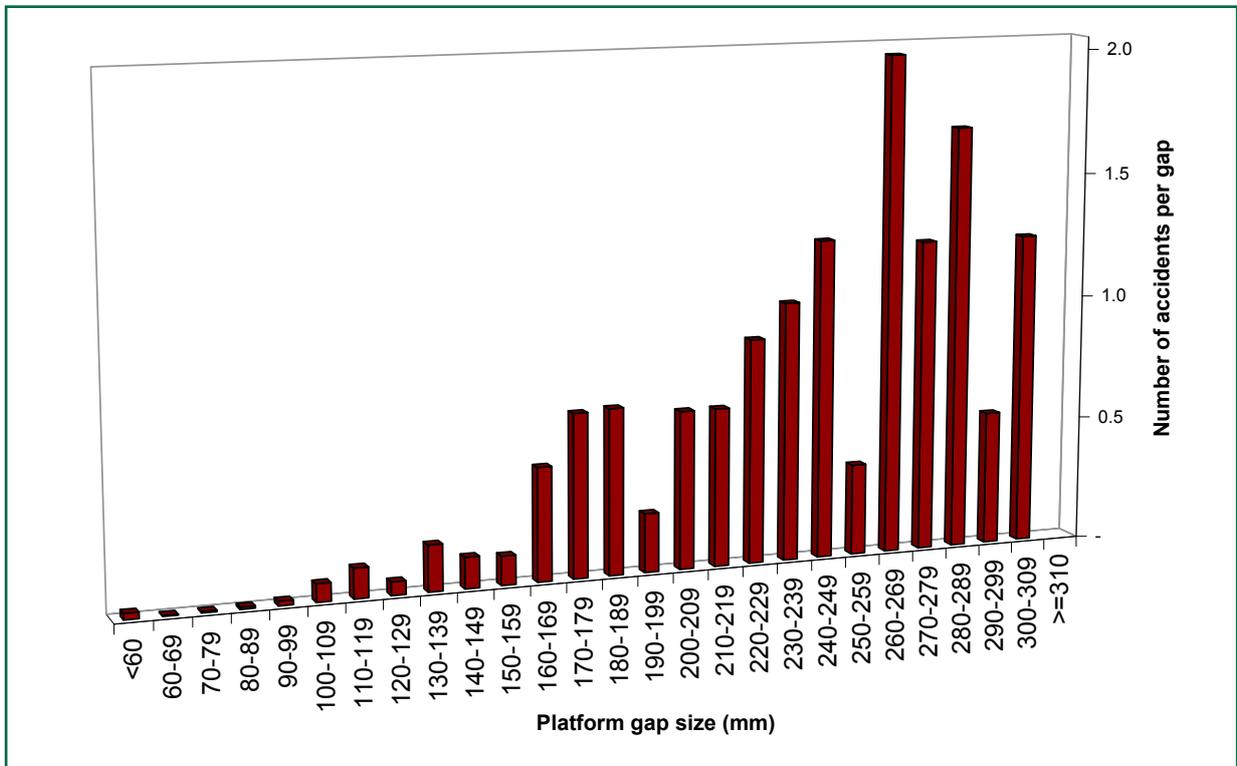
Figure 19: The number of accidents per gap vs. gap width on the Kowloon-Canton Railway between 2001 and 2006²⁸

- b. Reducing the gap. A study carried out by the Kowloon-Canton Railway Corporation between 2001 and 2006 showed that where the gap was less than 160 mm the risk of an accident was low but that for gaps of 160 mm or more the accident rate increased²⁷ (see figure 19). Ways to achieve this include:

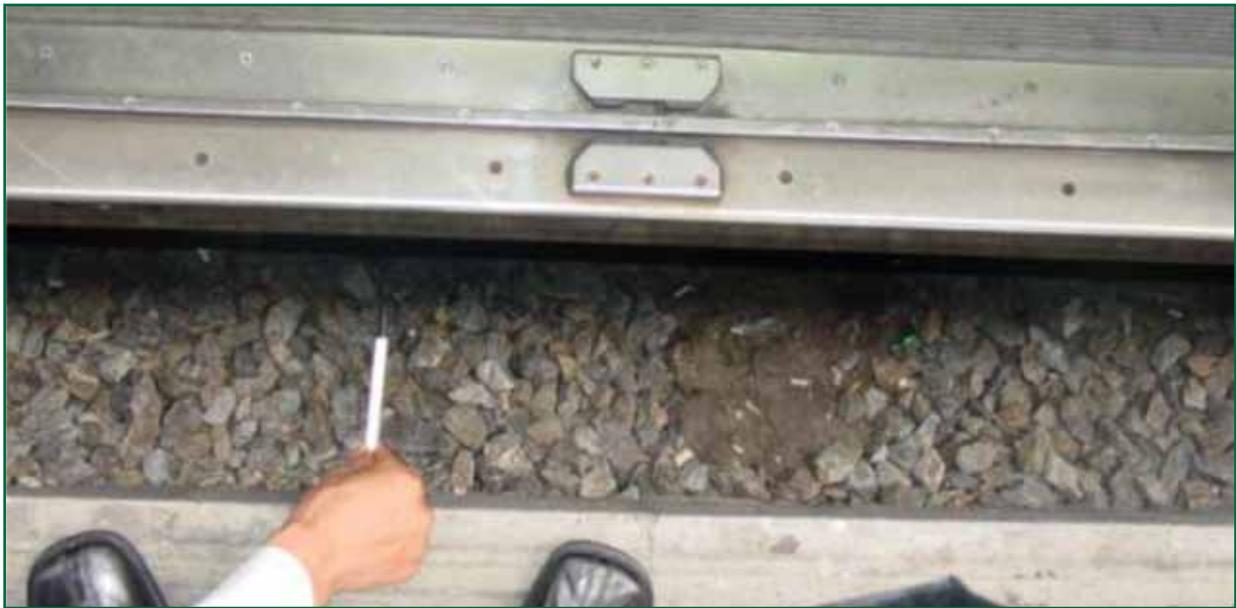
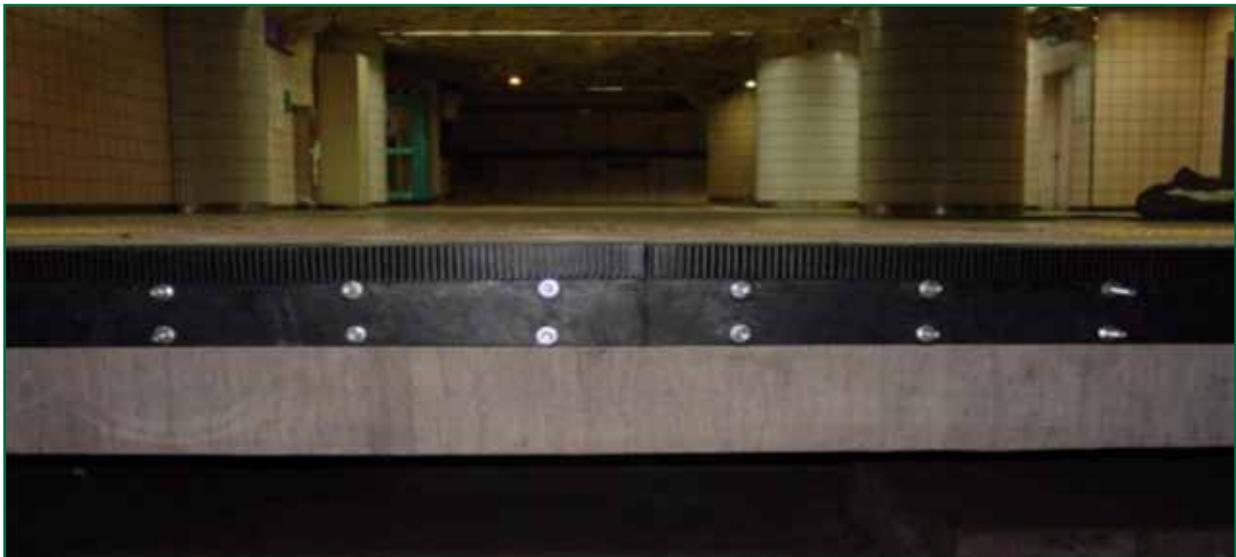
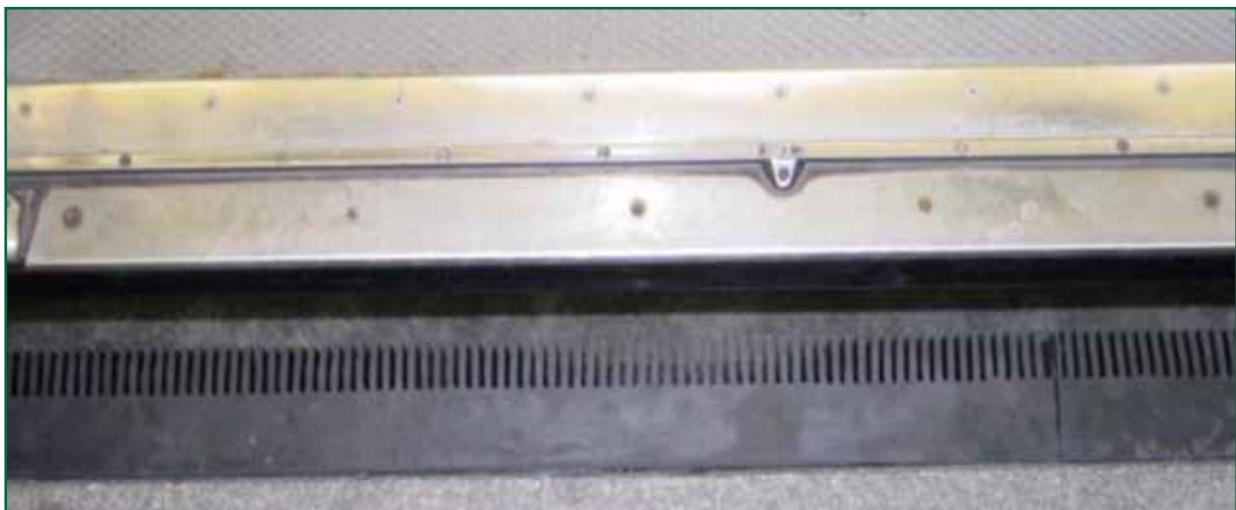
Figure 26: A platform edge (not on the Merseyrail network)

Figure 27: Gap filler bolted to the platform edge

Figure 28: The platform edge after fitting gap filler

- iii. Adapting the infrastructure. Figure 25 shows a platform edge gap reduced by raising the platform edge. Figures 26 to 28 show the gap reduced by fitting gap fillers to the platform face. The gap fillers are made from blocks with rubber prongs: the prongs are able to support a person's weight vertically and deflect horizontally without damaging themselves or the trains that pass and contact them. The gap can also be reduced by moving the track closer to the platform, moving the platform coping stones closer to the track or both.
