Rail Accident Investigation Branch

# Rail Accident Report

**Person trapped in doors and pulled along platform at King's Cross station, London  
10 October 2011**

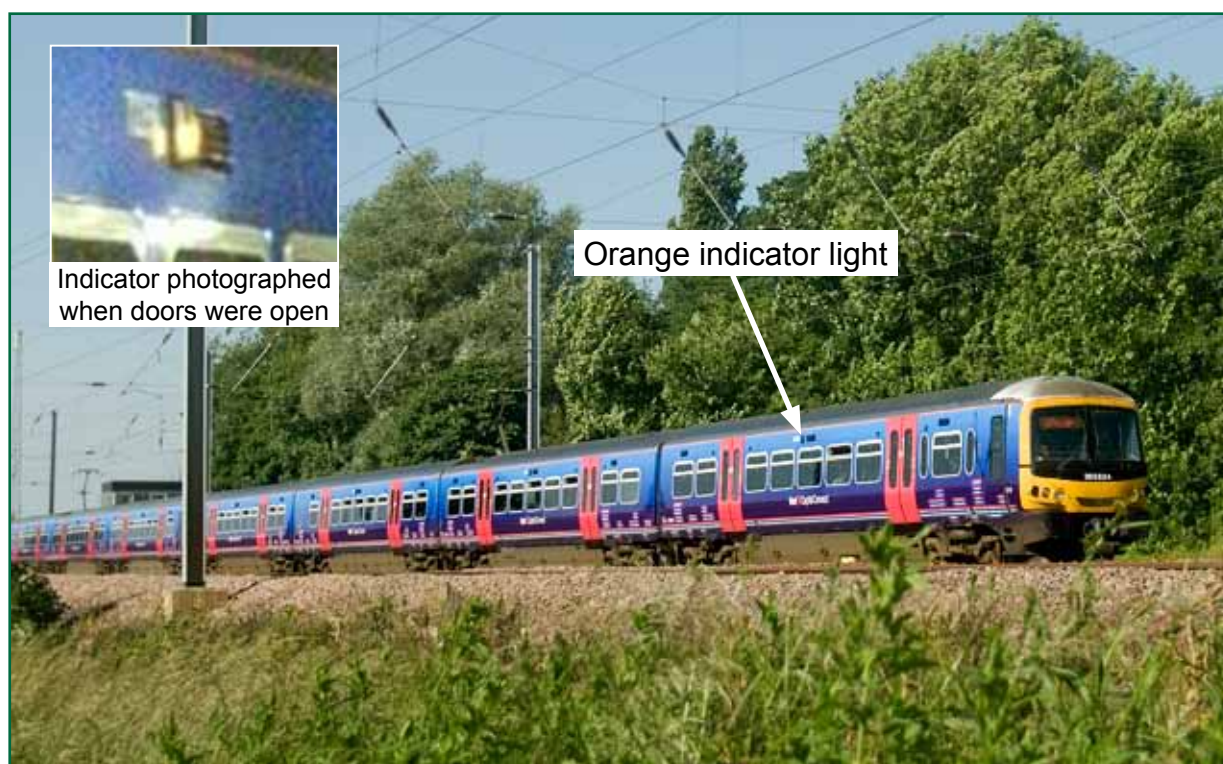
Figure 1: Class 365 train

- 4 On 10 October 2011, the 17:53 hrs service from King's Cross to Royston was an eight coach train formed by two Class 365, four-coach, electric multiple units, numbers 365501 and 365528 (figure 1). As is normally the case, the train was being operated in the driver-only mode of operation. The train was owned by Eversholt Rail (365) Limited and managed on their behalf by Eversholt Rail UK (Ltd). It was operated by First Capital Connect (FCC), who also employed all the staff involved in the incident.

- 5 Each Class 365 coach has two pairs of sliding doors on each side. Orange coloured indicator lights, mounted externally near the roof of each coach, illuminate until the doors on that coach are fully closed (figure 1). When all indicator lights are extinguished, the driver receives a visual indication in the cab. The driver cannot (under normal operating conditions) apply power to move the train without this visual indication.
