Rail Accident Investigation Branch

Rail Accident Investigation: Interim Report

**Partial failure of a structure inside Balcombe
Tunnel
23 September 2011**

Report IR1/2013
January 2013

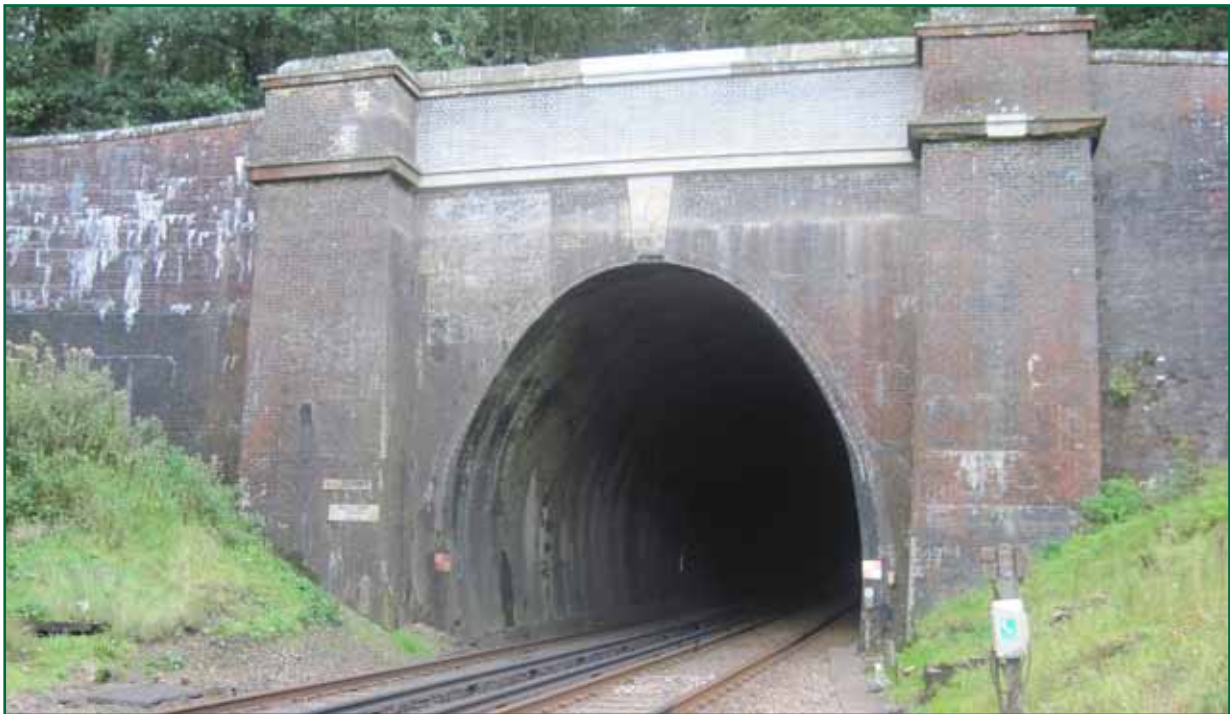
- 6 Balcombe tunnel is in profile a horseshoe shape (figure 1) with a lining approximately 0.5 metres thick formed by seven rings (layers) of bricks. The structure inside the tunnel that was defective, and observed as such by the train crew, is one of five similar steel water catchment trays² attached to the tunnel's brick lining above train roof level. The trays are intended to catch water dripping from ventilation shafts³ and water seeping through the brickwork in other areas of the tunnel. Water collected on the trays is conveyed into the tunnel drainage system.

Figure 1: Balcombe tunnel (north portal) (photo courtesy of ORR)
