Rail Accident Investigation Branch

# Rail Accident Report

**Incident involving a runaway track maintenance  
trolley near Haslemere, Surrey  
10 September 2011**

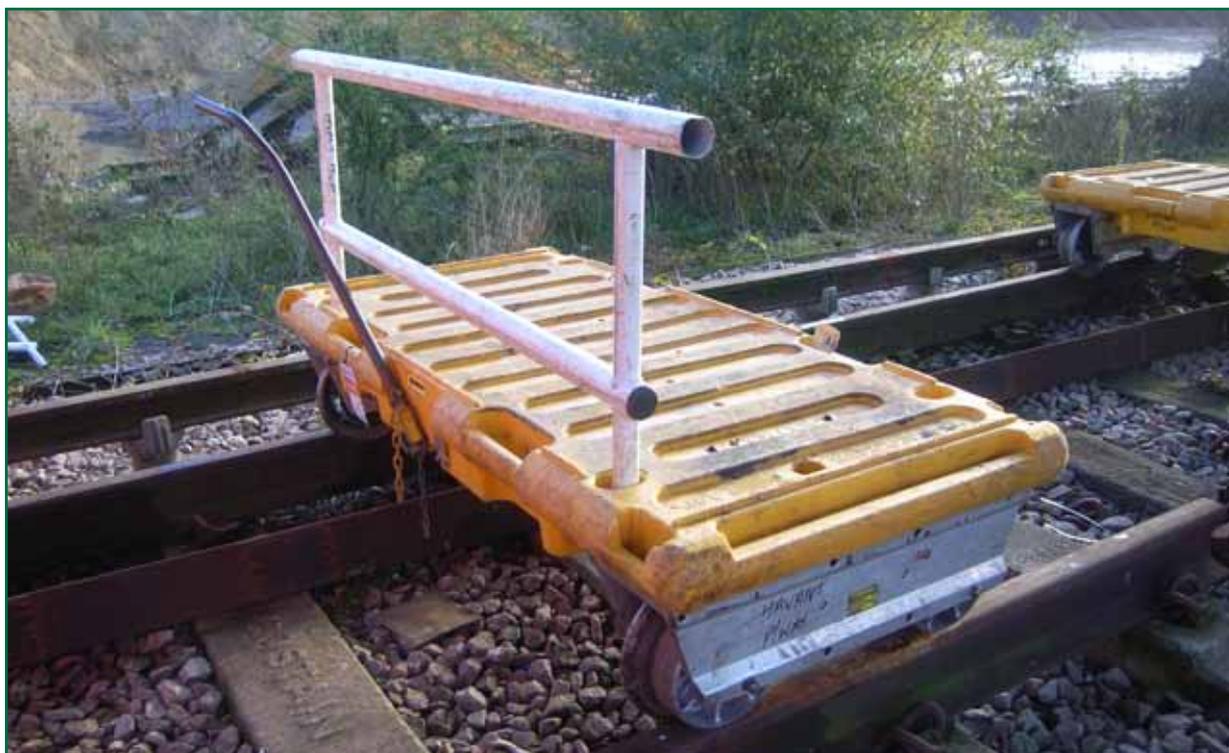
Figure 3: LT1000P 'trakrat' trolley

- 18 The trolley was a Wolfe Designs 'trakrat'<sup>1</sup> LT1000P (figure 3). Two of these trolleys were based at Havant track maintenance depot; it is likely that the trolley involved in the incident was No. E0007515 (refer to paragraph 46) although it has not been possible to confirm this as trolley use is not recorded. Network Rail had taken delivery of thirteen LT1000P trolleys in August 2009, following product acceptance of the 'trakrat' family of trolleys by Network Rail during 2008. The LT1000P was the smallest product in the range, which included the LT1250A, LT1500A and LT1500A welders' trolleys.

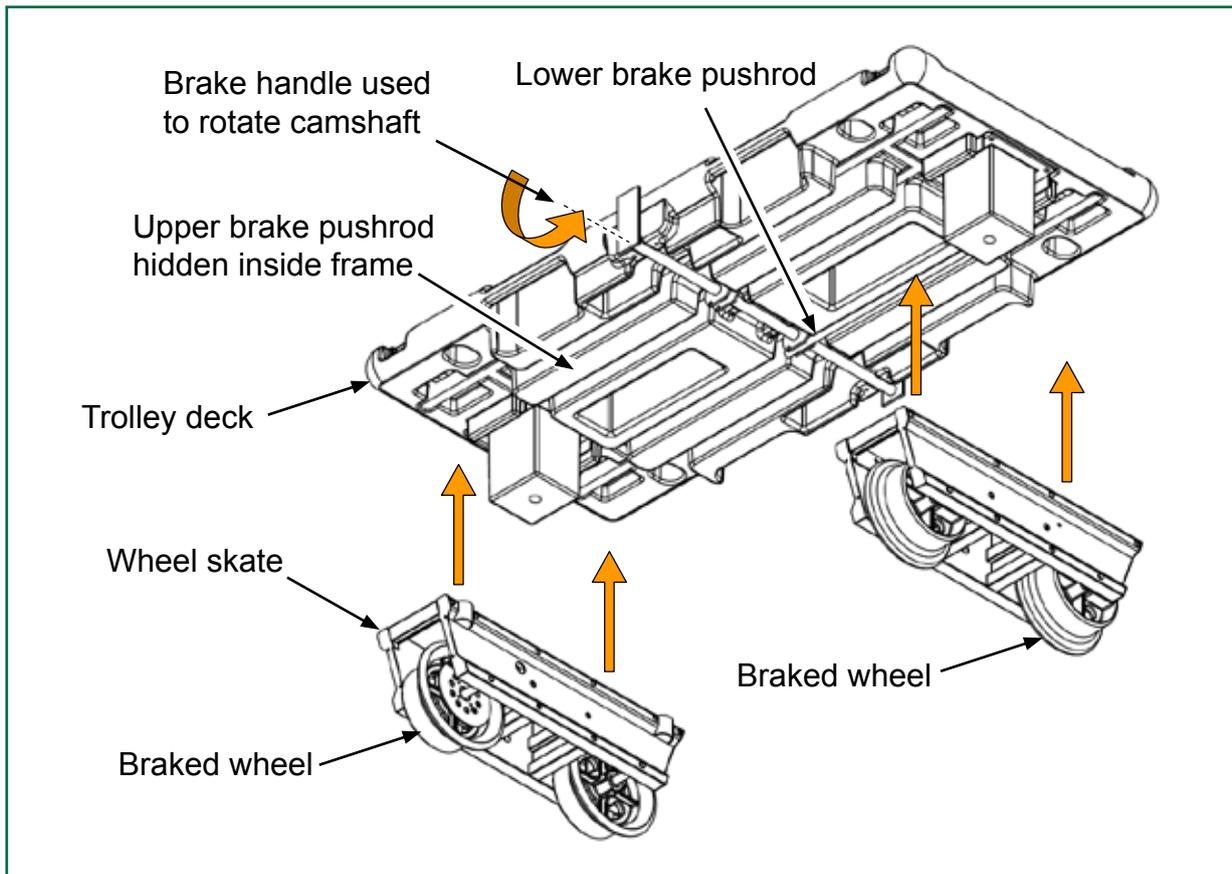
Figure D1: Underside of 'trakrat' LT1000P, showing location of wheel skates and brake linkage (Courtesy of Norlec Sheet Metal)

- D1 The two 'trakrat' trolleys which had been in use at Havant track maintenance depot on 10 September 2011 were examined at Woking by the RAIB and Network Rail on 4 October 2011. Testing demonstrated that the brake handle could jam with the brakes released, and the trolley could then run un-braked without further intervention from the operator.
- D2 The wheels on the 'trakrat' family of trolleys are carried in demountable wheel skates or bogies, figure D1. There are two braked wheels, on diagonally opposite corners of the trolley. The brakes are normally held in the applied position by means of springs, and are released by a brake handle which is attached to either end of the trolley, figure D2.

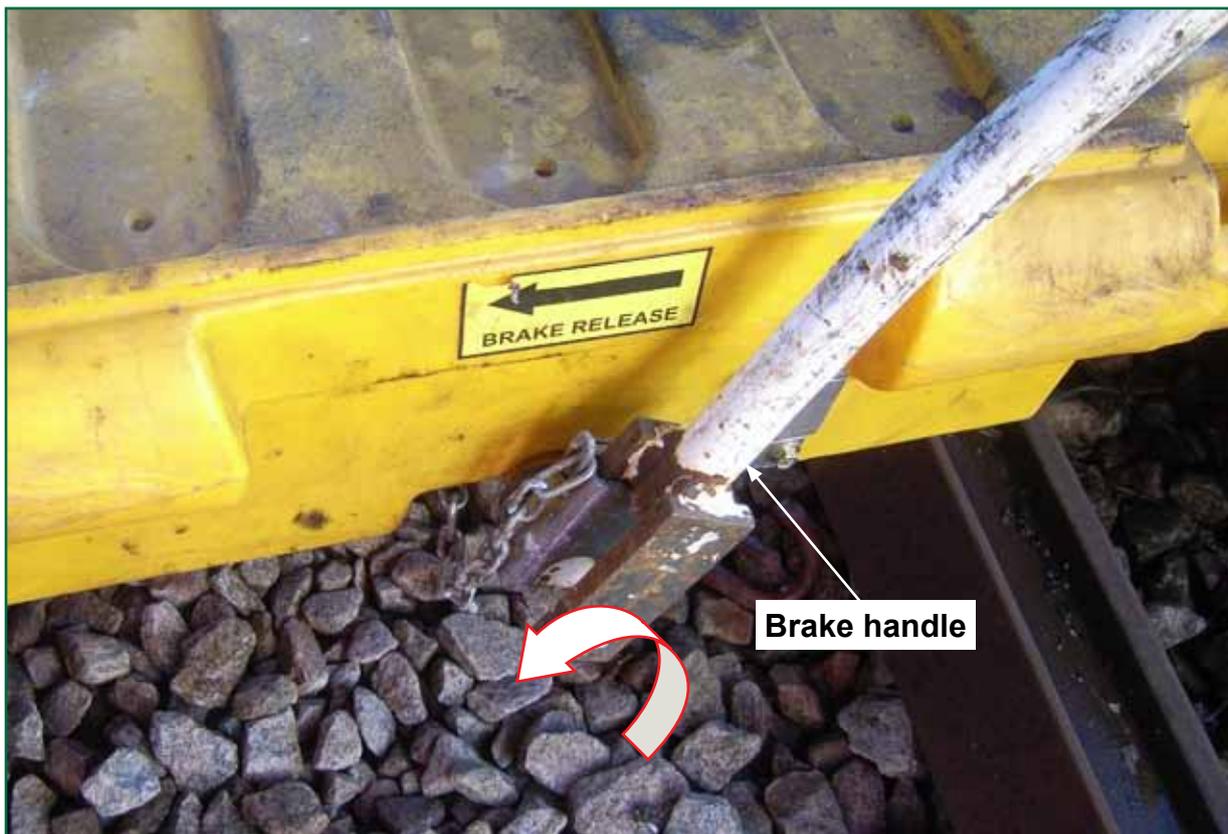
Figure D2: One end of 'trakrat' LT1000P, showing use of brake handle to release brakes

- D4 One of the features of the linkage arrangement is that the longitudinal camshaft is rotated in opposite directions depending on which end of the trolley the operator is standing. On one end (eg figures D1 & D2) the shaft is rotated anti-clockwise to release the brake, ie the operator must push the handle to the left, and on the other (figures D3 & D4) it is rotated clockwise and the operator must push the handle to the right. The indication to the operator as to which direction he should push the handle is given by a label on the end of the trolley, figure D2.

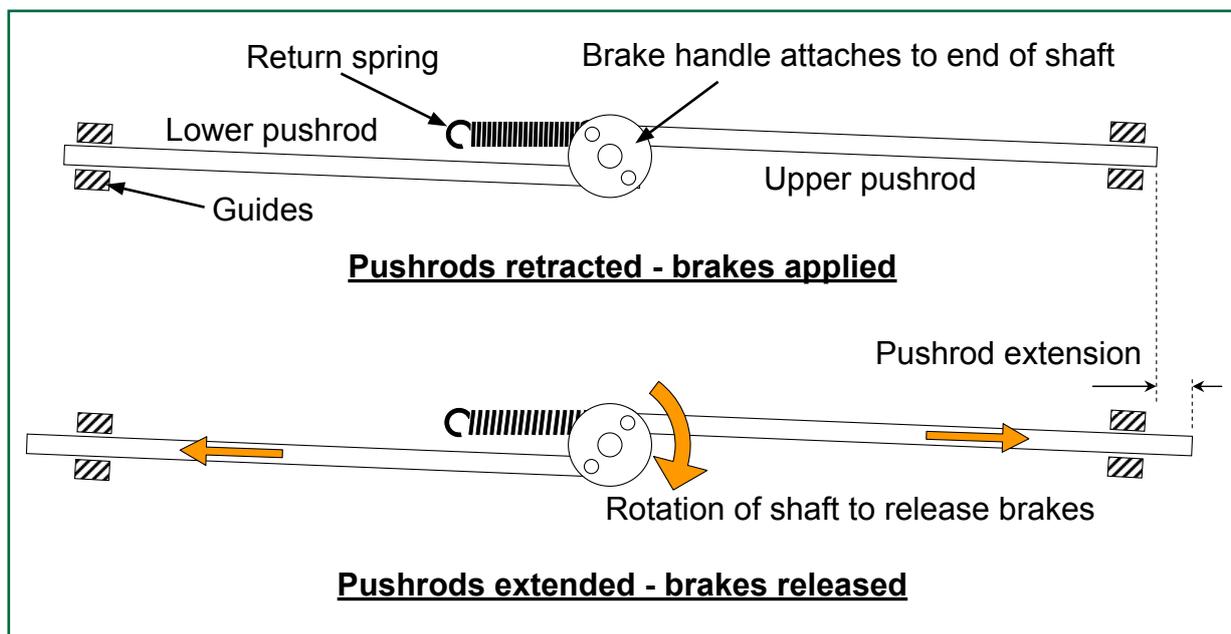
Figure D3: Two views of the brake linkage as designed, showing extension of the pushrods to release the brakes

- D3 The brake handle is used to rotate a longitudinal camshaft, which drives one pushrod per braked wheel, figures D3 & D4. When extended, the pushrods overcome the force of the springs holding the brakes on. Because the pushrods are connected eccentrically to the longitudinal shaft, they are offset from each other. The upper pushrod has a return spring to keep the pushrods normally in the retracted position. In this state, the wheel skates can be detached from the trolley deck for transporting to and from site.

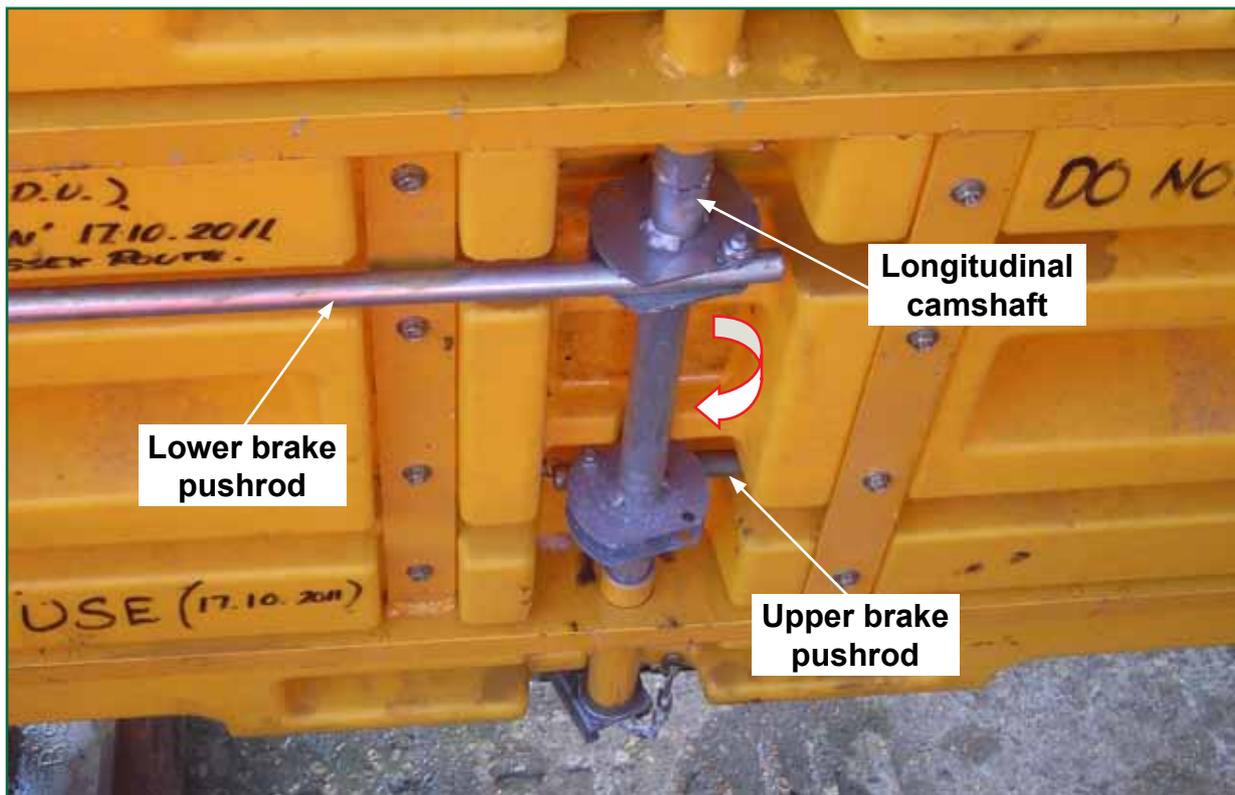
Figure D4: Underside of the trolley from Reading depot, showing brake pushrod linkage as designed

45 Although the brake handle was designed to return to the 'on' position when released, the brake linkage mechanism (refer to appendix D) may have jammed so that the handle remained in the 'off' position. Seven 'trakrat' LT1000P trolleys from four different track maintenance depots were examined after the incident, see table 1. Both of the trolleys from Havant track maintenance depot were found to have bent brake pushrods. The condition of the brake linkage was consistent with the brake handles having been forced in the wrong direction, which had probably been causing incremental damage over a period of many months (refer to appendix D, paragraph D5). All of the trolleys examined, except one, had brake pushrods which were sufficiently bent to allow the linkage to jam on occasion and prevent the handle from fully springing back. The exception, from Reading depot, was in good condition and appeared to have received little use.
