Rail Accident Investigation Branch

Rail Accident Report

Near miss incident at Ufton Automatic Half Barrier Crossing, Berkshire 4 September 2011

Report 28/2012
December 2012

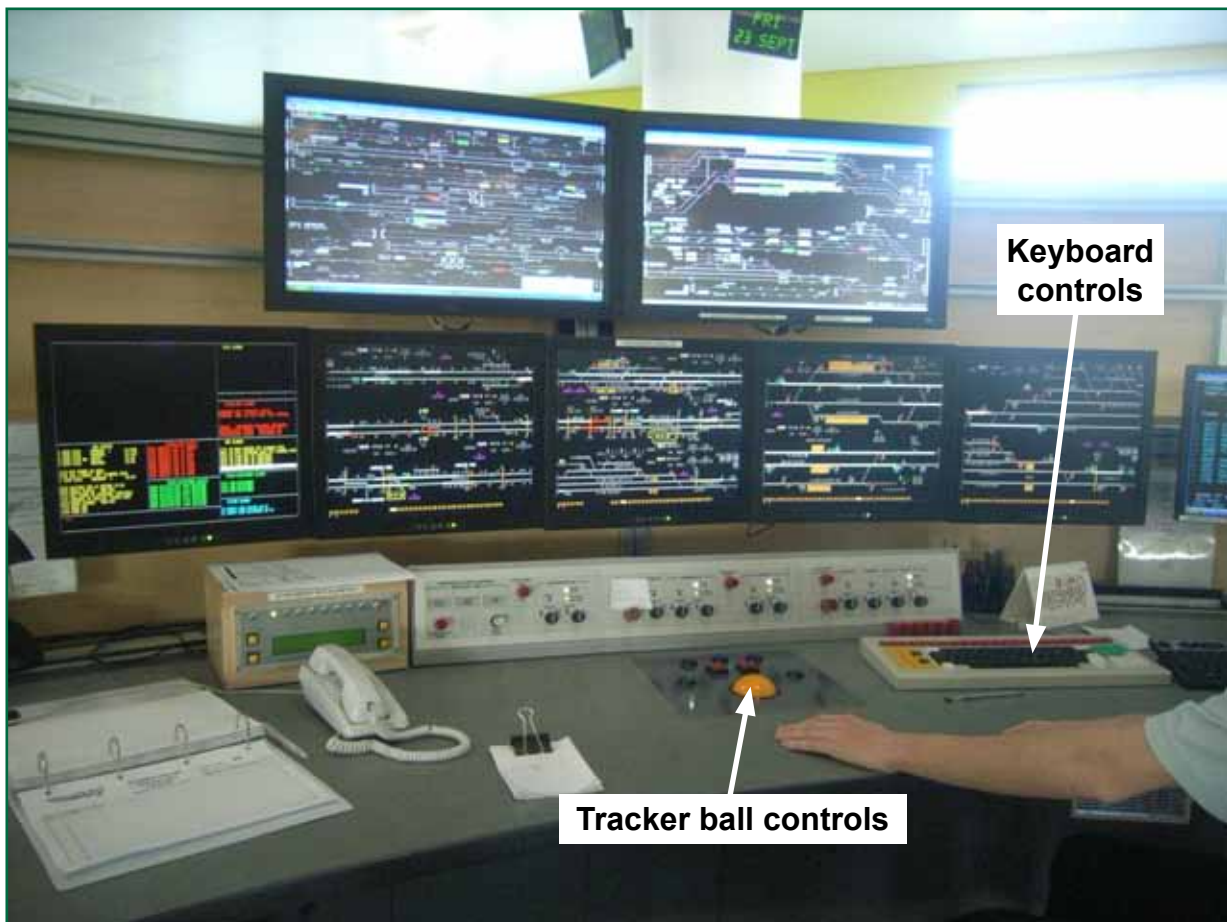
Figure 4: Newbury workstation

- 21 The TVSC contained five IECC *workstations* all in one large room with one signaller operating each of the four workstation positions and one signaller shift manager supervising the signallers at the fifth workstation. Each workstation included several flat screen visual display units (VDUs) displaying the track layout and the position of trains. The signaller monitors the trains and operates the equipment to set *routes* and operate points etc using a tracker ball with buttons and a keyboard (figures 4 and 5). Each workstation also includes a *Cab Secure Radio* (CSR) system (for direct communication with a train driver) and a touch screen telephone system.

- 22 The Newbury workstation covered the area from Theale (inclusive) in the east to Westbury (exclusive) in the west. This included Ufton crossing.

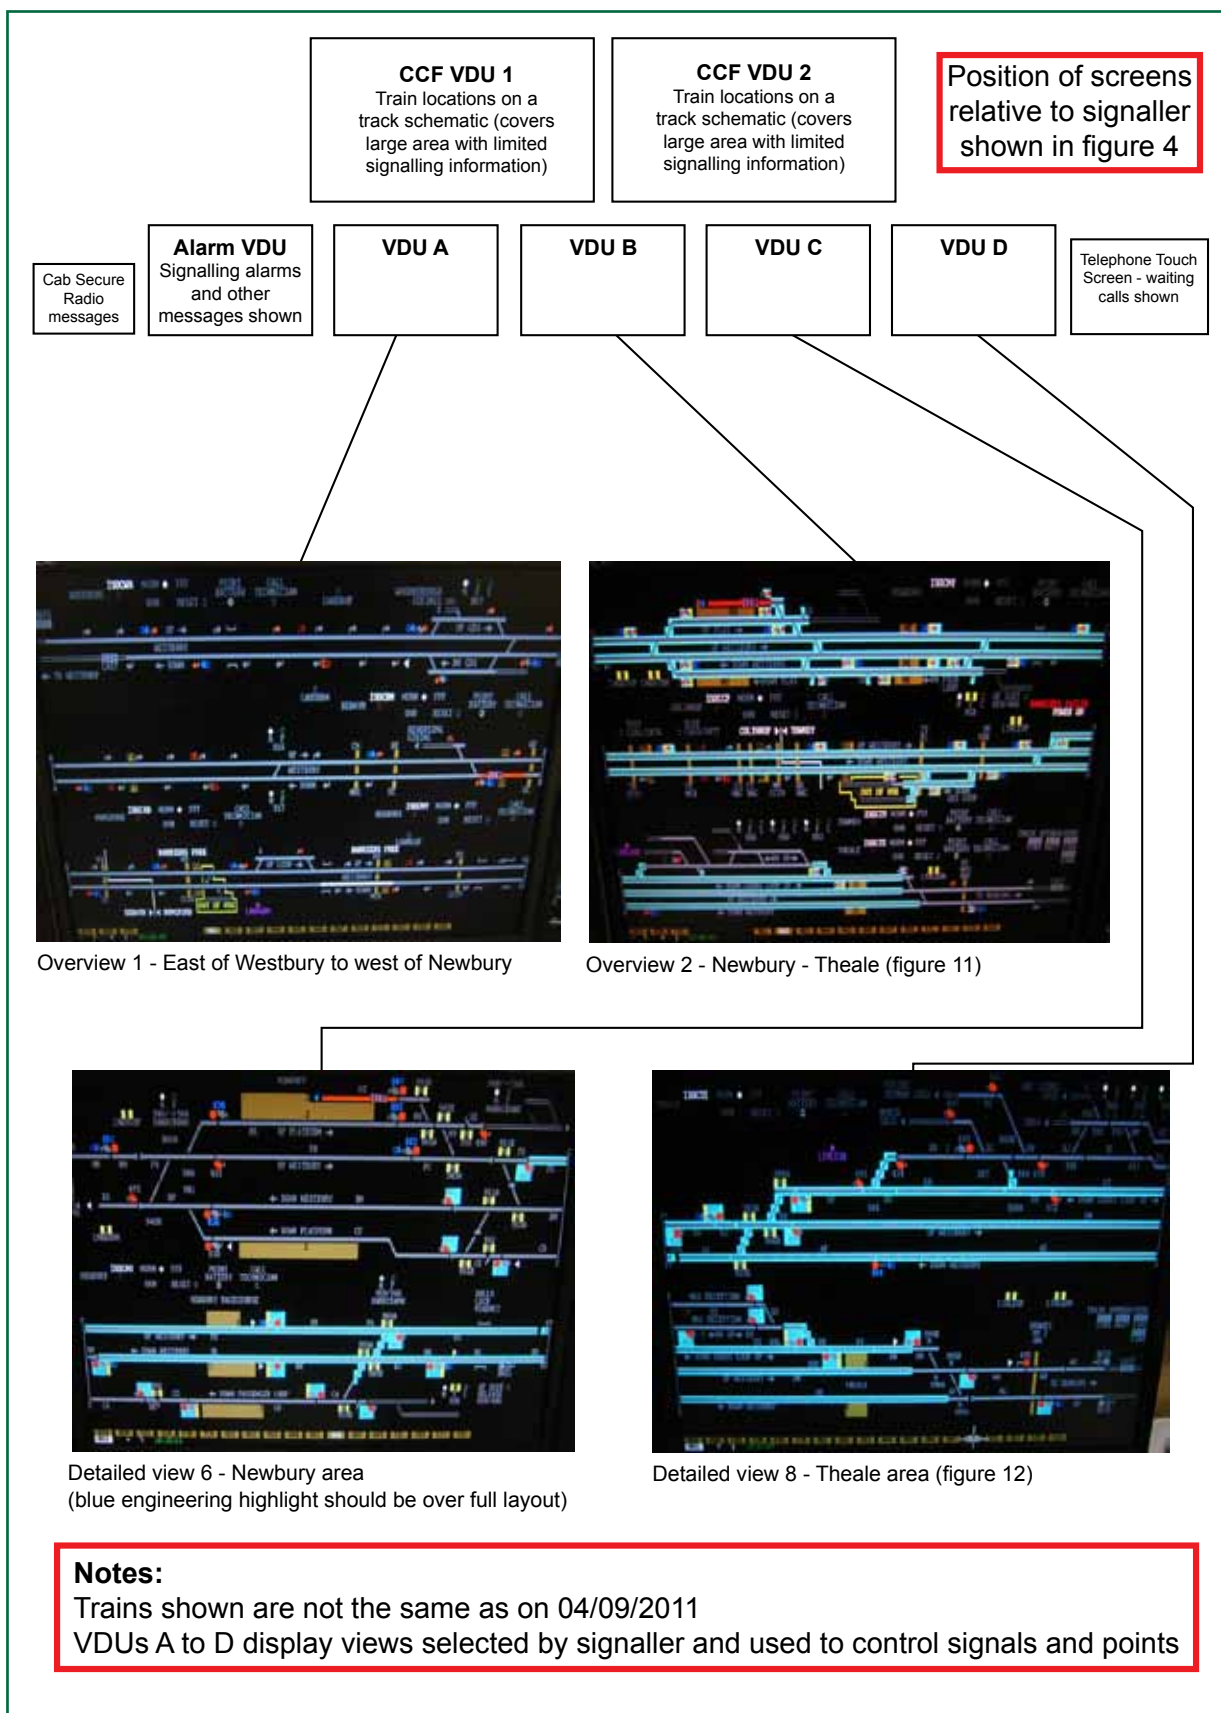
Figure 5: Newbury workstation screens as probably displayed when signaller B took over the workstation on Sunday 4 September 2012

- 108 It is possible that the signaller removed the reminder using the 'arrow' button on detailed view 8 (figure 13). Neither Ufton level crossing, nor an indication of the crossing's status (eg barriers failed) is visible when the reminder is removed using the arrow on detailed view 8. The barrier status is shown on overview 2 and (although probably not displayed when the reminder was removed) detailed view 7. Even if one of these views was displayed on an adjacent screen, the status would not be adjacent to the arrow on detailed view 8.

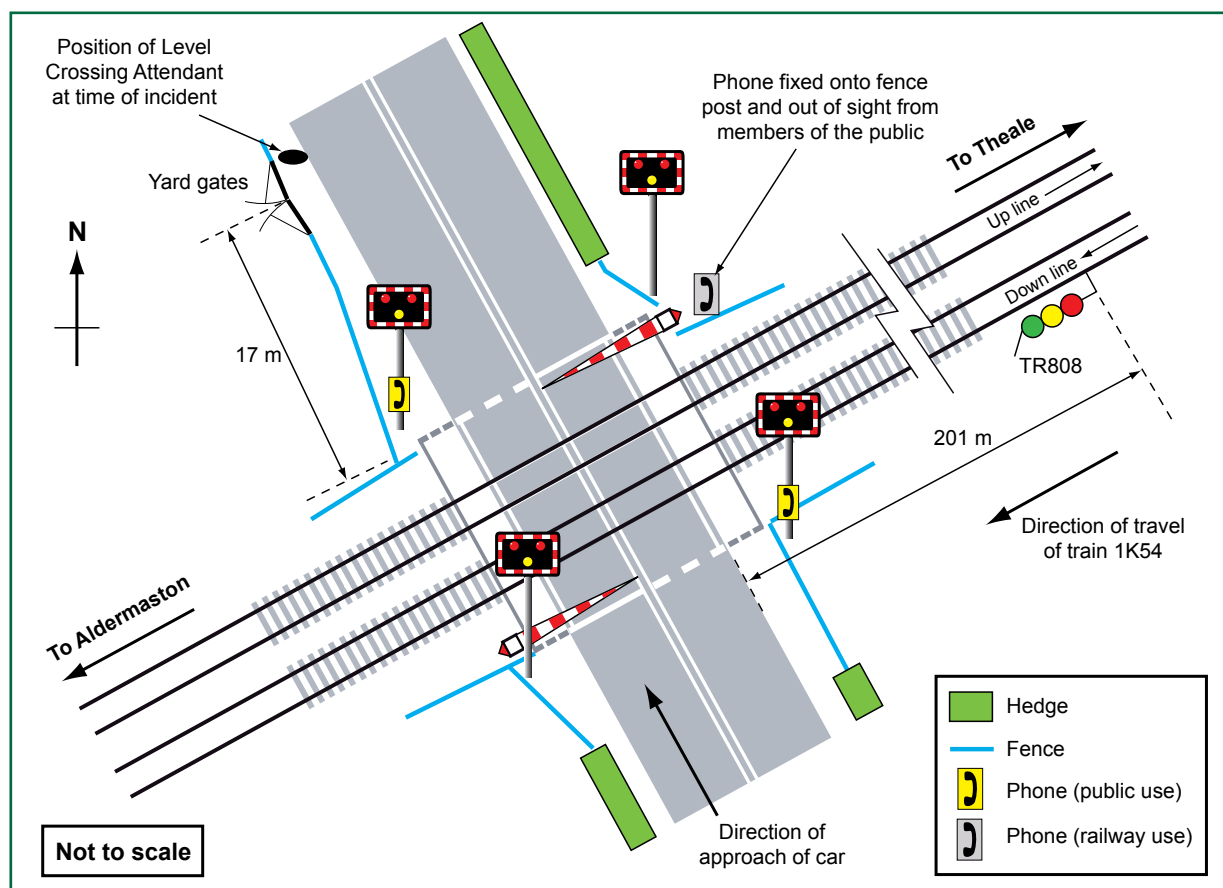
Figure 7: Plan of crossing

- 26 Ufton level crossing is an Automatic Half Barrier crossing (AHB) (figures 2 and 7). The road traffic light signals and barrier lowering are normally automatically activated by an approaching train. There is no automated linkage between an AHB and the railway signals. In normal operation the crossing operates independently from the railway signals.

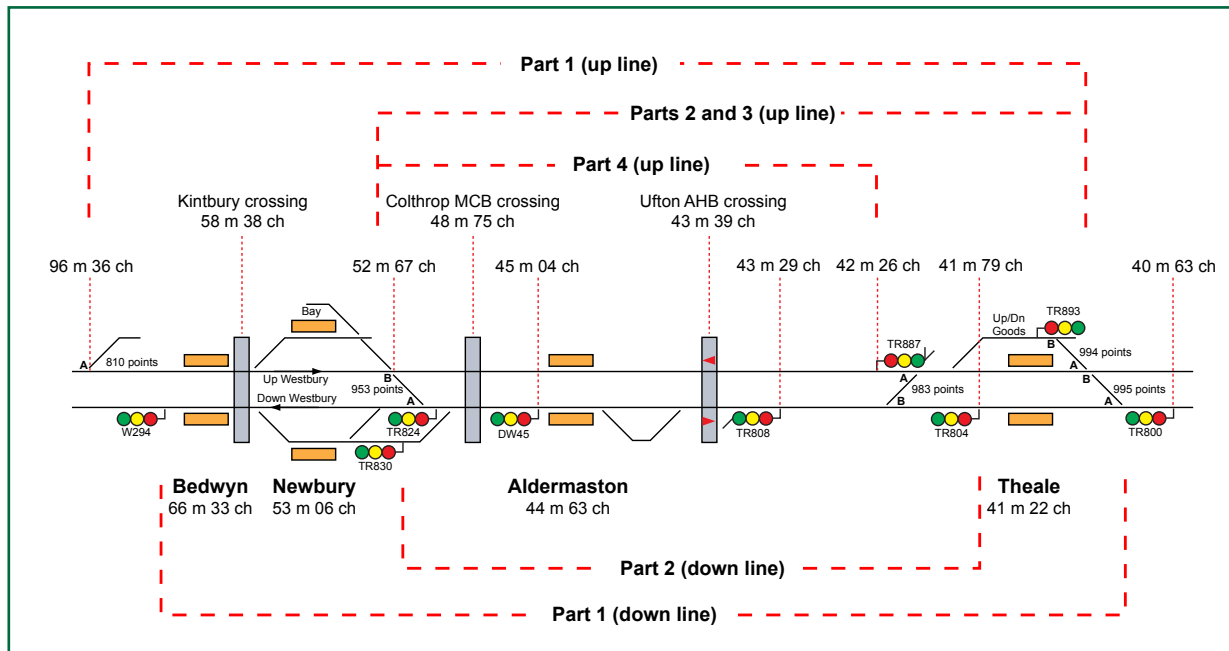
Figure 8: Schematic diagram of possession limits (parts 1 to 4)

- 32 The possession had been planned in four parts which allowed restricted passenger services to operate before all engineering work was complete (figure 8). The plan had been circulated to TVSC signalling staff and engineering staff before the possession started and a summary of the four part plan is shown below:

- Part 3: 12:20 hrs to 12:45 hrs:
down Westbury line reopened from Theale to Newbury allowing train 1K54 to operate in the down direction; and
 - Part 4: 12:45 hrs to 16:20 hrs:
crossover and up Westbury line reopened at Theale station allowing up direction trains to operate between Newbury and Theale via the down line under *single line working* conditions.

- 44 At 11:56:44 hrs, the PICOP rang signaller A to state the possession limits were now reduced to the part 2 limits (paragraph 32 and figure 8). The signaller agreed with the possession alterations and completed the associated paperwork.

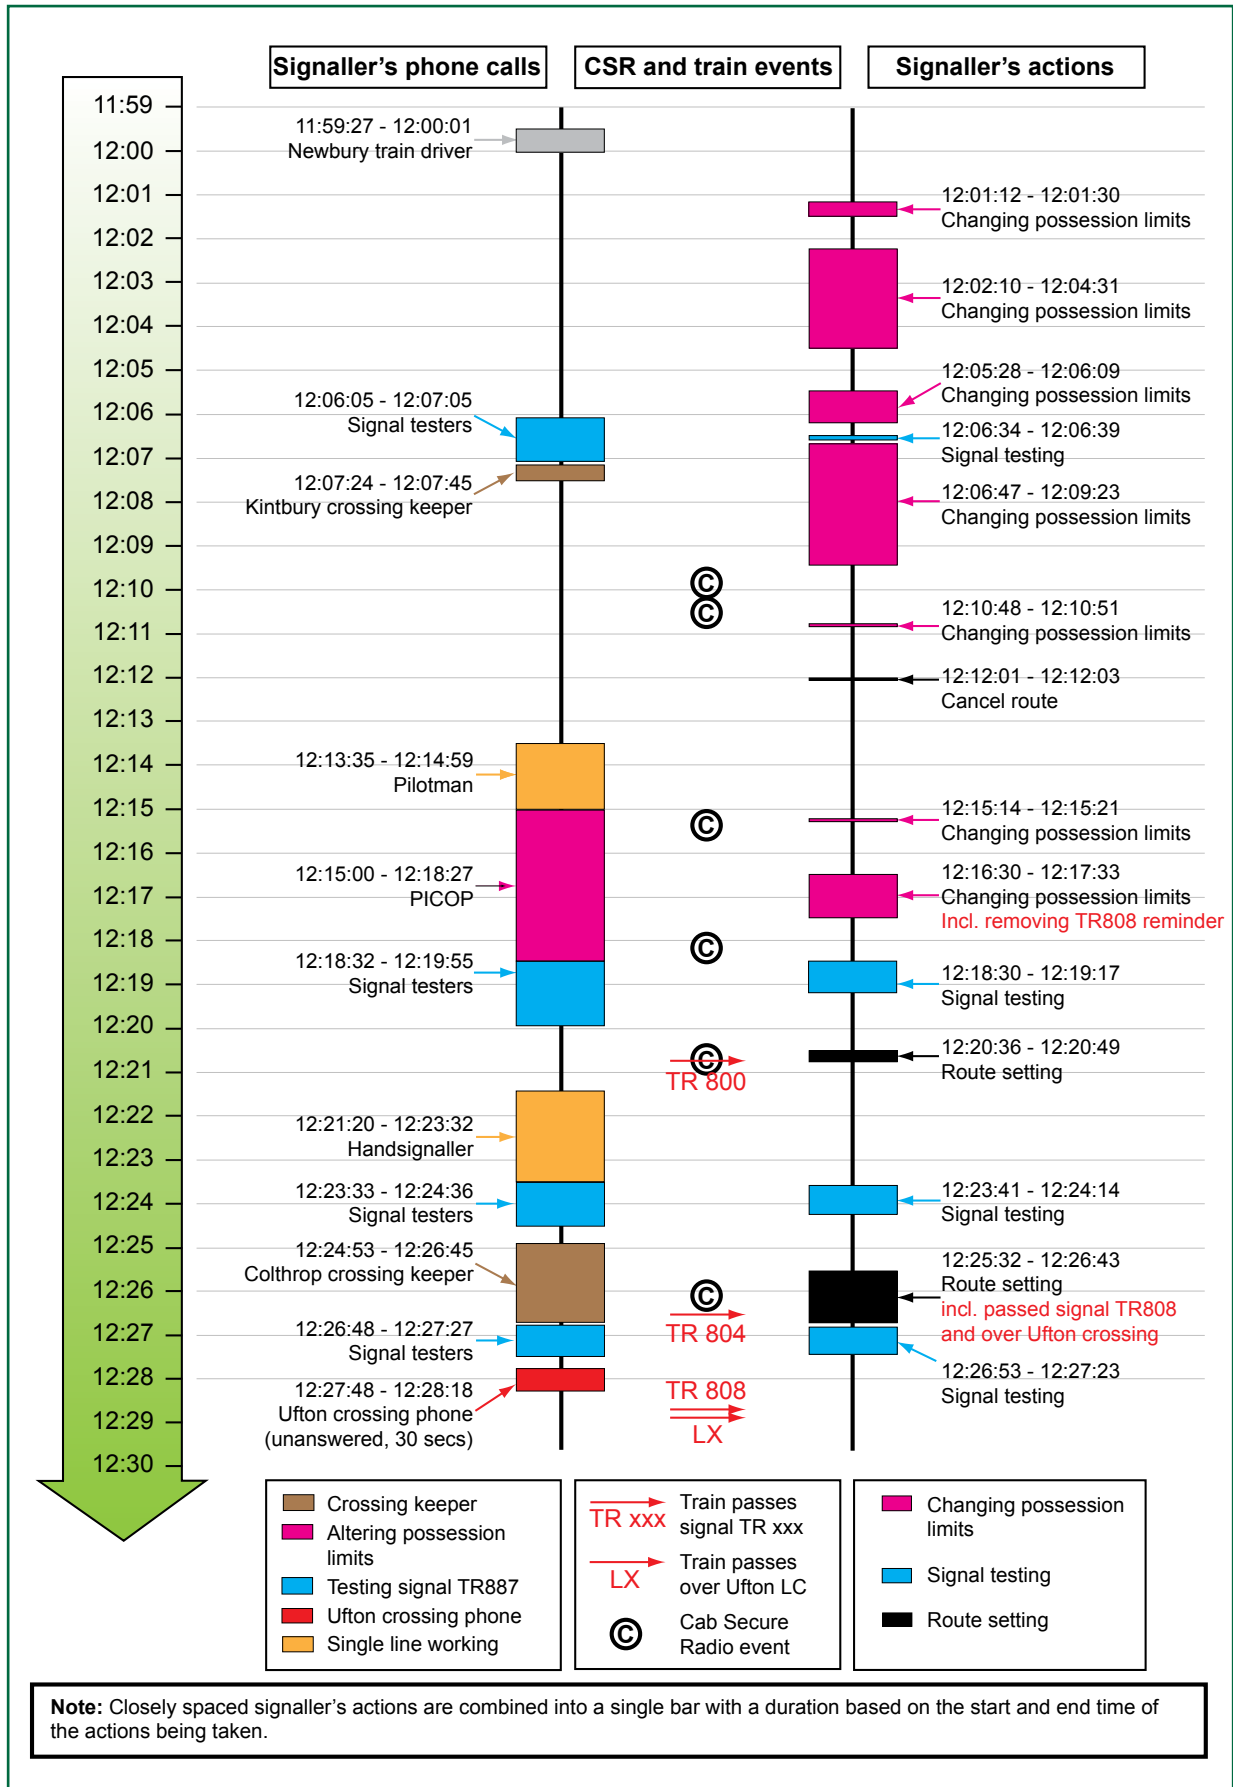
Figure 9: Timeline

- 46 Subsequent events leading to the near miss at Ufton crossing are shown on the timeline at figure 9 and described in paragraphs 47 to 67.
- 47 Signaller B immediately removed the signal reminders, point reminders and engineering possession highlighting from areas which had been returned to normal traffic when part 2 of the possession had been implemented. He then operated the controls needed to allow a train berthed in Newbury station bay platform 3 to be shunted to platform 2. These actions were completed by 12:09:23 hrs.

95 The RAIB have assessed signaller B's activities using data recorded during the incident supplemented by a 'reconstruction' undertaken on an IECC simulator. Telephone calls, cab secure radio messages and control operations (eg setting routes and applying/removing reminders) are summarised on figure 9. In addition to these directly measurable activities, the signaller also required time to complete the standard Network Rail forms used to record possession arrangements, time to view his VDUs and thinking time.
