Rail Accident Report

Derailment at Princes Street Gardens, Edinburgh 27 July 2011

Derailment at Princes Street Gardens, Edinburgh, 27 July 2011

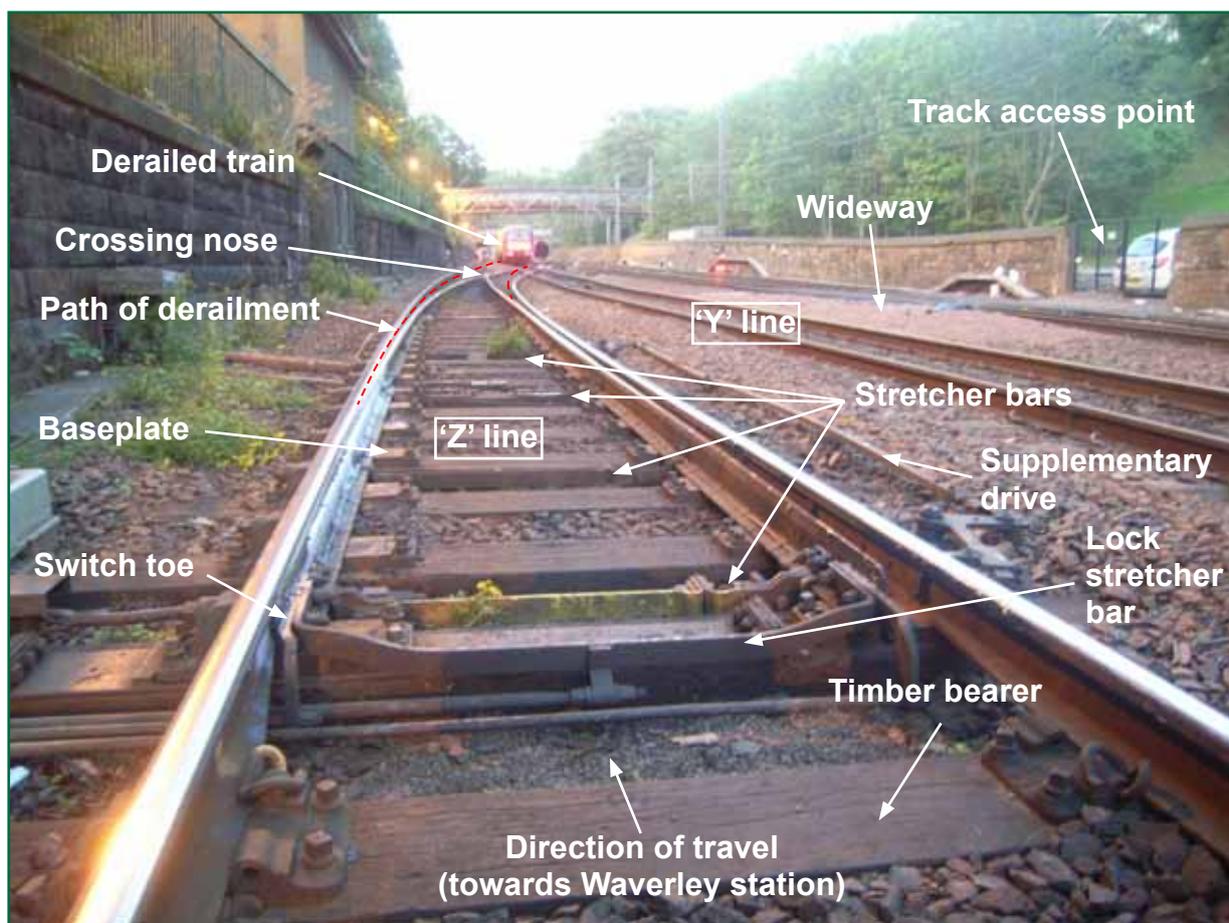
Figure 3: Points 167B

- 5 At around 17:52 hrs on 27 July 2011, train 5P37, which formed the 17:10 hrs *empty coaching stock* service from Cowdenbeath to Edinburgh Waverley, was derailed while running at 19 mph (30 km/h) on its approach to Waverley station (figures 1 and 2). The three-coach train was traversing *points 167B* in the *facing direction* and was directed to the right-hand route when the leading axle of the third coach took the left-hand route, causing both axles of the leading *bogie* to derail (figure 3). The train continued for approximately 110 metres before coming to a stand.

- 6 The driver and conductor, who were the only occupants of the train, were uninjured. The derailment caused damage to points 167B and to two further sets of points beyond, which were in the path of the derailed wheels. The track was pulled out of alignment where the derailed *bogie* was drawn across it and there was damage to track fixings and *bearers*, signalling cables and to a drainage pit. The train also suffered significant damage to the bogie and underframe equipment, and to the connecting corridor between the second and third cars. A significant spillage of oil from the final drive gearbox, which is situated on the trailing axle, occurred at the *crossing nose* (figure 3).

- 9 There are four tracks in this area, two north lines and two south lines, separated by a *wideway* (figure 3). The *Sectional Appendix* gives the lines the notations 'Z' (*up north*), 'Y' (*down north*), 'X' (*up south*) and 'W' (*down south*).
- 10 All lines are electrified by means of overhead line equipment; this played no part in the accident.

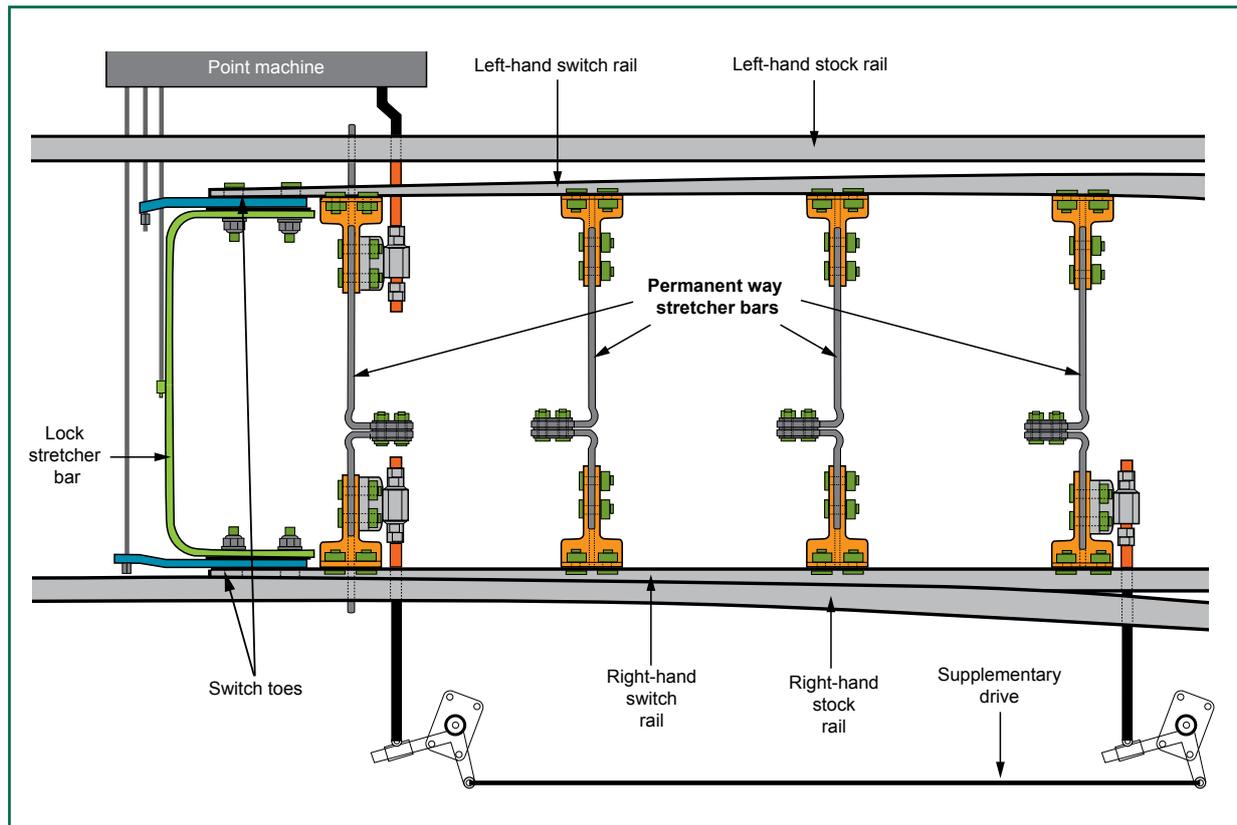
Figure 4: Simplified diagram of a set of points (not to scale)

- 19 Points 167B were located on a right-hand curve of around 450 metres radius. They were laid with 50 mm of positive *cant* on the outer (left-hand²) rail of the curve at the switch toes (figure 4), decreasing to 25 mm of positive cant at the crossing nose.

- 20 Points 167B were fitted with *switch type 'E', vertical design, full depth, chamfered* switches manufactured from *BS113A Grade A* rail and installed in 2002. The switches were mounted on timber bearers and operated on *base plates* fitted with *slipper bearings*. The *switch rails* were connected by four permanent way *stretcher bars* which maintained the designed distance between the two rails (figure 4).

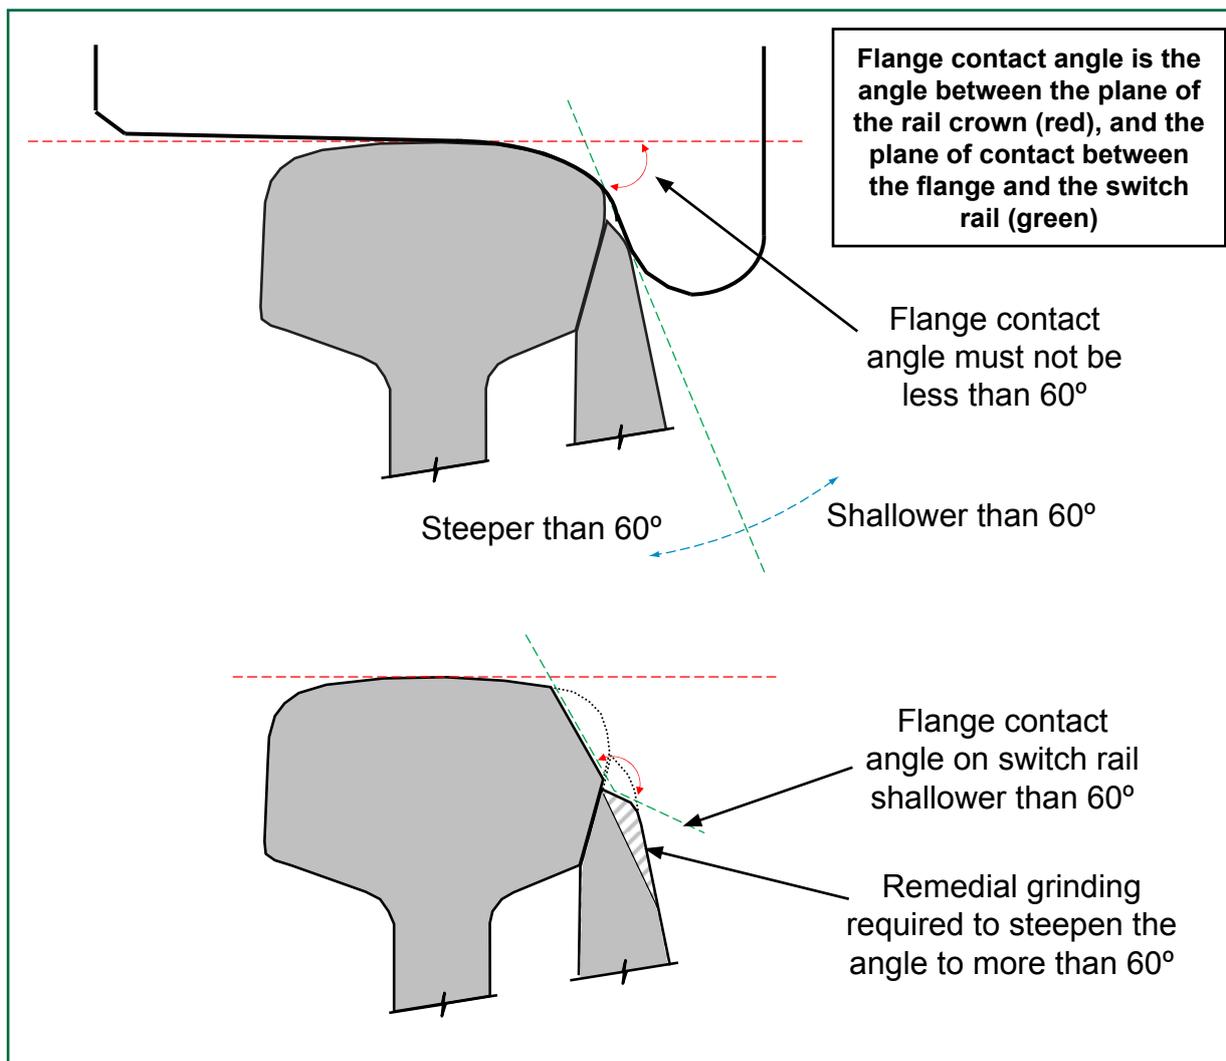
Figure 5: Illustration of derailment hazard 2 as defined by standard NR/SP/TRK/053 (issue 5)

- 36 The technical officer found the left-hand switch rail of points 167B was not compliant with the 053 standard because it failed to meet certain safety limits (paragraphs 79 to 80). The main concern was that the *flange contact angle* that the switch rail presented to the wheel flange was too shallow (figure 5) and therefore had the potential for causing a derailment. Consequently, an urgent grinding repair was organised for the following night shift on 24/25 July 2011 to restore a steeper angle on the switch rail that would meet the standard (paragraphs 82 to 83). In the interim, the switch rail remained in use for traffic.

- 55 A change in the flange contact angle to present a shallower angle to the train wheel (figure 5) in the early part of a sideworn switch (where the switch rail is steering the wheel to the turnout route) can increase the risk of derailment. Wheels that encounter such a change of contact angle may, depending on such factors as the amount of friction between the switch rail and wheel, vehicle suspension characteristics, and the speed of the train, climb up the *gauge face* of the switch rail. This is known as 'flange climb'. From there wheels can either drop back down or continue on to the top of the switch rail and take the other route. Wheel flanges usually leave visible marks on the switch rail to indicate where this is happening.

⁷ A flange contact angle of at least 60° or steeper (ie more than 60°) minimises the risk of a derailment occurring should a high coefficient of friction develop between the wheel and the rail (figure 5).

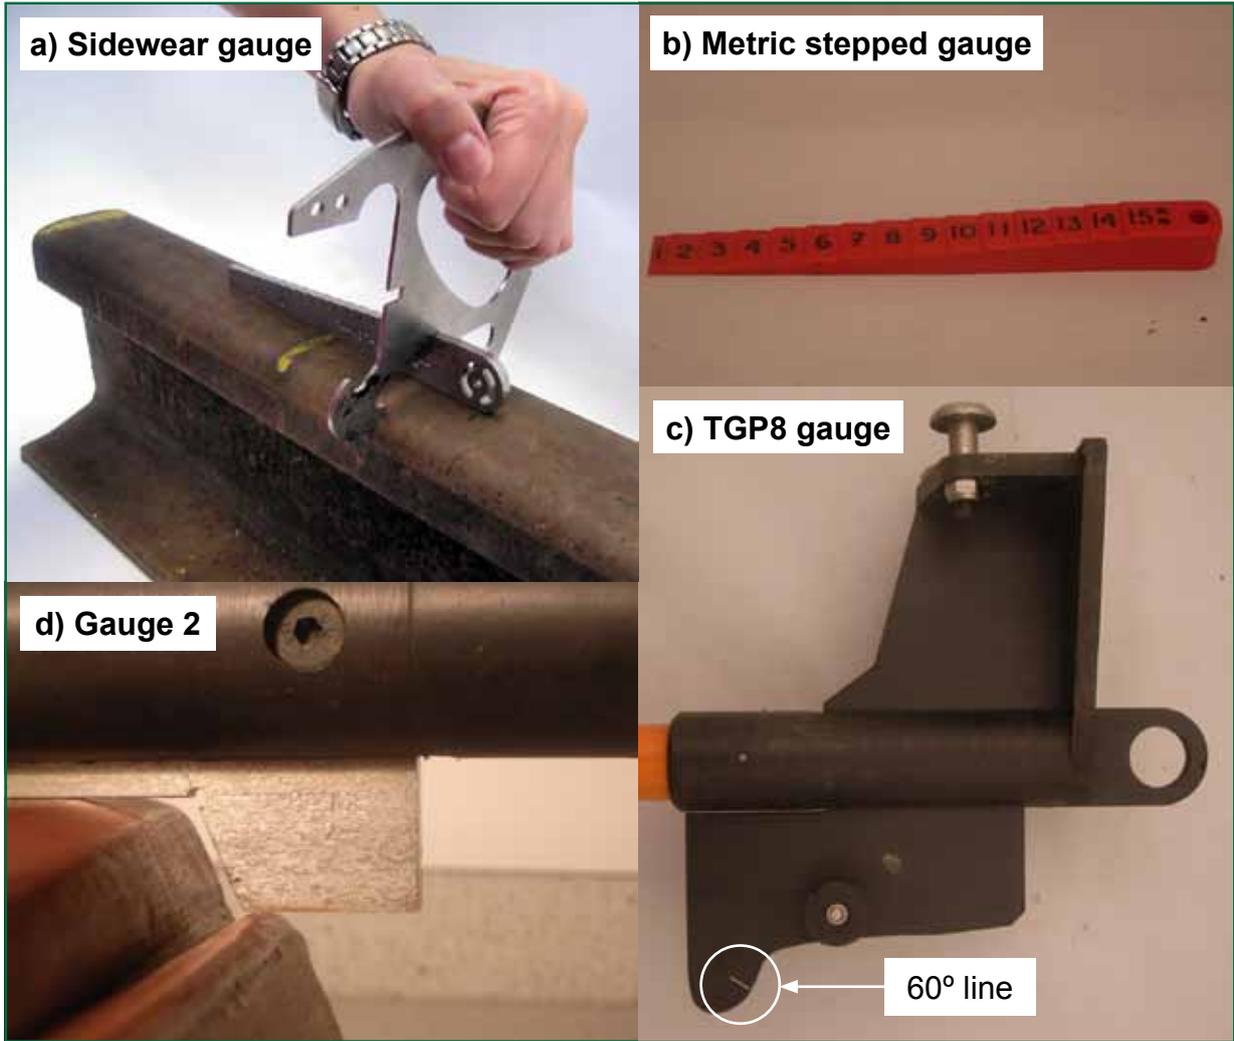
Figure 14: Gauges used in the inspection of switches

- 56 The Network Rail TGP8 gauge has the profile of a P8 wheel and is used to show where the wheel flange can contact the switch rail (appendix D and figure 14c). There is a line marked on the gauge representing a flange contact angle of 60° which is the intervention limit for derailment hazard 2⁷. A switch will fail a detailed inspection to the 053 standard if there is contact below the 60° line on the TGP8 gauge for more than 200 mm on the rail. The limit changes, however, after a grinding repair, where any single contact on or below the 60° line causes the switch to fail the inspection.

- 57 The TGP8 gauge is normally applied in the first metre of the switch rail where the wheel flange makes first contact with the switch rail. However, switch rails that are reduced in height because they have previously been ground or worn near the toe may not make first contact with the wheel flange until further into the switch and it will then be necessary to check the flange contact angle beyond the first metre. The need to extend the length of switch rail inspected is determined by gauge 2. If gauge 2 passes over the switch rail (appendix D and figure 14d) in the first metre, then the distance over which the TGP8 gauge is applied increases from one metre to three metres.
